**[Docket No. FAA-2004-19960; Directorate Identifier 2004-CE-47-AD; Amendment 39-14153; AD 2005-13-16]**

#### **Airworthiness Directives; The New Piper Aircraft, Inc. PA-34 Series Airplanes**

**2005-13-16 The New Piper Aircraft, Inc.:** Amendment 39-14153; Docket No. FAA-2004-19960; Directorate Identifier 2004-CE-47-AD.

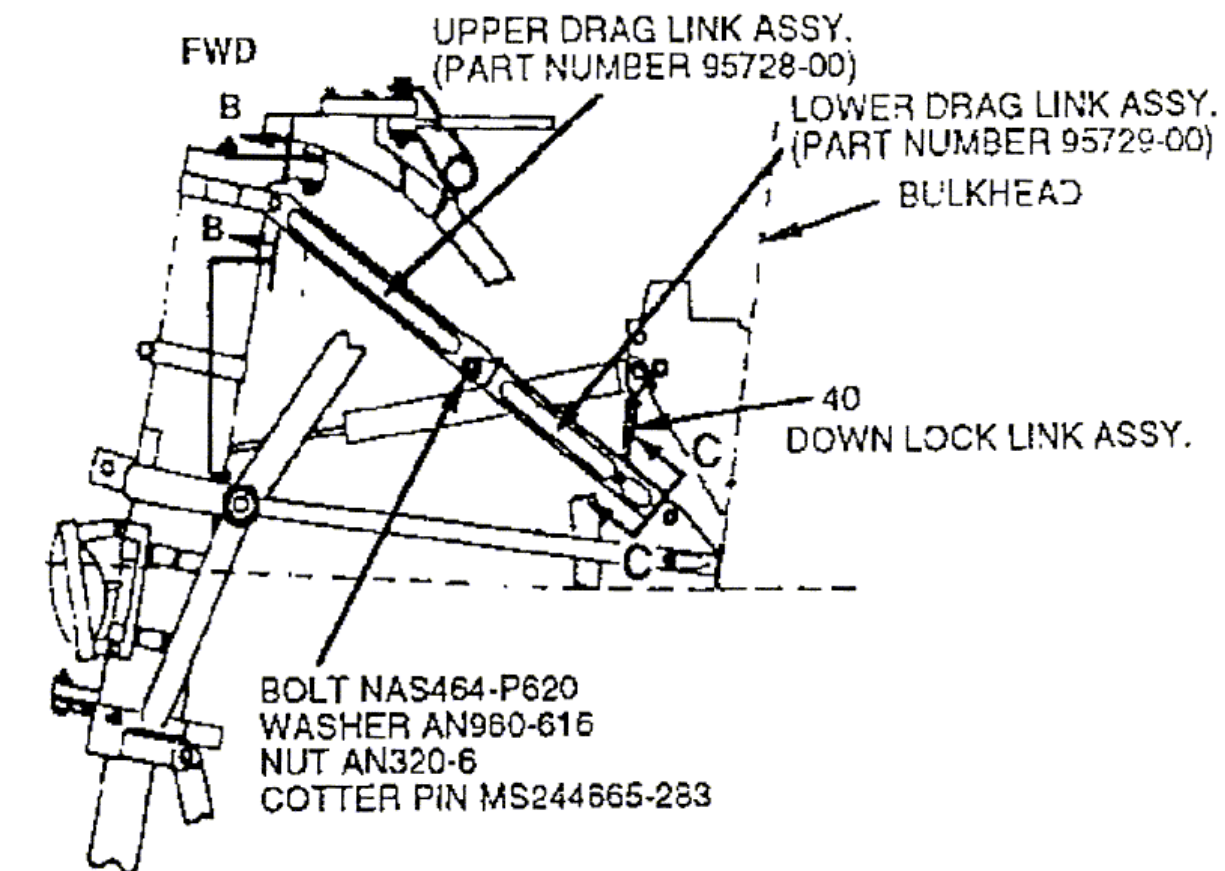
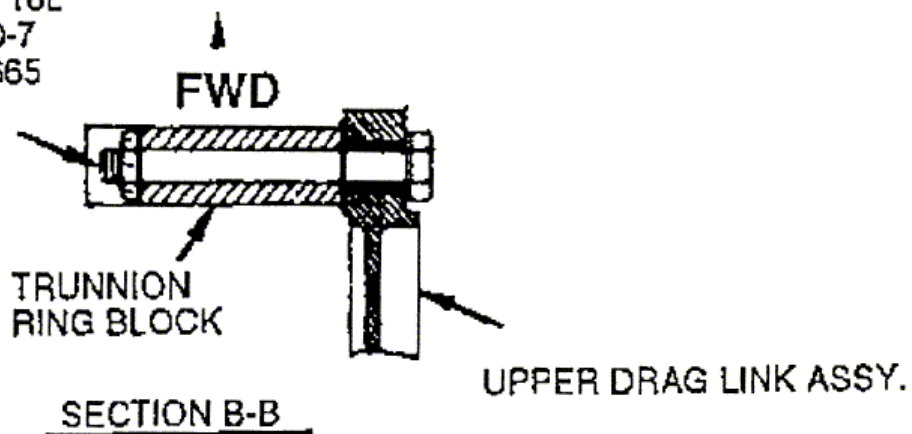
Figure 1.

AN7-35  
AN960-716  
OR  
AN960-716L  
AN320-7  
MS24665

"UPPER" DRAG LINK - TO -  
GEAR CONNECTION

Actions	Compliance	Procedures
(1) Replace the bolt and stack up that connects the upper drag link to the nose gear trunnion with new parts (or FAA-approved equivalent part numbers (P/N)) of the following: (i) Piper P/N 400 274 (AN7–35) bolt; (ii) Piper P/N 407 591 (AN960–716L) washer, as applicable; (iii) Piper P/N 407 568 (AN960–716); (iv) Piper P/N 404 396 (AN320–7) nut; and (v) Piper P/N 424 085 cotter pin.	Within the next 100 hours time-in-service (TIS) after January 28, 1994 (the effective date of AD 93–24–14), unless already done within the last 400 hours TIS before January 28, 1994 (compliance with AD 93–24–14). Repetitively replace thereafter at intervals not to exceed 500 hours TIS. Continue to repetitively replace until the actions in paragraphs (e)(2) and (e)(3) of this AD begin.	Follow Figure 1 of this AD.
