Nuts And Bolts - A Newsletter Written By Mechanics For Mechanics

# Accident Case Study

## A Tragic Case of Failure To Follow Procedures

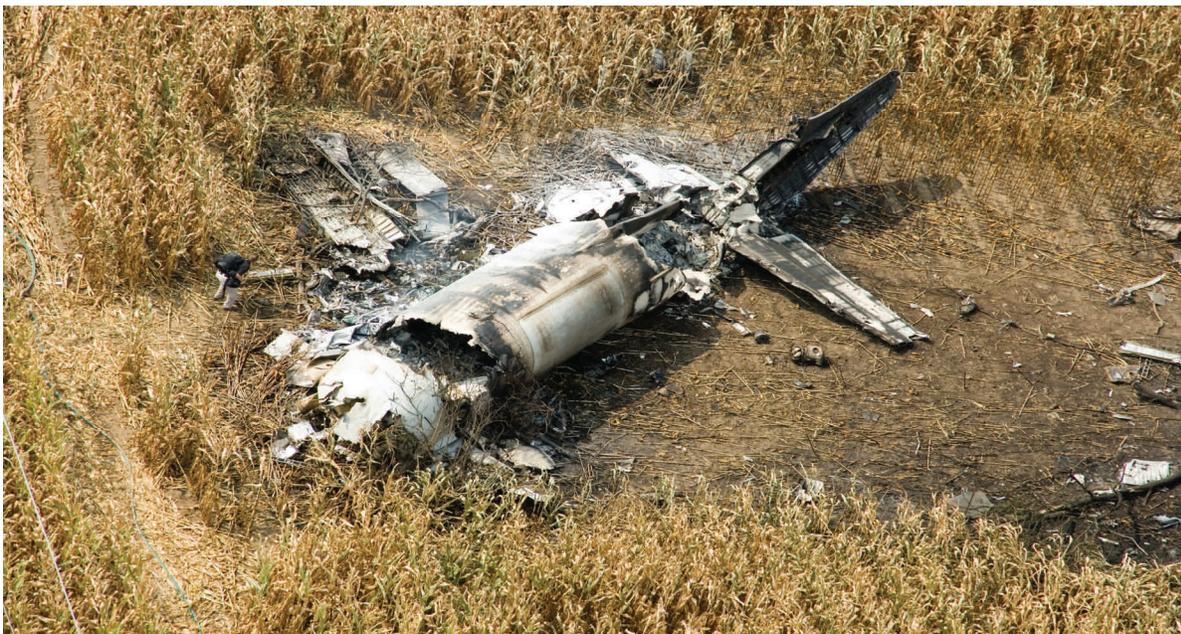
The airplane had impacted the terrain on a southerly heading. The cut through the high corn made by the airplane's landing gear, fuselage, and wings indicated that it was in a slight right wing down attitude on a glide path of about 10 degrees at impact. The initial contact with the corn revealed three parallel cuts consistent with the landing gear being in the down position. Both left and right propeller gearboxes separated from the engines and were found near the initial impact point. All four blades from both propeller assemblies were separated from the hubs and were found throughout the wreckage path. Both propeller hubs were located about 1,250 feet from the initial impact point, the furthest wreckage found in the debris field. The main wreckage was found about 825 feet from the initial impact point.

Approximately the forward 10 feet of the airplane, which included the cockpit, separated from the fuselage. It came to rest on the right side of the airplane and was consumed by post impact fire. The fuselage was partially consumed by fire just forward of the vertical stabilizer between Fuselage Station (FS) 623.00 and FS 798. The left wing had separated from the fuselage and was about 50 feet from the fuselage. It was partially consumed by fire, and fragments of the wing were found in the debris field. The right wing had separated from the fuselage. Part of the wing came to rest under the cockpit section, and was consumed by fire. Sections of the lower right wing were found in the debris field. Both engines had separated from the wings and were found with the main wreckage. A ground fire had consumed a swath of corn along the debris field.

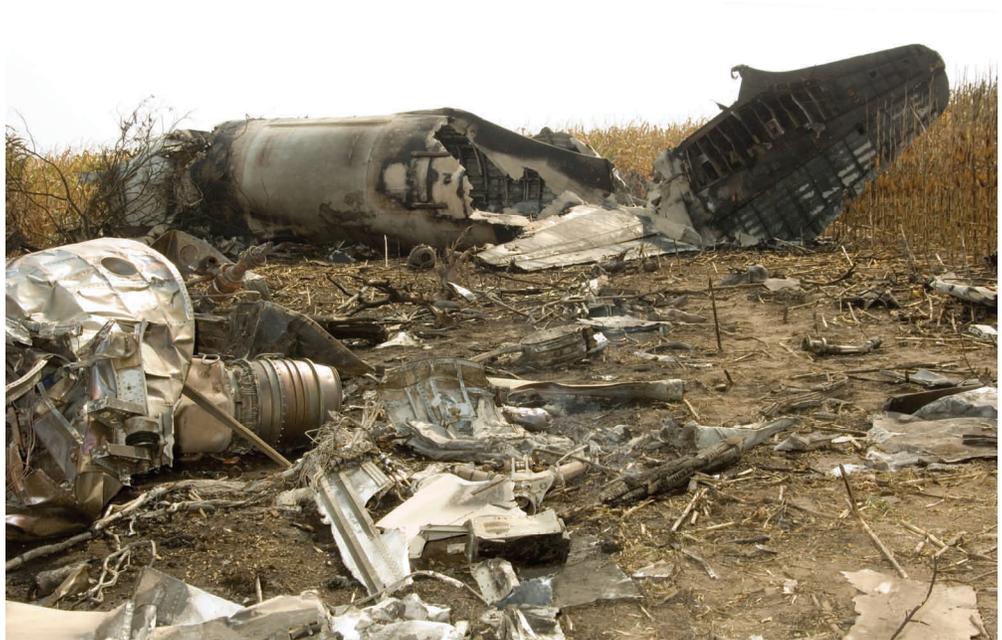
The elevator pitch control system was inspected. The cockpit and pedestal, upon which the elevator trim was mounted, was destroyed. The trim wheels were still connected to the axle, which was broken and torn from the structure. The elevator trim indicator was not visible nor was the trim drum or forward cables. The elevator trim cables were still routed through the floor beam fairlead holes to the empennage where they were attached to the elevator trim jack drum in the right horizontal stabilizer. The aft turnbuckles were intact, joined to both cables and lockwired. Although the pulleys and rubber fairleads were consumed by fire, the cables were still captured in location by their individual fairlead holes. The inboard cable at the FS 798 floor beam exited through the fuselage lower fairlead hole at FS 850 to the lower side of the elevator trim jack drum.

The Allison Maintenance Manual 1CC2-1, 8-2 page 18, Figure 8.2.108, indicated that the elevator trim inboard cable at the FS 798 floor beam, when correctly installed, exited through the fuselage upper fairlead hole at FS 850 to the top of the elevator trim jack drum. The inspection of the elevator pitch control system revealed no anomalies except the reversed elevator trim cables aft of FS 798.

The on-site inspection of the accident airplane revealed that the elevator trim cables were reversed. As a result, when the pilot applied nose-up trim, the elevator trim system actually applied nose-down trim.
