## **Continental Magneto, S6RSC-25P, Failed Distributor Gear, ATA 7414**

(This report—and the following report—comes to us from Hungary by way of the European Aviation Safety Agency. Both reports reference the same Cirrus SR22 airplane and Continental IO550N engine, but different magnetos.)

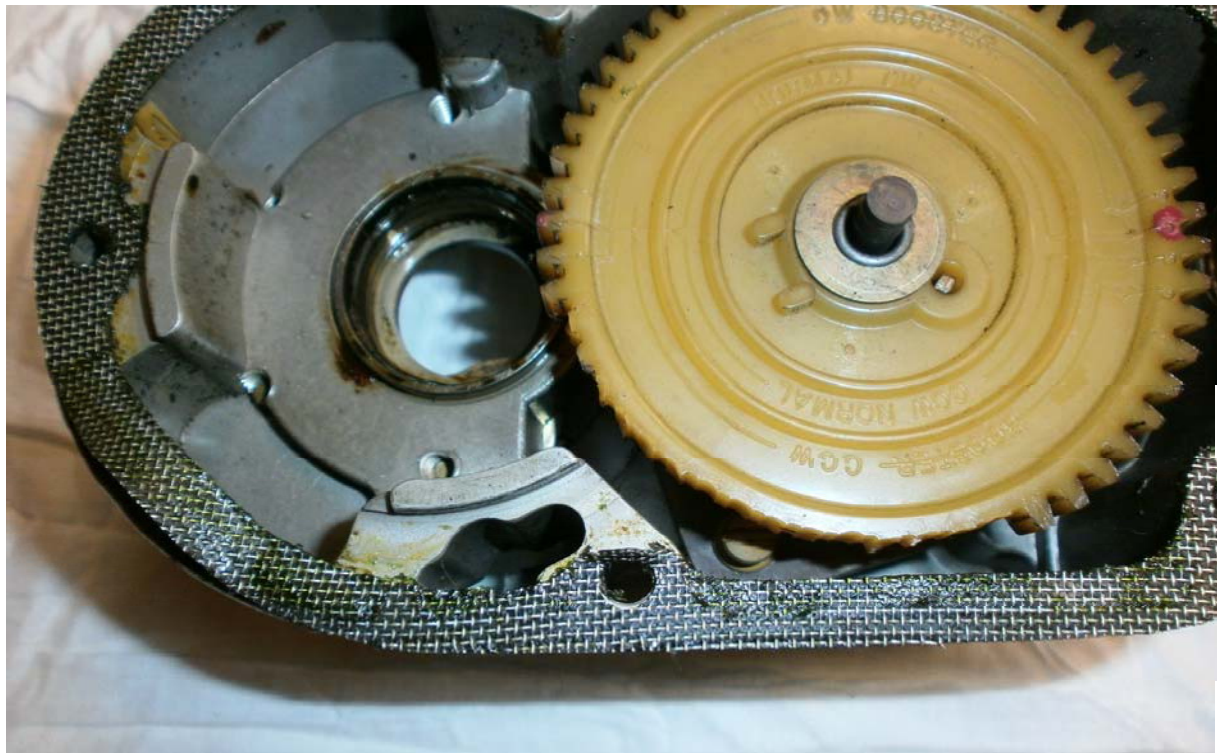
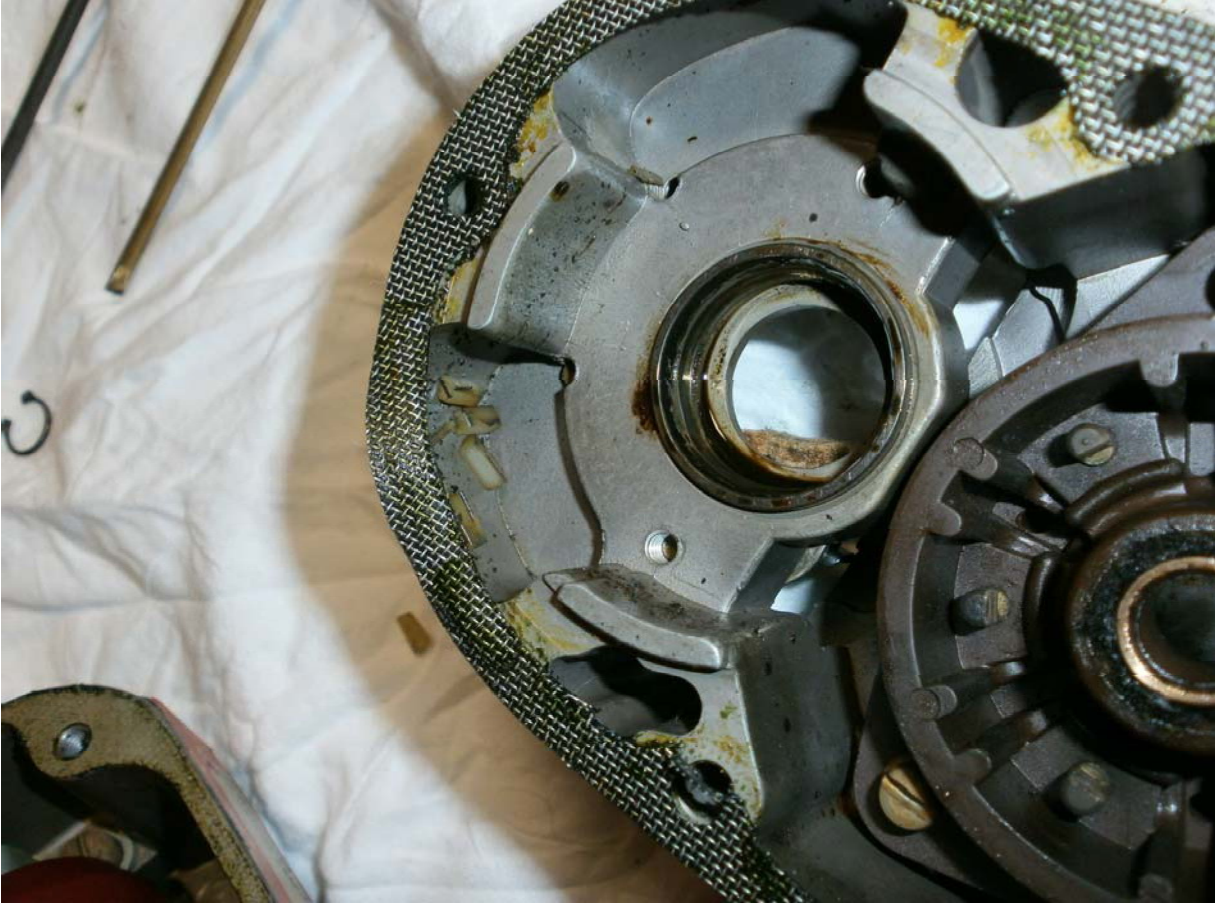
**Continental Magneto, S6RSC-25P, Failed Distributor Gear, ATA 7414**

A mechanic advised, "The crew reported severe engine vibration and raised EGT (exhaust gas temperature) at the same time in cylinder number three. A quick inspection on the ground revealed the R/H magneto to be inoperative. The operator decided to replace the magneto (P/N 10-500556-101) with a brand new one. After replacement was accomplished, further investigations followed: cylinder differential compression check; spark plug check. During this additional (inspection) we also found the ceramic on the upper spark plug of number three cylinder to be broken. It was replaced, and a test flight conducted. We climbed to 18,000 feet—everything reported normal.

"During disassembly of the magneto, the distributor gear failed. This defect might have caused an engine in-flight shut down that could lead to a loss of control. This magneto was replaced."
