## **Diamond DA40 Chafing Intake/Inlet Ring, ATA 7160**

### **Diamond DA40, Chafing Intake/Inlet Ring, ATA 7160**

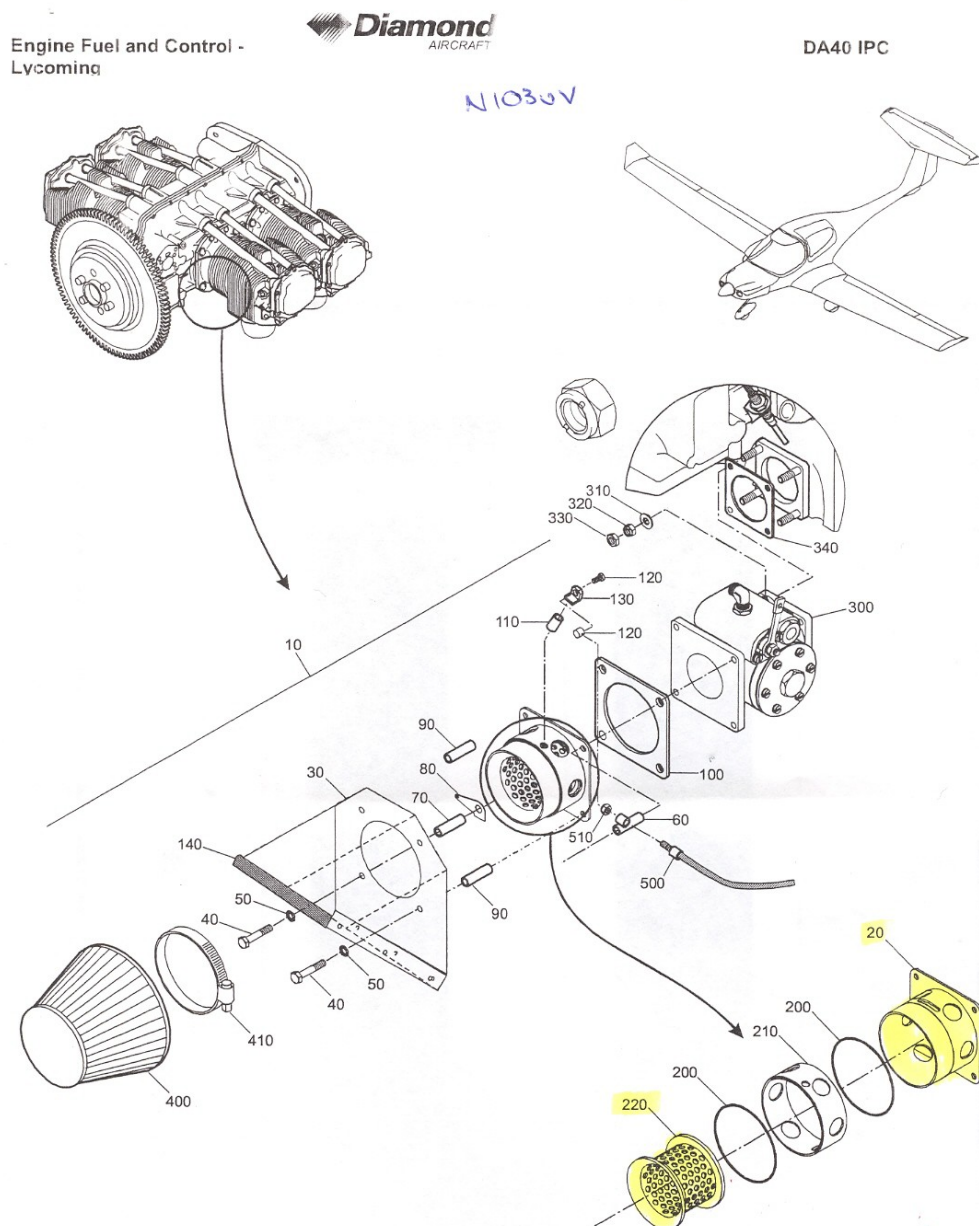
Figure 1 Engine Fuel and Control Injection and Air Filter

While performing a 100-hour inspection, a mechanic stated he found fine metal particles covering the throat and valve of the fuel injection servo (P/N 2576568-1). The mechanic sent the servo to a repair facility to determine whether any of the metal particles entered the servo's blast tubes. It has been determined the metal originated from the chafing of the loose fitting inlet ring (item 220; P/N 7166-20-31) within the flange (item 20; P/N 7166-20-33).

The loose fit is due to manufacturing. Diamond Aircraft has not come up with a fix as of this date. For now, we are cementing the inlet ring to the flange while awaiting a permanent fix.

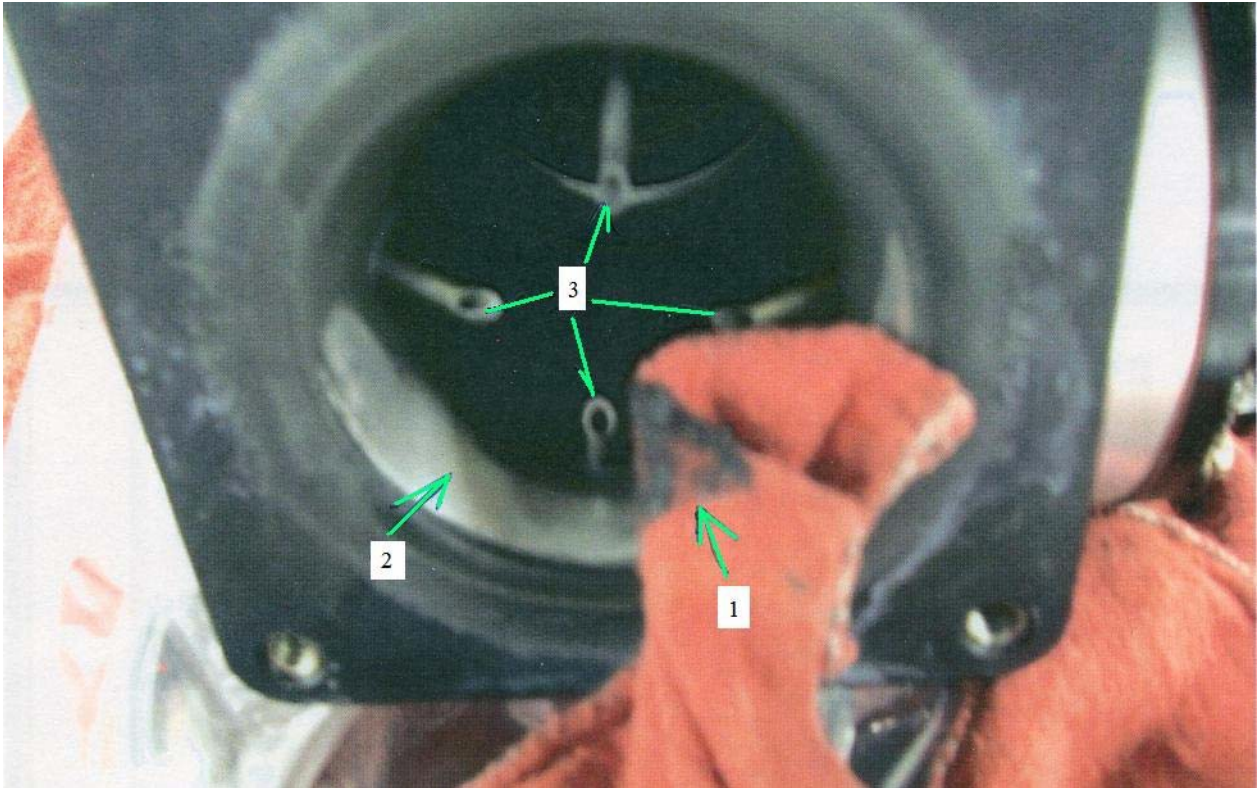
Figure 2 Fuel Injection Servo Inlet Showing Metal Particles

"Here you can see the metal adhering to the rag (1), and the resulting clean area at the inlet of the fuel injection servo (2). The particles coated the entire length of the throat and valve. We were concerned metal may have been ingested into the blast tubes (3). Upon inspection by an overhaul facility, it was found that no metal had entered the blast tubes."

Part Total Time: 686.5 hours.
