Bombardier CL-600-2B16, Water heater Failure, ATA 3820

AL 2009-01

10 February 2009

Galley or Washroom Water Heater failure

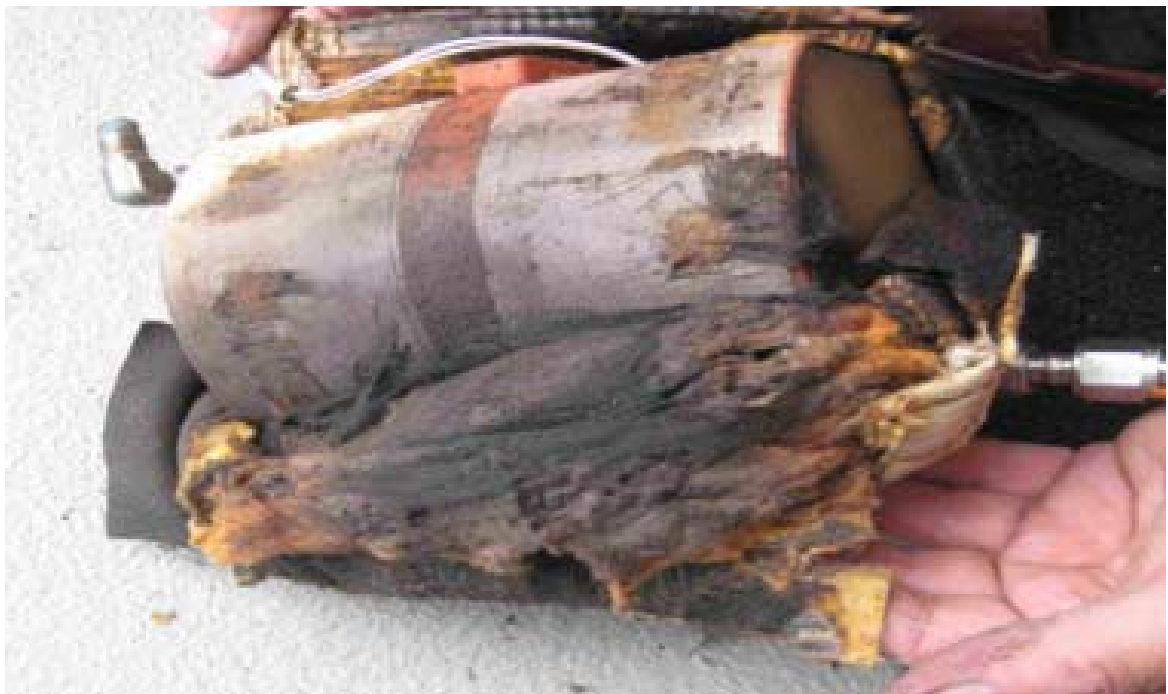
Transport Canada Civil Aviation (TCCA) has learned through the Service Difficulty Reporting (SDR) program that a Bombardier CL-600-2B16 (601-3R) Challenger's crew observed smoke coming out of the fuel control panel in the forward galley area. The aircraft declared an emergency and made a successful landing. Investigation has revealed the water heater insulation blanket in the forward galley had evidence of heat damage. The heater (P/N 444-0007 or 500-0120-7-0) is part of a United States Supplemental Type Certificate (STC) – SA696GL and SA4370SW.

Further investigation revealed the thermostat on the heater had failed allowing the temperature to climb well above design limits causing the heater's insulation and the adjacent aircraft insulation to begin to overheat (smoke). There have been four (4) known previous events where the thermostat has failed with similar results.

Transport Canada recommends that all operators and Approved Maintenance Organizations review aircraft records and verify if their aircraft has had interior modifications carried out at either Gulfstream's (formerly KC Aviation) Appleton or Dallas facilities. Also, TCCA highly recommends a visual inspection be carried out for this heater installation and evidence of water heater overheating at the earliest possible opportunity.
