Learjet 45, Failed Hydraulic Pressure Switch, ATA 2915

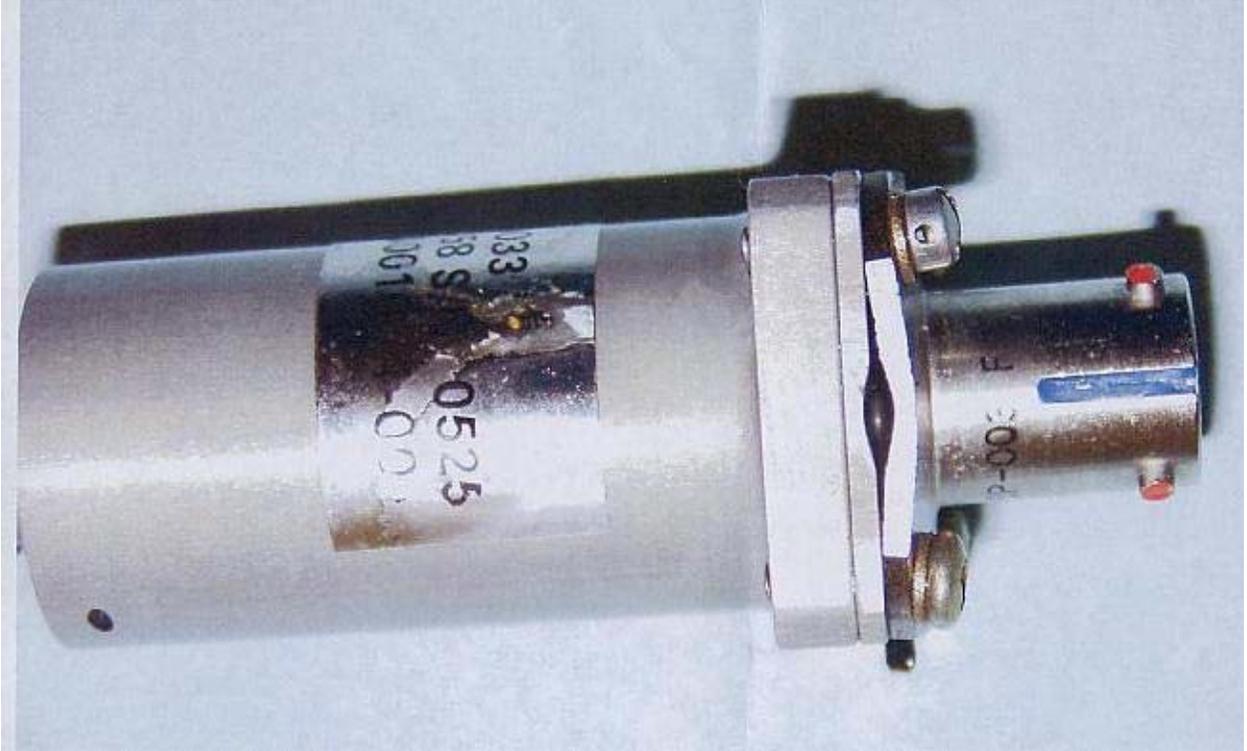
The crew diverted to the designated alternate airport, completed abnormal checklist procedures, declared an emergency, and executed a safe landing. Inspection of the aircraft revealed the left main hydraulic pressure switch S9 (*P/N 7629001004-001*) had failed, allowing the hydraulic fluid to escape under pump pressure until sufficient quantity was lost and resulted in cavitation in both left and right hydraulic pumps. This cavitation apparently caused pressure spikes of sufficient force to rupture both pump pressure output flexible hoses. This caused the failure of both pumps and the mechanics suspected it caused the landing gear control valve to fail. This (*control*) valve was inoperative during post-repair functional checks. The landing gear failed to retract when selected (*to the*) 'UP' position while the aircraft was on jacks and under pressure from a hydraulic power unit.

Based on the damage found on the S9 pressure switch, the submitter believed the probable cause of the switch failure stems from pressure spikes within the hydraulic system or an inadequate design of the switch assembly.

This failure resulted in a repair exceeding \$36,000.00 and 5 days out of service. If a hydraulic fuse had been installed and functioned correctly... the repair costs would have been approximately \$2,000.00 with 1 or 2 days out of service. The Team attached photos of the S9 pressure switch and ruptured hydraulic hoses.

The mechanics notified the Bombardier technical services of the issue; they indicated an awareness of other switch failures. The mechanics team recommended that a review of the hydraulic system be conducted to determine if pressure spikes are evident, especially during high flow/high pressure situations.

The repair team strongly urged Bombardier to install hydraulic fuses in the supply lines to the two (2) pressure switches (S8 and S9). The Team believed if a fuse had been installed, this switch failure would have resulted with a very small loss of hydraulic fluid and the crew would have managed the indicated CAS message as a possible switch failure (given pressure indications from a separate transducer would have indicated normal pump output).
