Gulfstream G200, Burned Lavatory Electrical Connector, ATA 3897

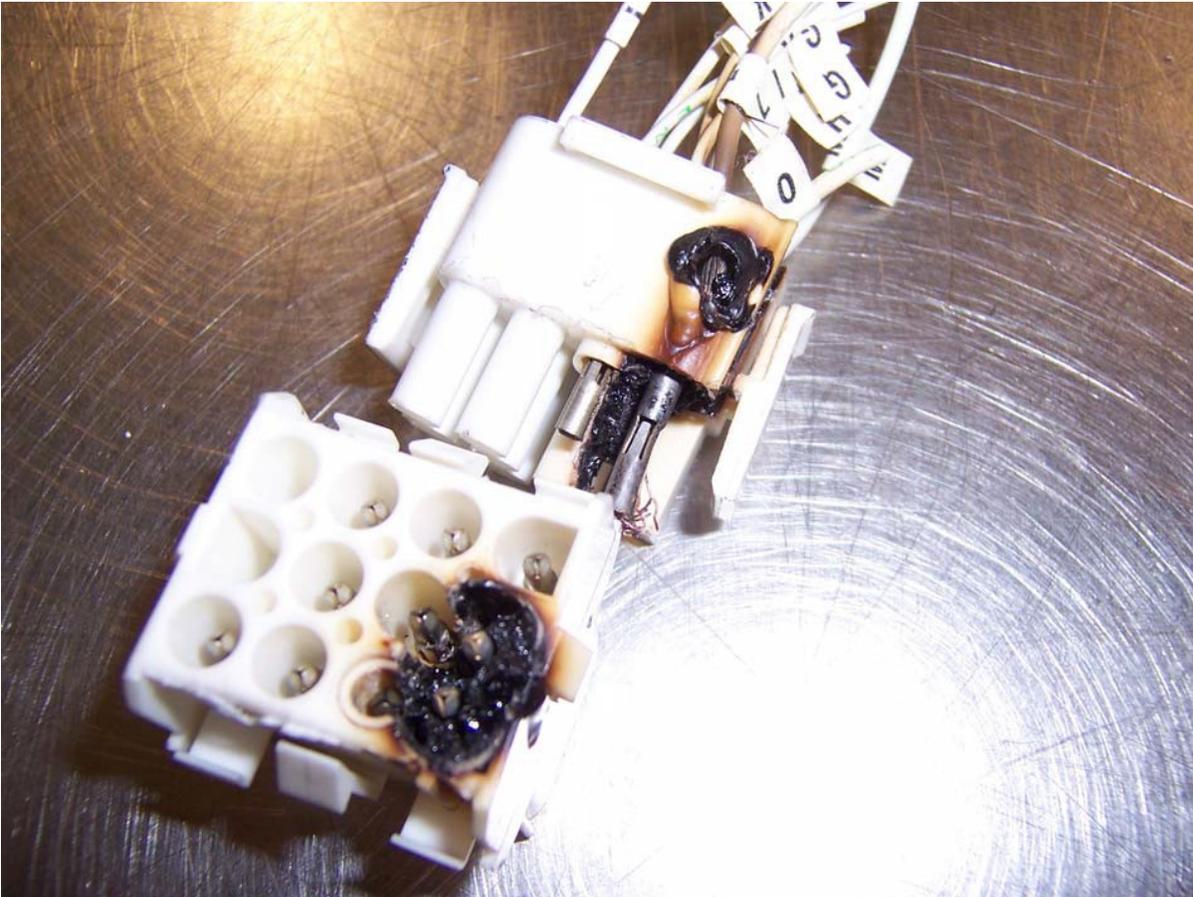
An electrical technician states, "While troubleshooting the flight phone (1) found the lavatory plug (number) 548 P2 showing signs of discoloration and overheat. I capped and stowed the wires for 548 P2 IAW WDM 20-00-00. I collared (blocked) the circuit breakers for the lavatory water heater, the ribbon heater, the water system control, and the toilet—and verified no power at plugs 548 P2 and J2."

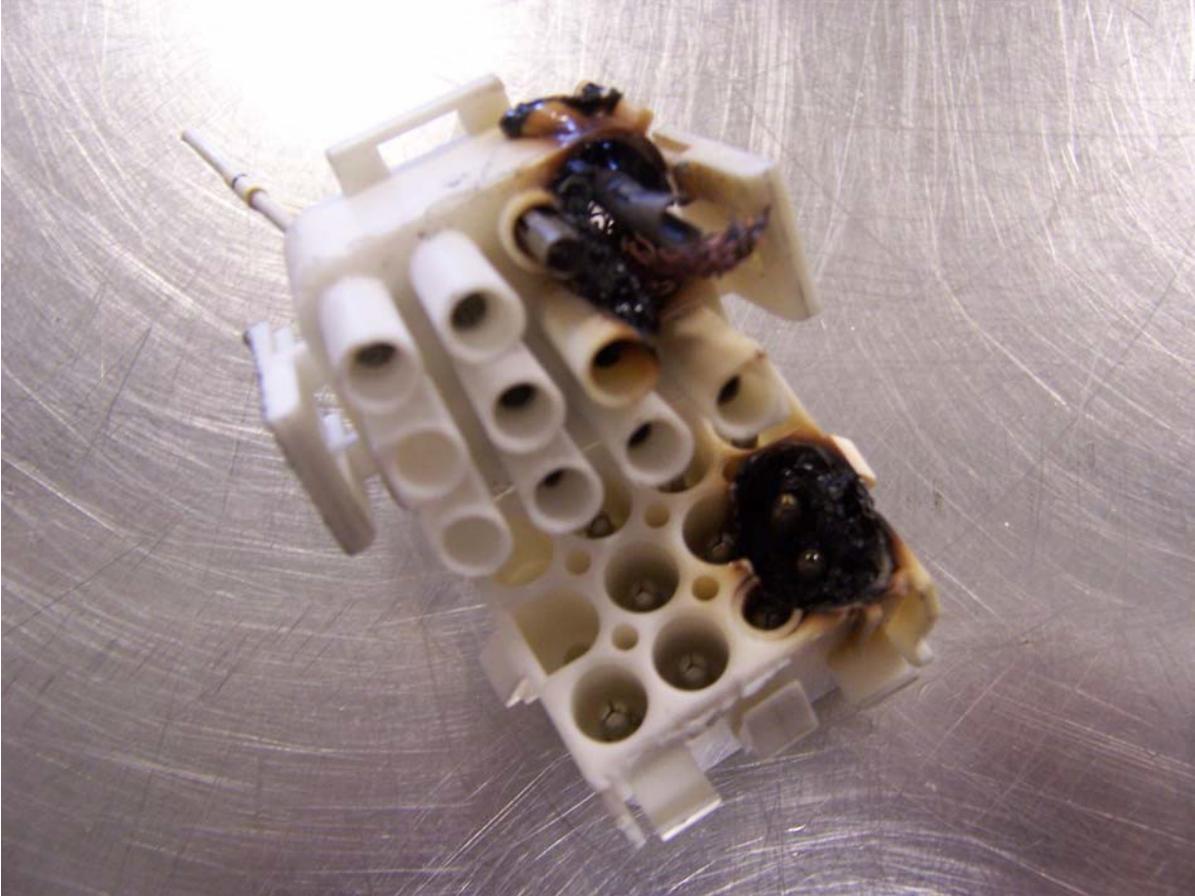
Gulfstream G200, Burned Lavatory Electrical Connector, ATA 3897

Part Total Time: 2,869.0 Hours
