Cessna 172S, Failed Ignition Switch, ATA 7430

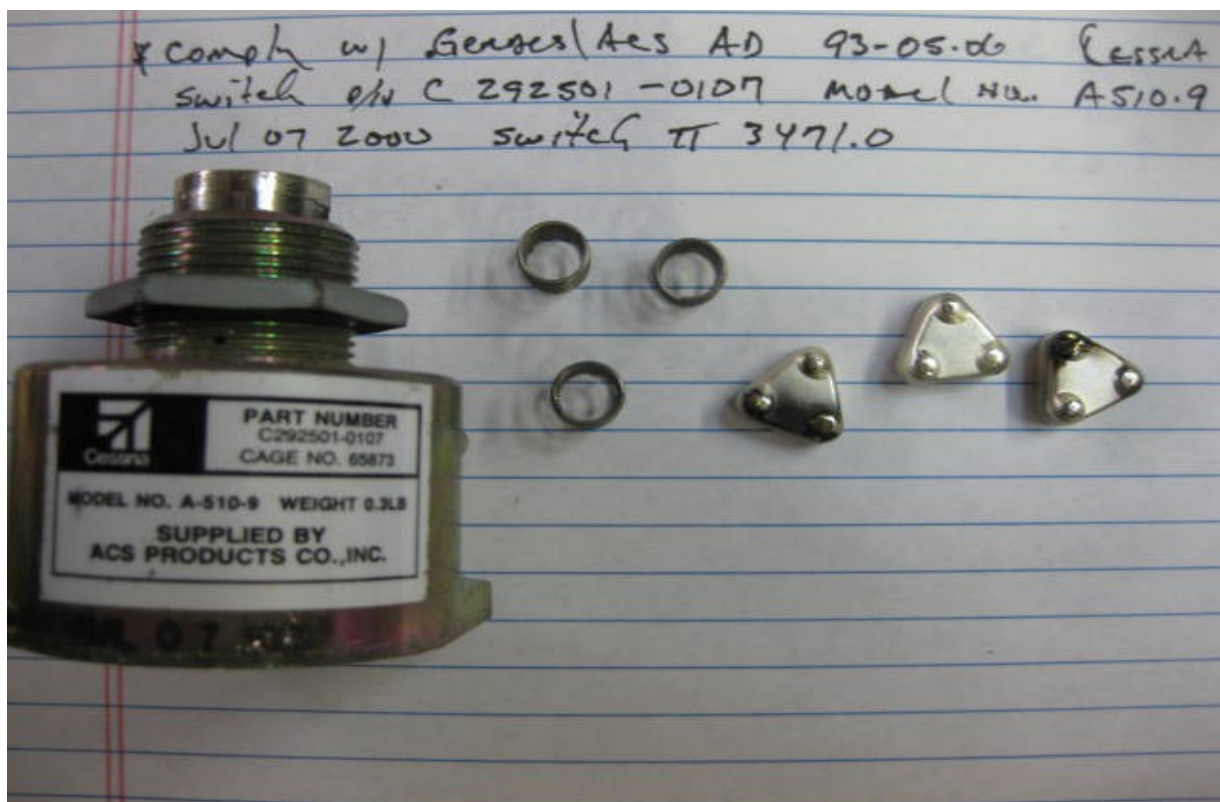
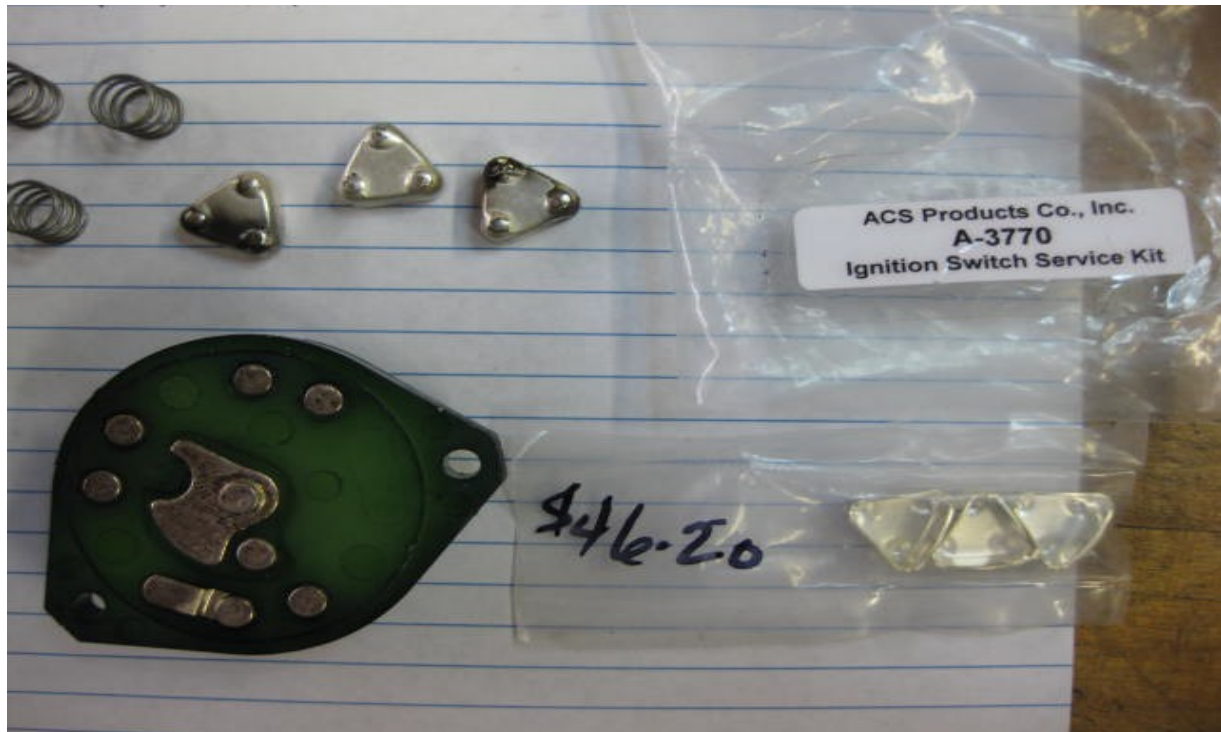
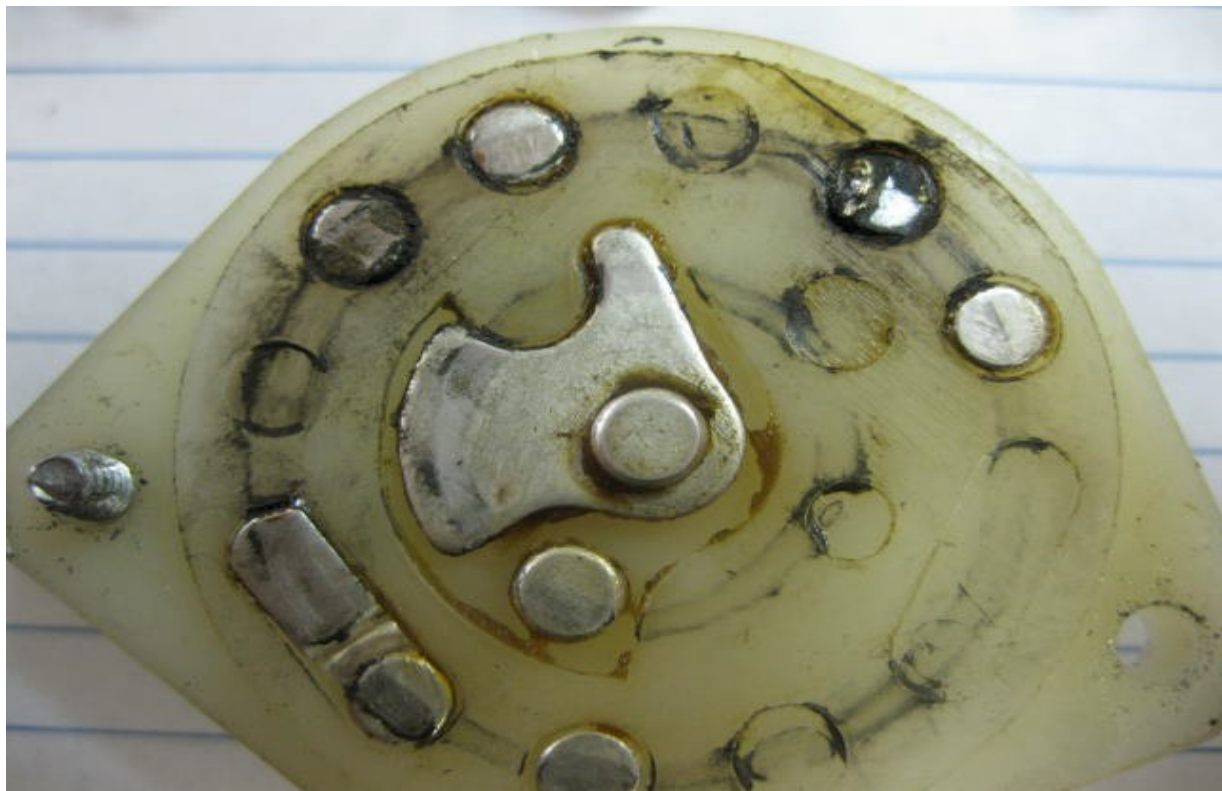
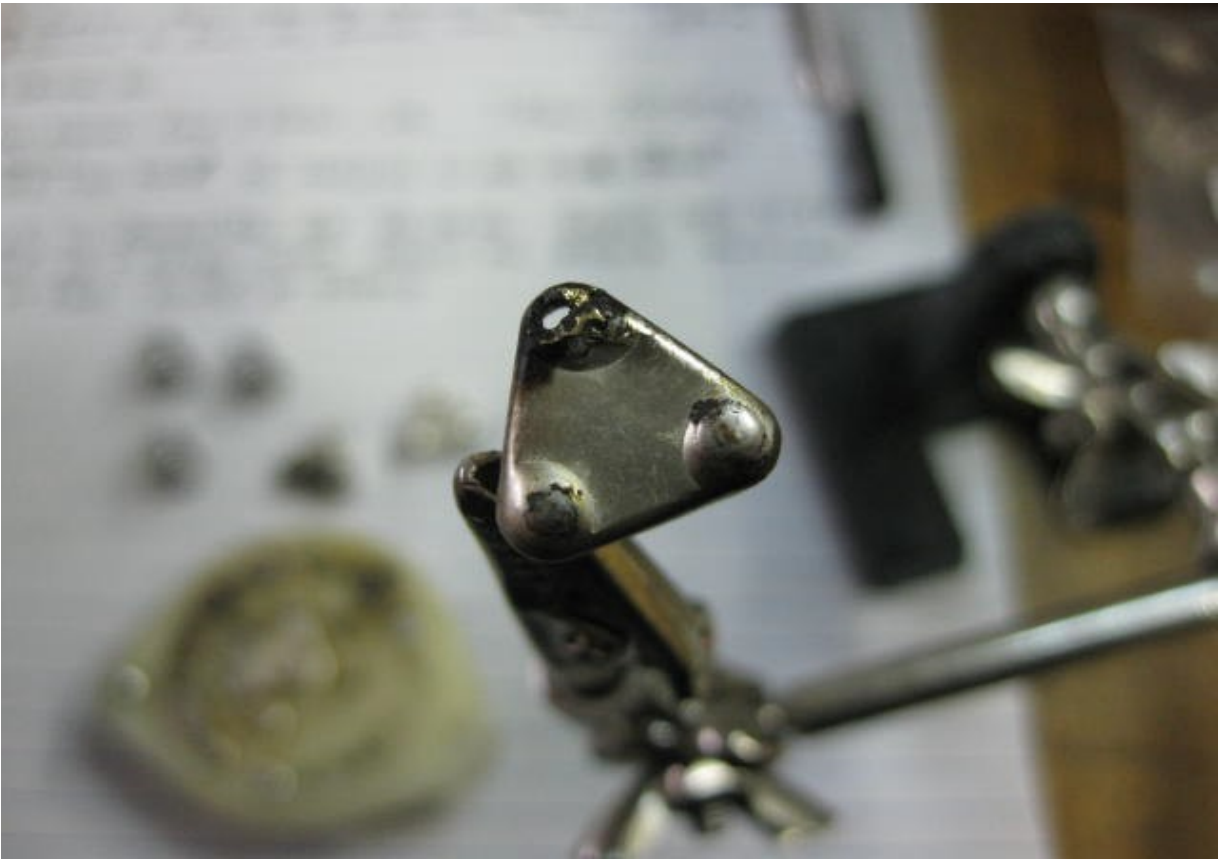
A submitter states, "The ACS/Gerdes ignition switch (*on this aircraft*) has never been inspected in accordance with Cessna SEB91-5R1 (*bulletin*) to comply with Airworthiness Directive 93-05-06. Upon disassembly of the switch, the circuit board plate was found to be severely worn, and one contact point was burned. (*This*) contact cup was burned completely through, creating a hole in the contact point. The screw heads holding the body of the switch to the terminal board assembly were painted red—as required by SEB91-5R1 and as described by identification of a factory new switch. However, there was no visible grease on the cups or the circuit board.

Discussions with other mechanics and inspectors (*causes*) me to believe this AD is overlooked due in part to mechanics assuming no AD exists for switches manufactured after 1993. The text of the Airworthiness Directive as well as the text in SEB91-5R1 and ACS Service Bulletin SB92-01 do not support this assumption. I have three other aircraft of the same vintage (Cessna 172S) due for inspections in this shop with no documentation of Compliance with this recurring AD."
