Cessna 208, Broken Nose Landing Gear Spring, ATA 3222

(The Wichita Aircraft Certification Office provides the following safety admonition. Aerospace Engineer Gary Park narrates the discussion; contact information follows the article.)

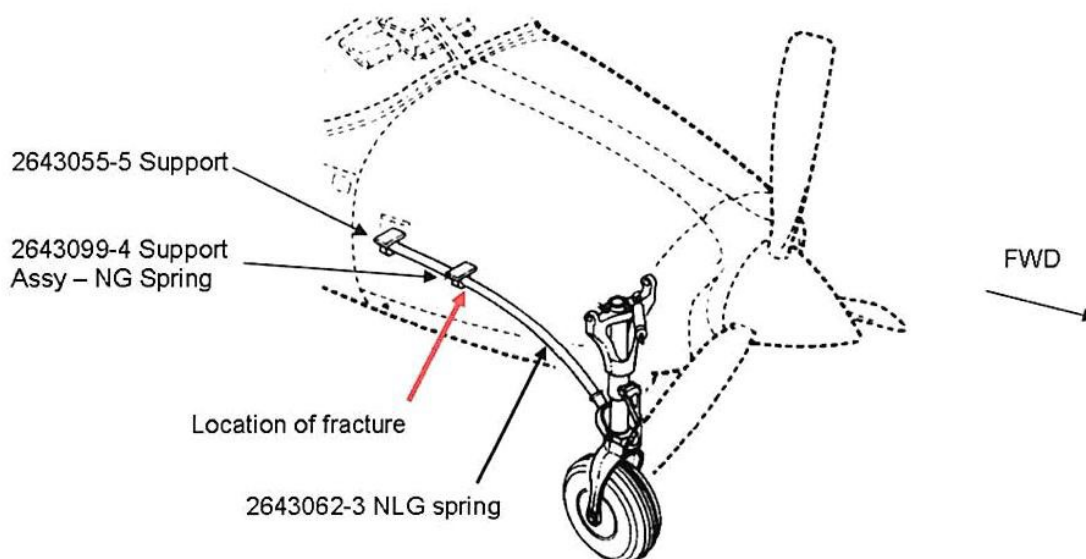
The schematic in Figure 1 shows the location of the fracture relative to the Support Assembly (P/N 2643099-4). Photo 2 is a magnified view showing the chevron pattern indicating the origin of the fracture at the lower outside diameter of the NLG spring. Photo 3 presents a tilted magnified view showing pitting corrosion along the outside diameter that coincides with the origin of the fracture. Photo 4 depicts a longitudinal metallographic cross-section through the origin of the fracture showing the corrosion pitting.

Figure 1: Location of the fracture relative to the Support Assembly (P/N 2643099-4).

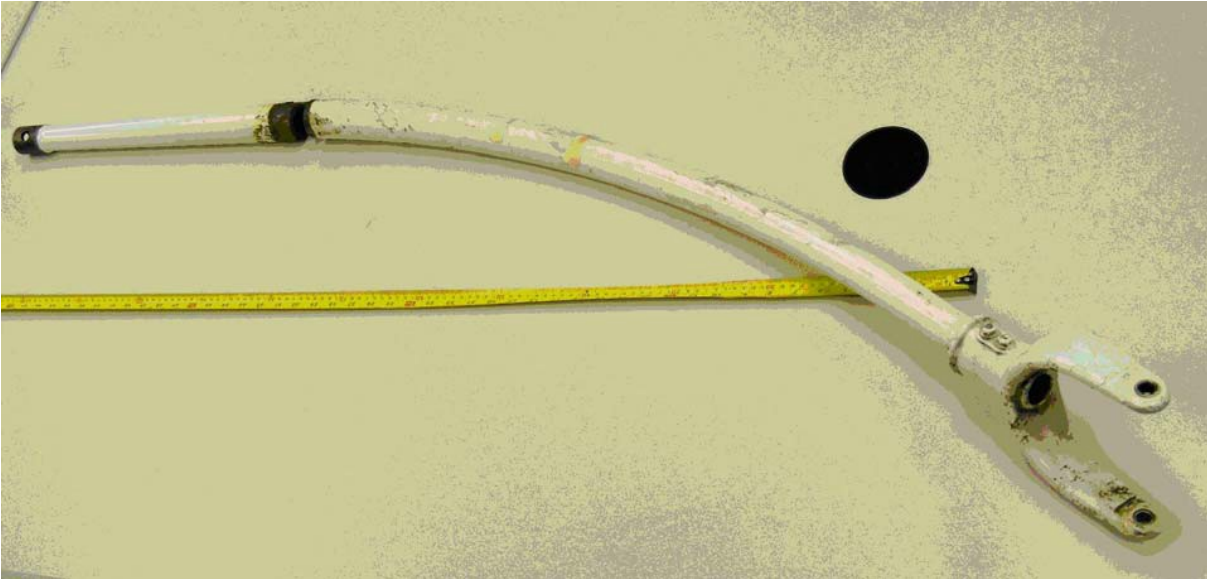
The FAA Wichita ACO received a Cessna 208 broken nose landing gear spring (P/N 2643062-3) shown in Photo 1. Installed on the airplane in December 2004, this NLG spring fractured during a landing in Puerto Rico in May 2010. It had nearly 3,000 flight hours. The fracture was analyzed and the following conclusions were identified: (1) Significant corrosion in the area of the fracture origin was present at the outside diameter of the NLG spring with pit depths slightly exceeding 0.02 inches; (2) stress-corrosion cracking was observed to a depth of nearly 0.02 inches, followed by ductile overload.

Figure 1 Photo 1: An over overall view of the broken NLG Spring

The Corrosion Prevention and Control Inspections found in the Cessna Maintenance Manual (5-30-01 & 02) require reoccurring visual inspections of the NLG for evidence of corrosion. The inspection information from the manual for mild or moderate corrosion (airplanes without TKS anti-ice system) is shown in the Table 1. For severe corrosion (airplanes with TKS anti-ice system), divide the inspection intervals in this table by two.

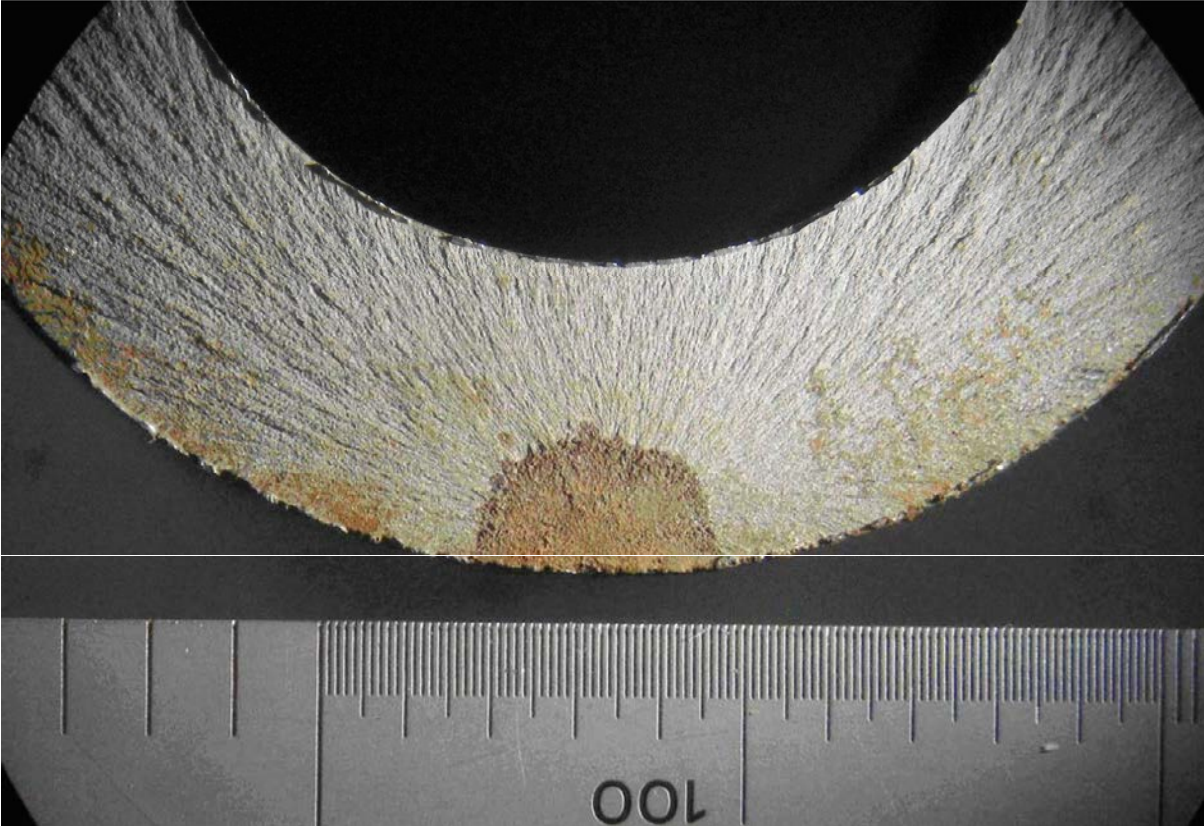
Figure 2 Photo 2, A magnified view of the fracture surface showing the Chevron pattern at the origin of the fracture

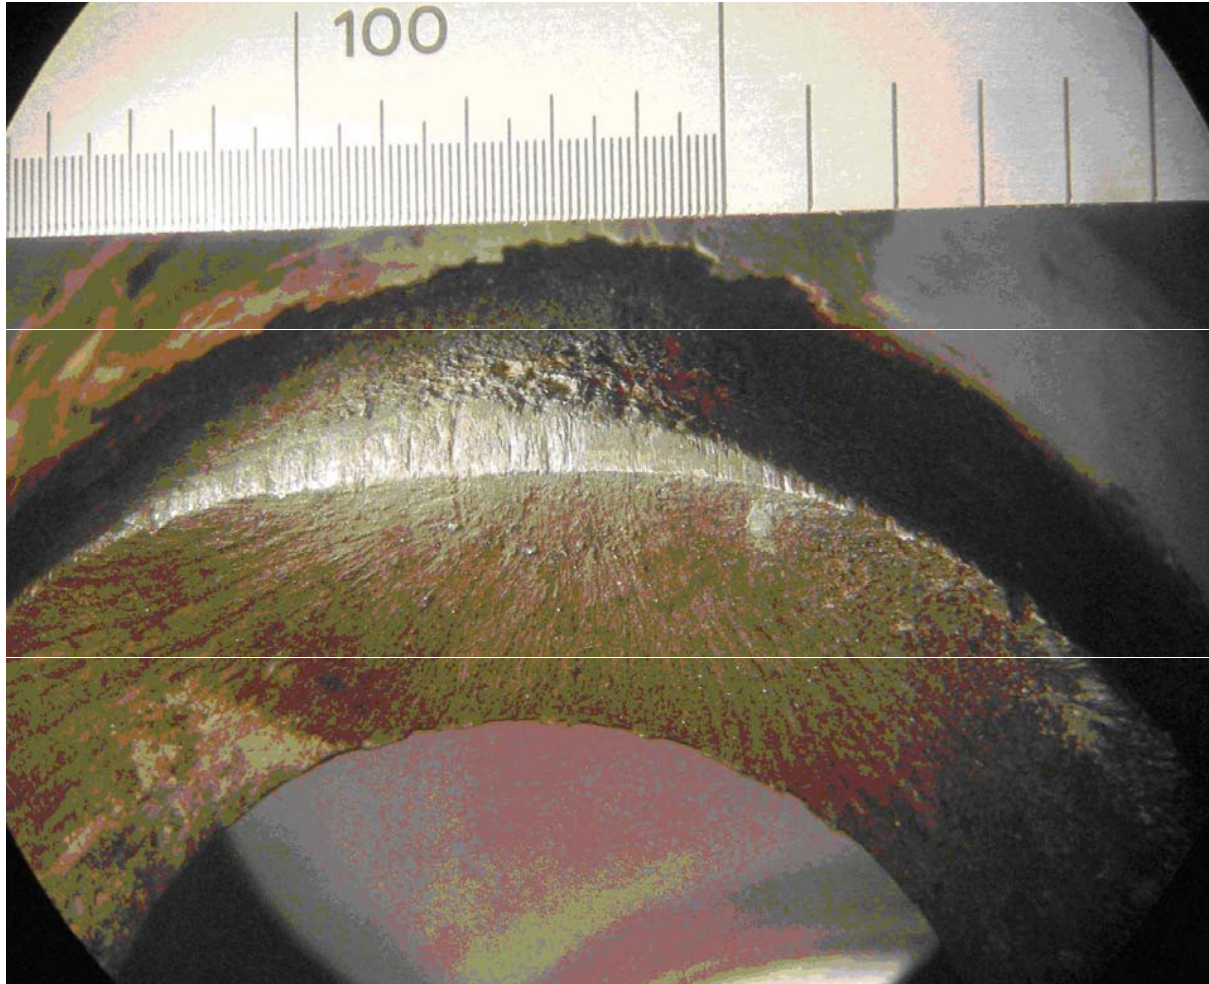
Figure 3 Photo 3, A tiled magnified view of the fracture surface showing pitting corrosion coincident with the area at the origin of the fracture

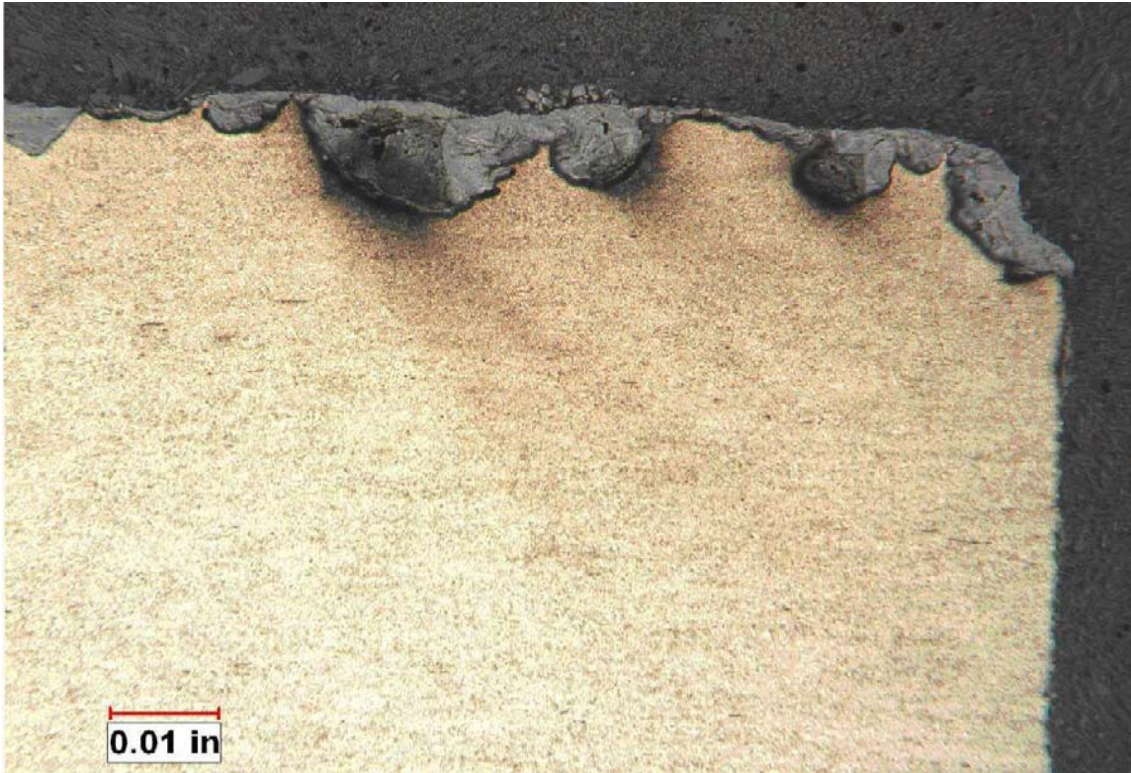
Figure 4 Photo 4. The view depicts a longitudinal metallographic cross-section through the origin of the fracture showing the depth of the corrosion pitting
