Cessna 208B, Rudder Torque Tube Corrosion, ATA 5540

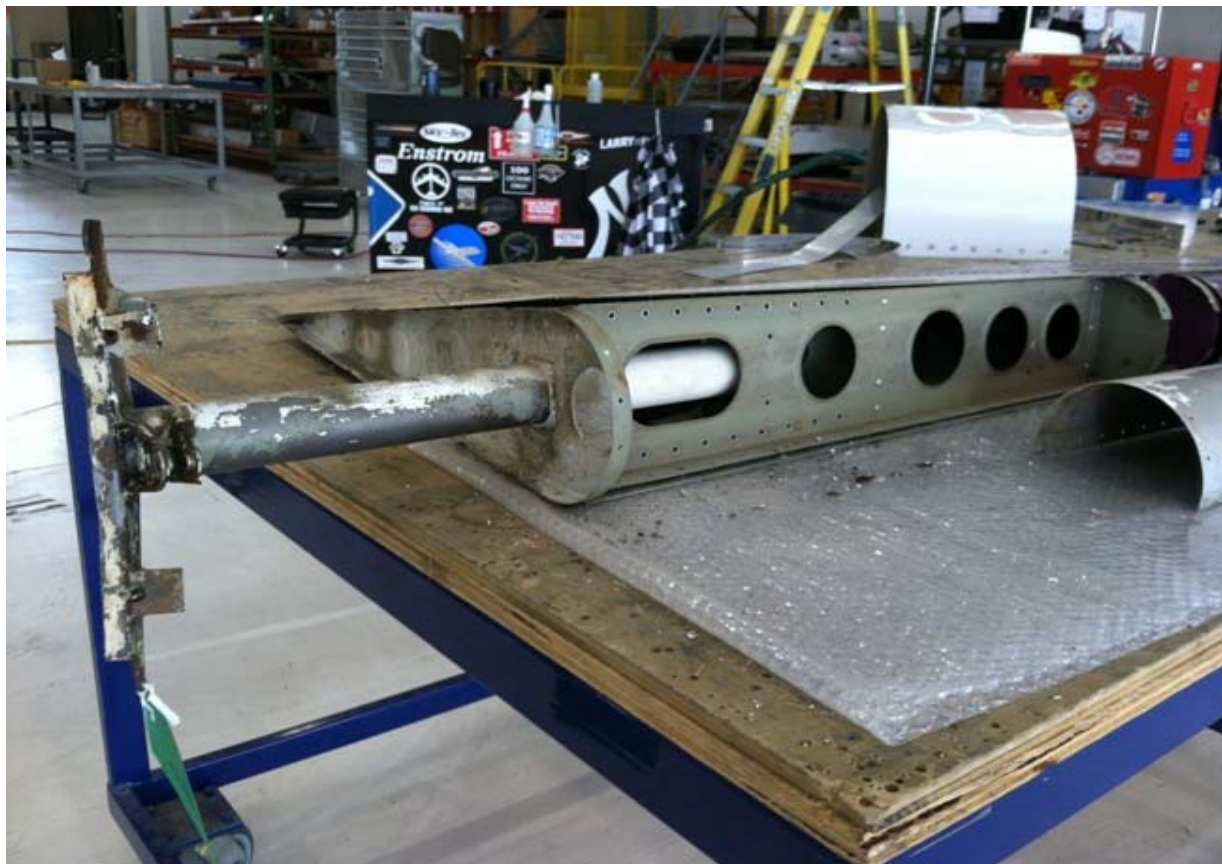
A repair station technician states, "This Hawaiian based aircraft arrived at our facility) for maintenance. The rudder was removed from the aircraft, and its skin (then removed) to allow access to the rudder torque tube (P/N 263066-3). This torque tube was scheduled to be replaced due to elongated holes in the bell crank. Severe corrosion was found on the upper part of the torque tube which is located under the skin, this area is not visible to any scheduled maintenance. The corrosion had reached the stage of 'blistered rust', and the 'L' angle on one side was easily separated with (minor) force (about 11 pounds; and wiggled twice)." "By design the rudder is not sealed on the top. The (torque tube top attach) bracket is located about a foot from the bottom, this cross member seems to pool water running down from inside the rudder (even though) there are drain holes in the design. Hawaii is listed as a 'moderate' corrosion environment.

"The operator had no way to inspect this location. A borescope would need to be used to (even) get an idea of the health of this part; however, it is better to remove and disassemble the rudder. The technician suggested a rudder inspection (hole be designed and implemented) so maintenance can easily inspect the torque tube for corrosion."
