Cessna 335, Corroded Wing Attaching Fittings, ATA 5741

Cessna: 335; Corroded Wing Attach Fittings; ATA 5741

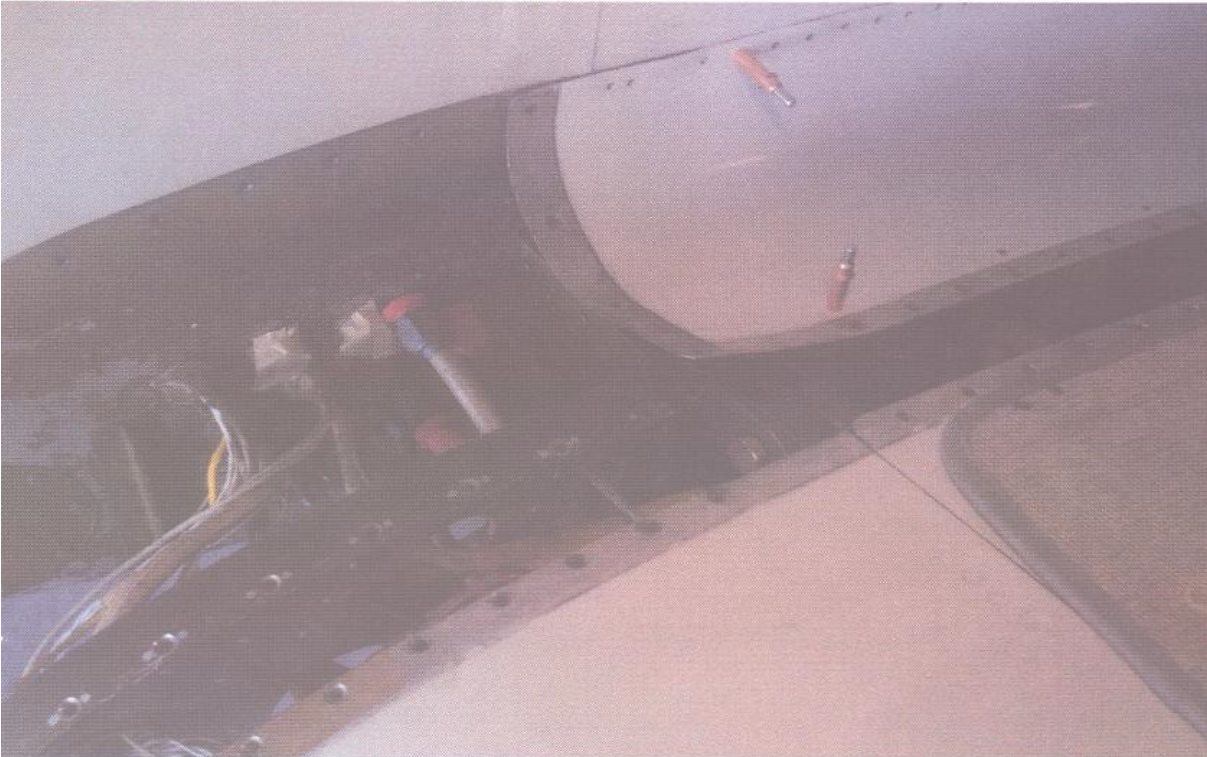
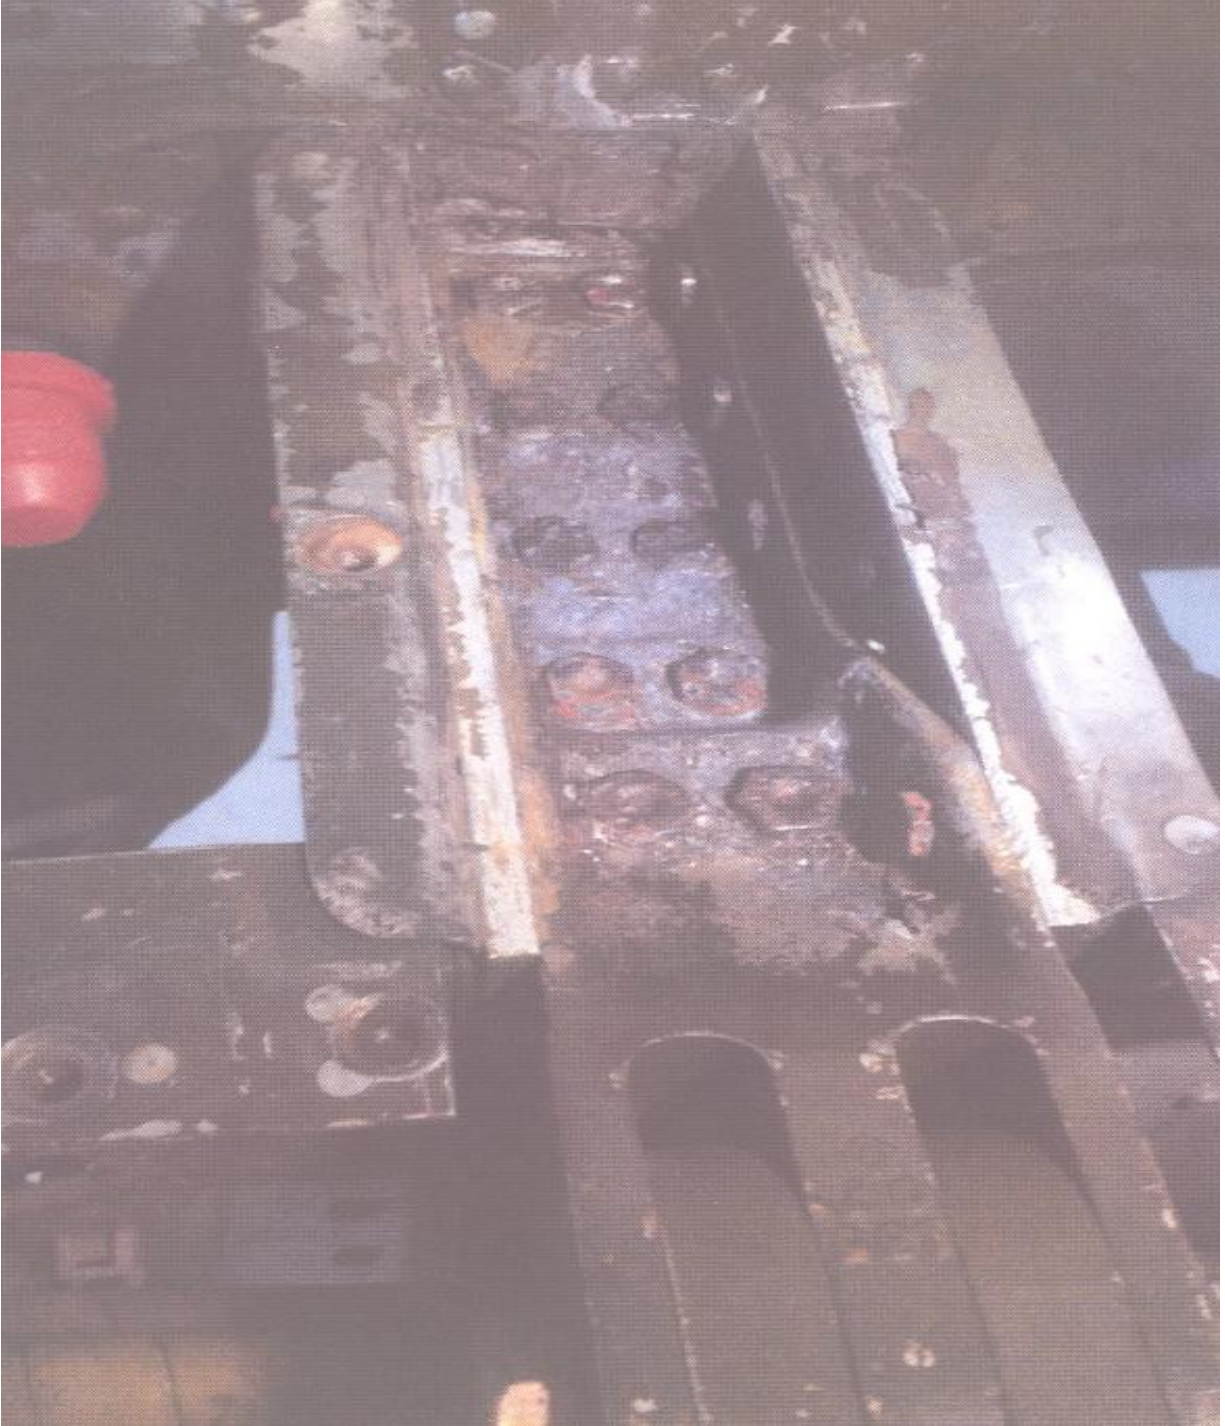
A technician for an air charter service says, "During a 100-hour inspection, the forward upper L/H wing attach point (was found to have) corrosion on the wing attach fitting (P/N 08113507). After removing the upper wing-fuselage fairing, inspection revealed inter-granular corrosion on the fitting, and severe rust on the mounting bolt heads. The fitting was replaced due to the severity of the corrosion. Probable cause (for this corrosion) is the fuselage-wing fairing not being sealed properly in the area above the fitting. This allowed moisture to pool in the recessed area of the fitting, causing the rust and corrosion. The fuselage-wing fairing is riveted to the fuselage, making (detailed) inspection of the upper forward mounts difficult."
