De Havilland DHC8103, Corroded Aileron Control Shaft, ATA 2710

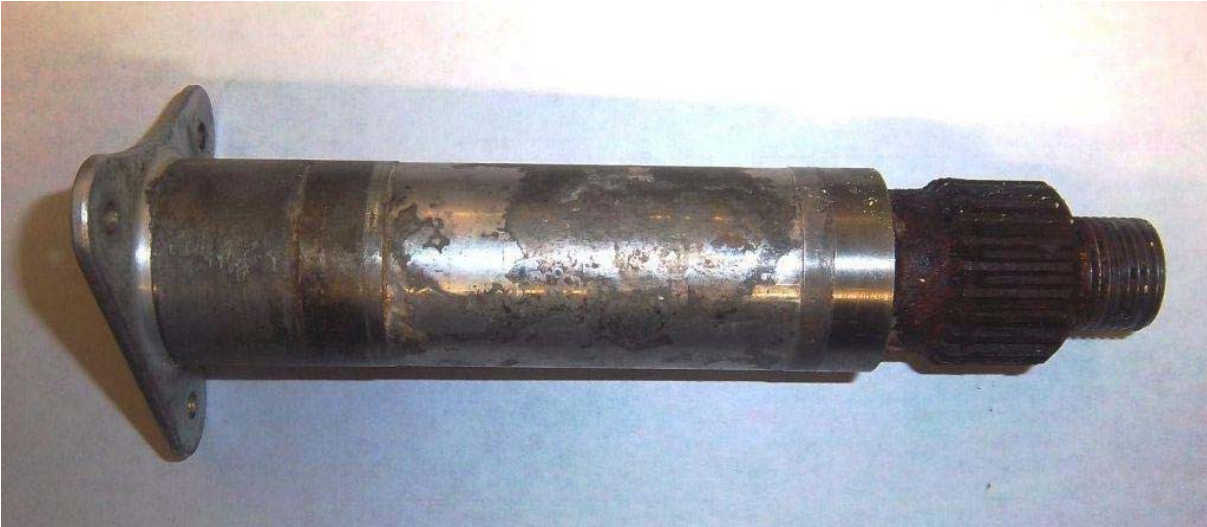
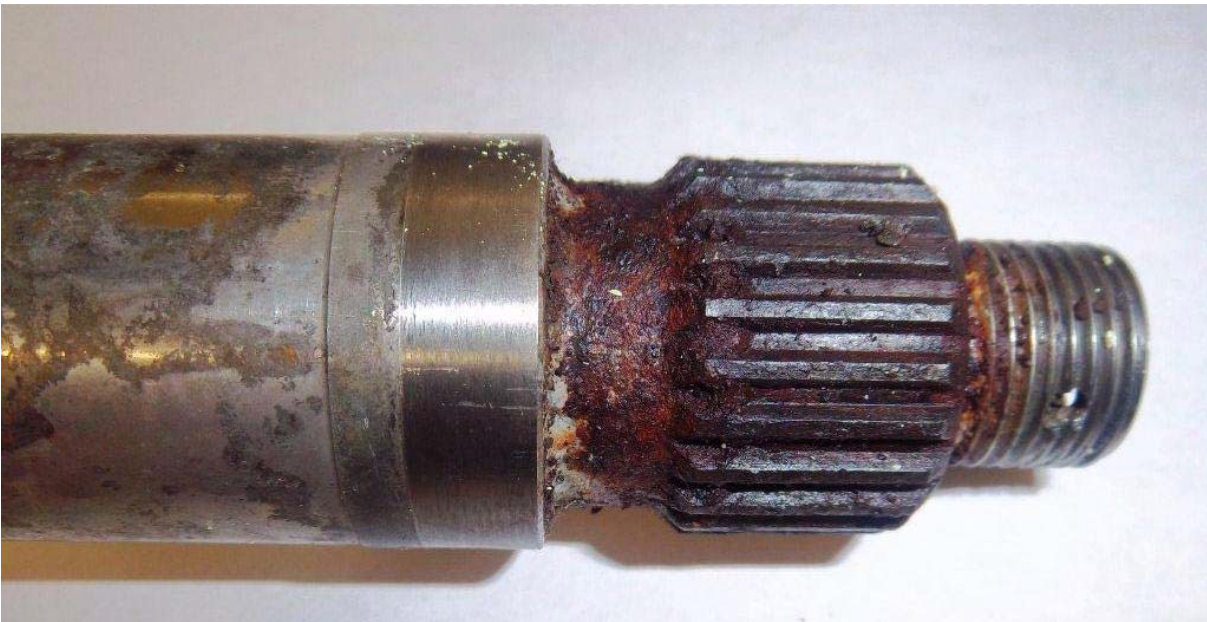
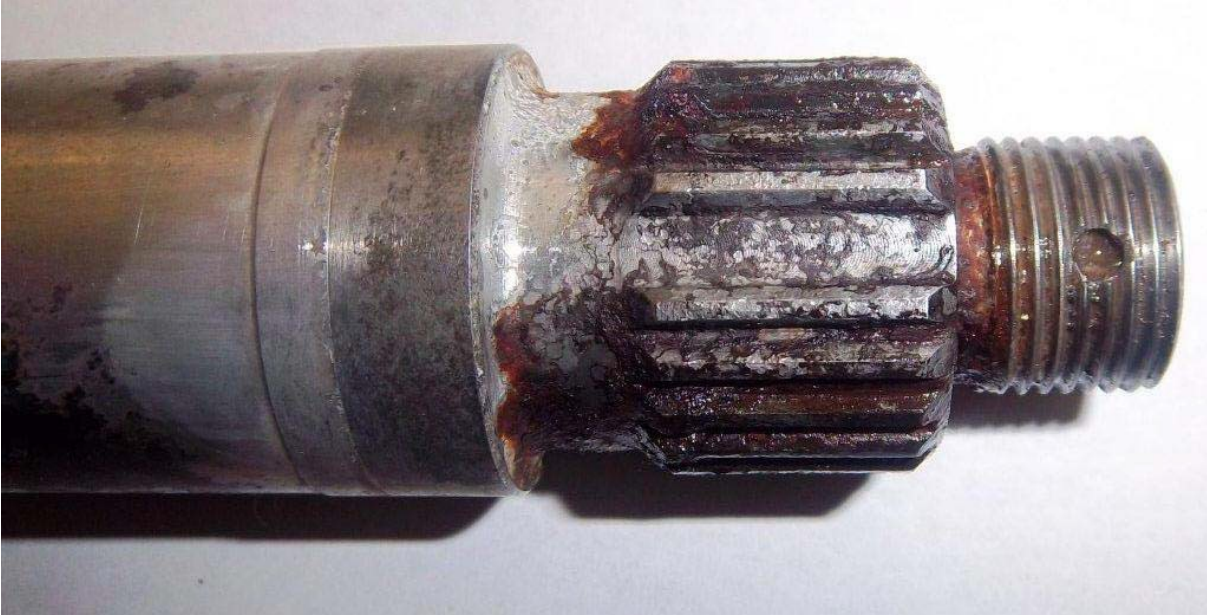
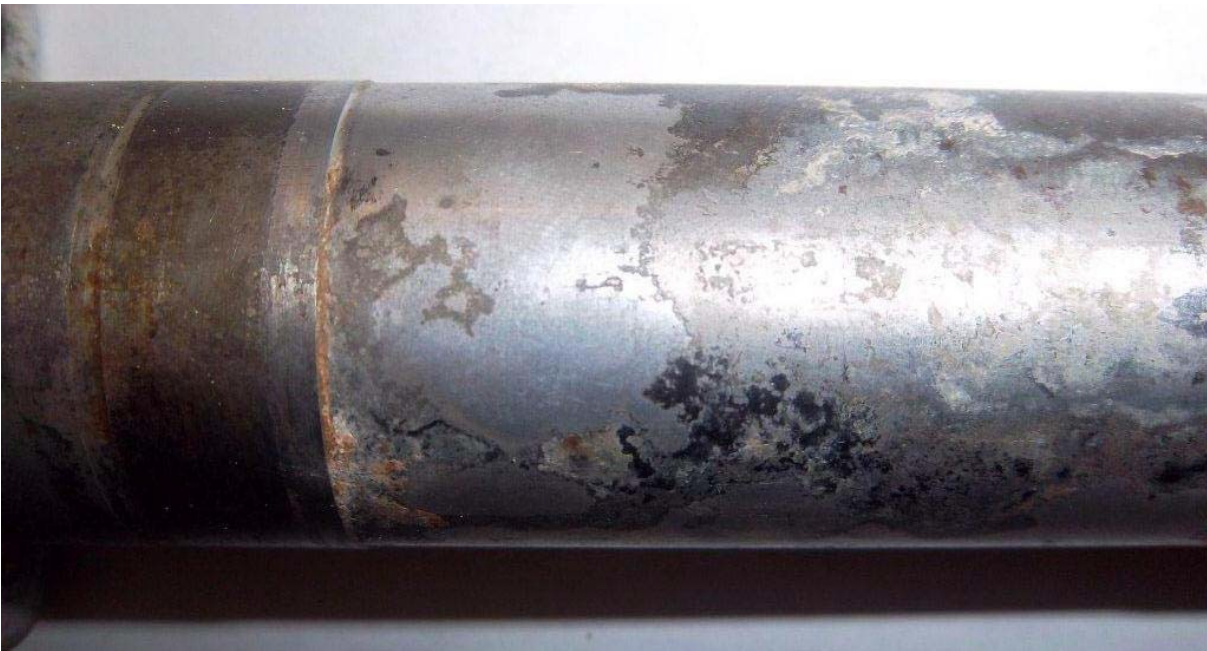
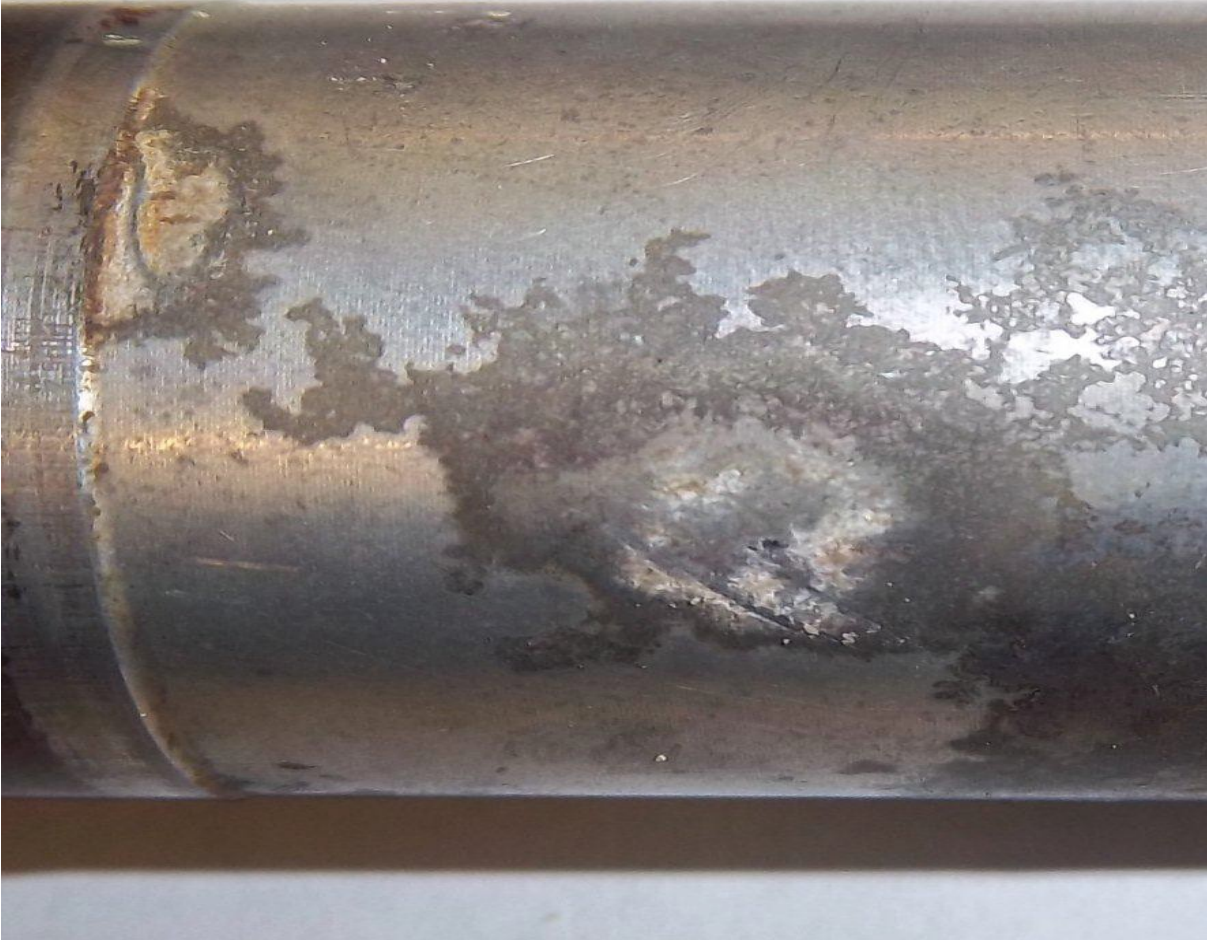
An air carrier operation writes, "Roll control was very stiff. (*We checked*) the tension of the aileron fuselage cables and lubricated the aileron quadrant bearings externally for (*initial*) troubleshooting."

"We replaced the L/H and R/H bearings in the aileron quadrant IAW Mod Kit 8MK0930-001 instructions and the AMM 27-12-31. The control cable tensions (and their safeties) were not disturbed. The L/H aileron control shaft (P/N 82740083-101) was replaced due to corrosion."
