## Douglas DC915F, Corroded Outflow Valve Doubler, ATA 5320

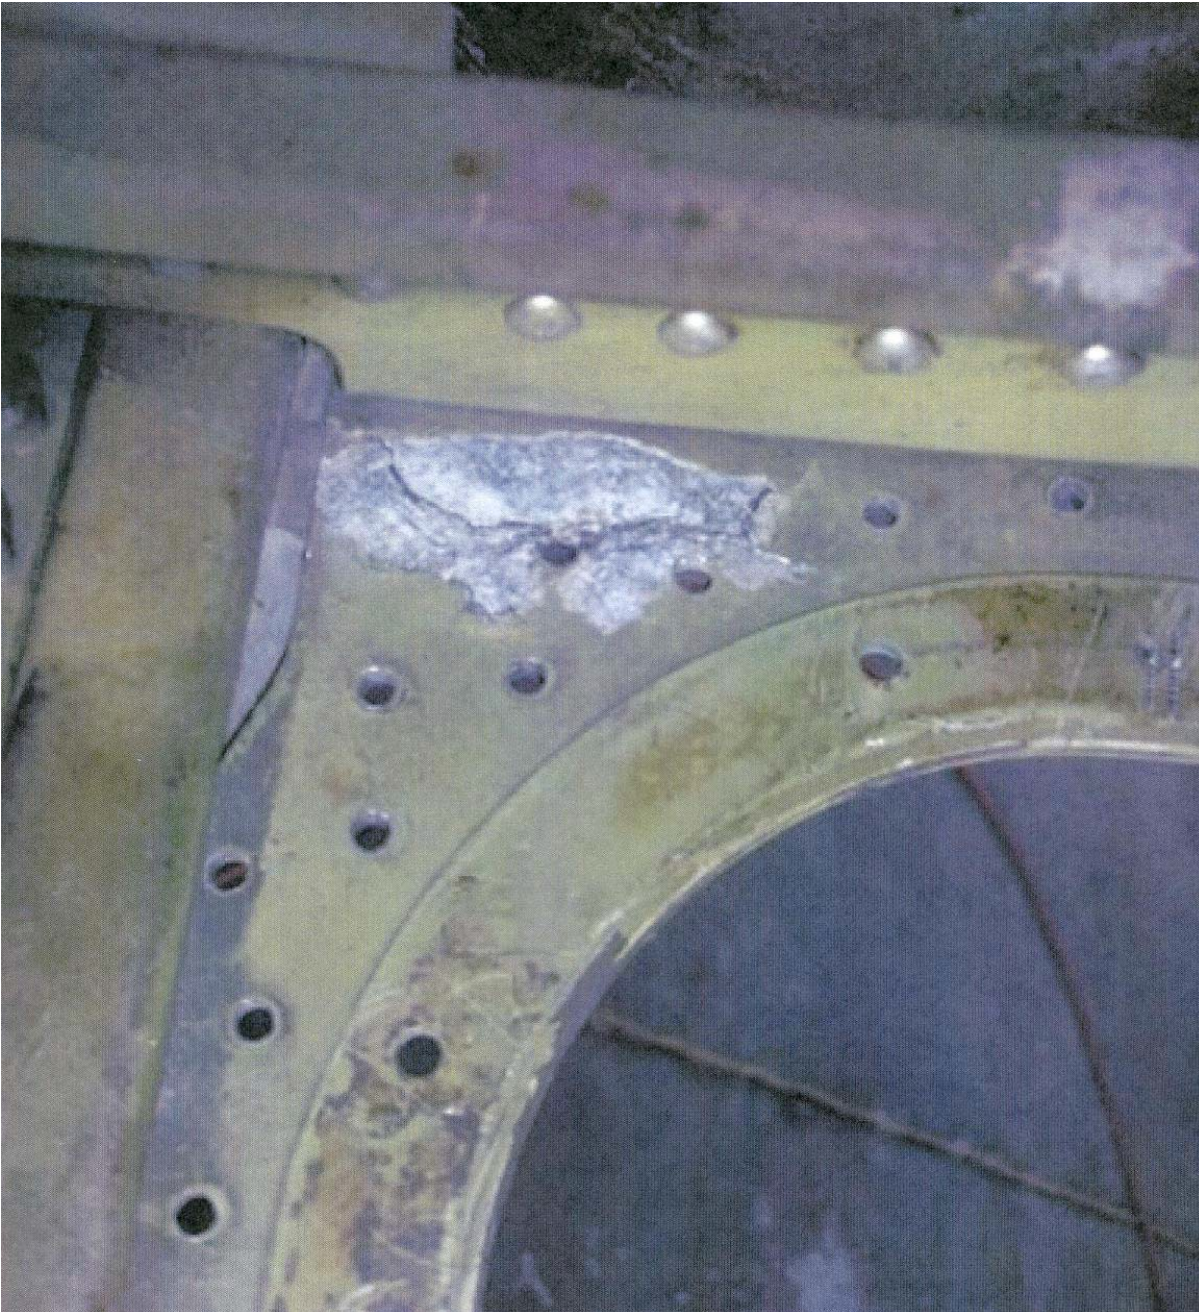
**Douglas DC915F, Corroded Outflow Valve Doubler, ATA 5320**

An unidentified submitter writes, "During an "A" check, maintenance found two rivets with missing heads forward of the Lavatory Service Door. Upon investigation, inspection found the Cabin Air Outflow Valve Doubler (Plate) corroded beyond limits at station 786; longeron 23L. Maintenance installed a new doubler IAW DC-9 Structural Repair manual 51-30-2. This included the replacement of the two rivets that were missing. The aircraft was returned to service. Reference SRM 53-30-0, page 11, item 30; and SRM 53-30-0, page 14, Item 30 for the location and detail of the doubler (plate). This item was found during an "A" check, but it is normally inspected as part of the CPCP program (*corrosion prevention*) which was not due at this time. This is not a Principal Structural Element (PSE)." (*Doubler P/N: 59145581. Note the SDRS database records 6 such P/N's.*)

Part Total Time:71,968.0 Hours
