Embraer 120 ER, Worn MLG Actuator Rod-End, ATA 3230

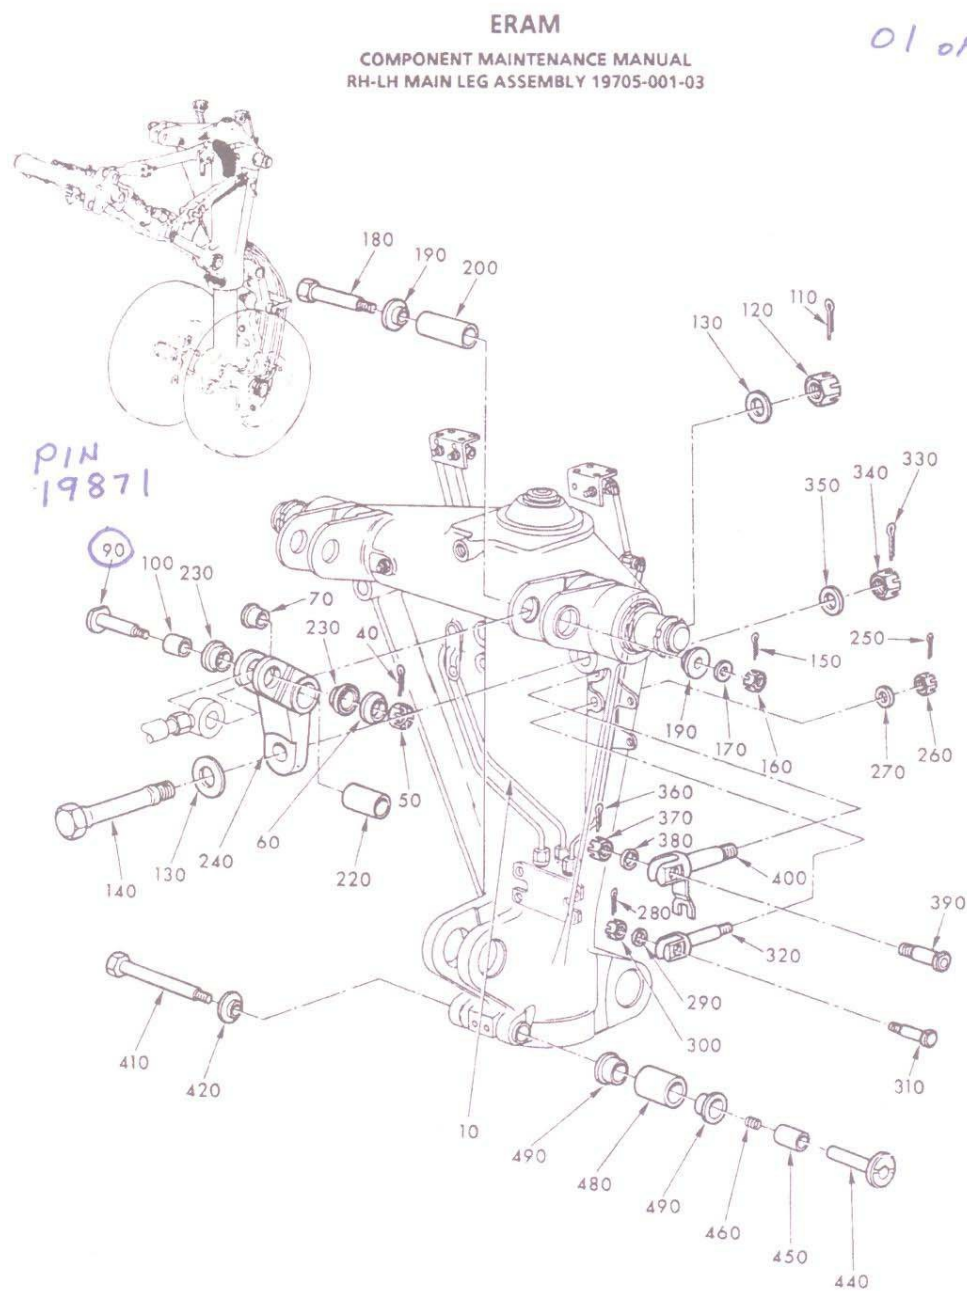
32-12-01

"Maintenance found the left gear was not retracting fully up and locking into position. The problem was *(determined)* to be excess play in the retract actuator rod-end (P/N 21126-000-00). This rod-end bearing (swivel) was found seized to the attaching pin that secures the actuator to the MLG leg. This caused the rod-end to pivot on the OD *(outside diameter)* of the pin—instead of the bearing rotating on the rod-end bearing race. The pin (P/N 19872) was found worn 0.064 inches deep approximately 210 degrees around the OD circumference. The actuator, pin, and bushings were replaced. The landing gear system checked 'good' and the aircraft was returned to service." *(This particular rod-end P/N is found four times in the SDRS database.)*
