Hawker 800XP, Corroded Fuselage Attachment Links, ATA 5741

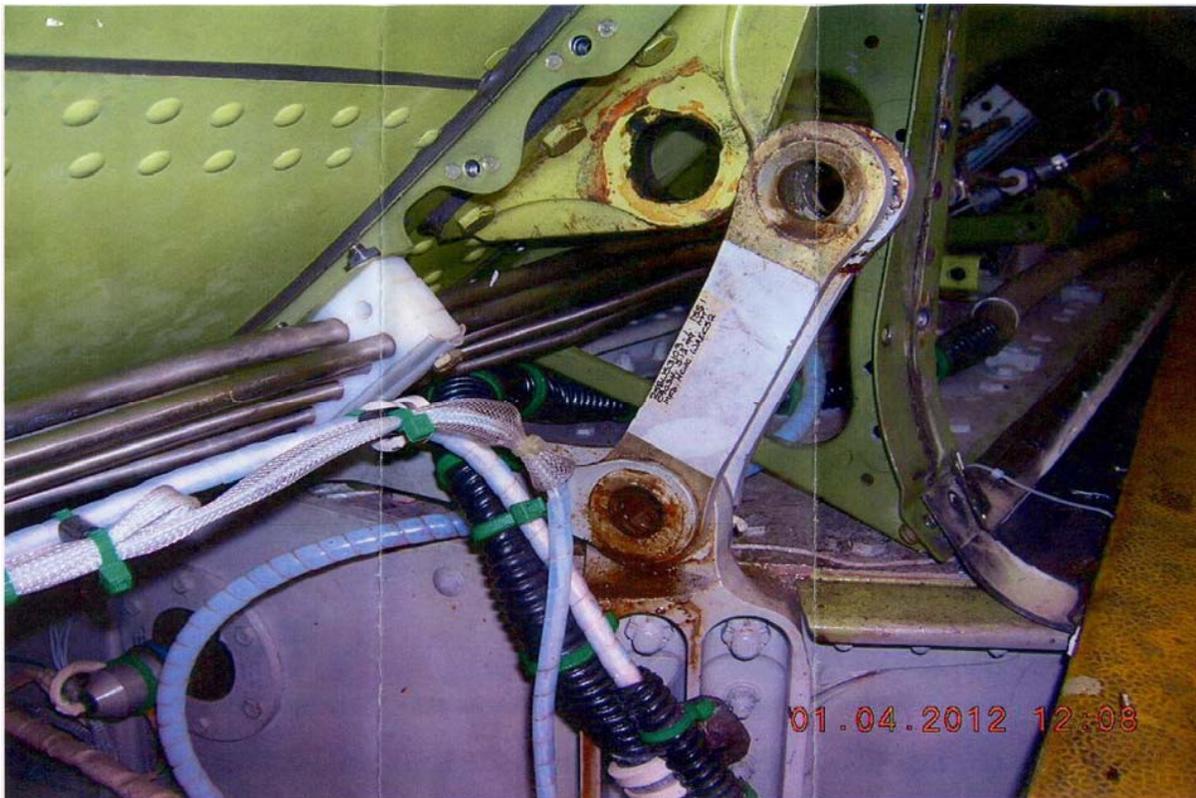
A repair station technician says, "Severe corrosion was found in the L/H lower, wing-to-fuselage casting lug during a 12/8-year links/brackets/bolts inspection.

"Probable cause: exposure to constant moisture from improper fuselage-to-wing fairing sealing practices (produced the corrosion), and/or constant exposure to TKS anti-icing fluid from improper plumbing practices that may have led to system leaks (and then subsequent corrosion).

"Recommendation: proper sealing methods (should be employed) when attaching wing-to-fuselage fairings. And proper plumbing practices (should be used) when performing maintenance on wing anti-ice systems. Note: Use of a corrosion preventative compound...at this location may prevent this condition ...with scheduled applications." (Wing-to-fuselage link/bearing P/N: 25-8WS3103-1. The following photos are distorted vertically—Ed.)
