Hawker 800XP, Failed Elevator Trim Rod-ends, ATA 2731

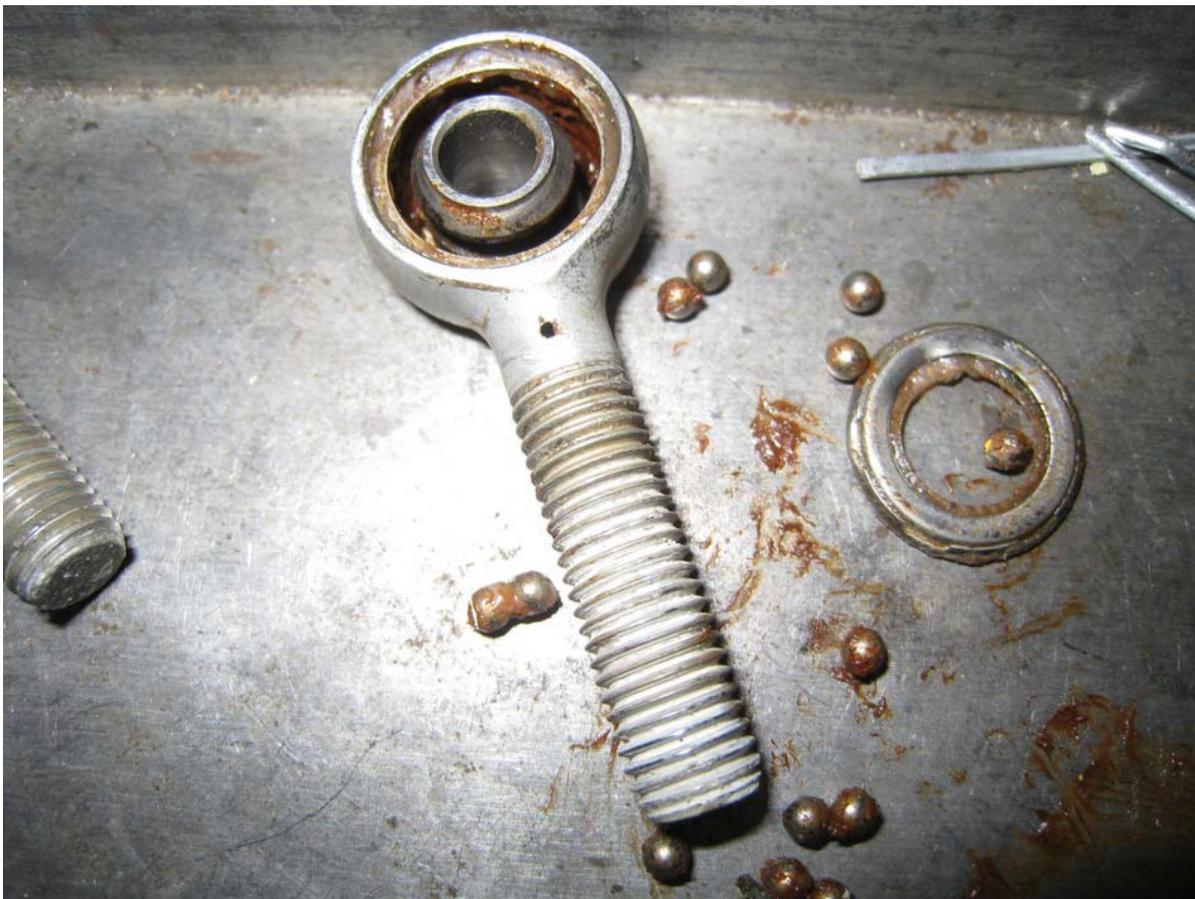
A submitter writes, "When conducting a maintenance preflight inspection, the technician noticed rust stains coming from the aft rod-ends (*P/N CN635MESP56*) of the elevator trim tab rod on both left and right elevator trim tabs. Further inspection revealed the grease seals on one end of both the left and right trim tab rod-ends had come off, and the ball bearings were mostly missing. Fortunately, the other rod-end on each of the trim tabs was still intact. However, rust stains were also noticed coming through these grease seals. In the process of replacing the rod-ends, it was noticed that TKS deicing fluid had penetrated into the hollow inner portion of the trim tab control rod, (*but*) no evidence of corrosion existed.

Part Total Time: 4,520.0 hours

"Recommendation: Conduct a close-up visual inspection of the elevator trim tab rod-ends for rust staining and grease seal separation on an annual basis. Any time rust staining is observed coming out of the rod-ends, replace them. At each 48-month inspection, remove the rod-ends and visually inspect the control rods for corrosion."
