## Lear 45, Broken Hydraulic Float Switch, ATA 2930

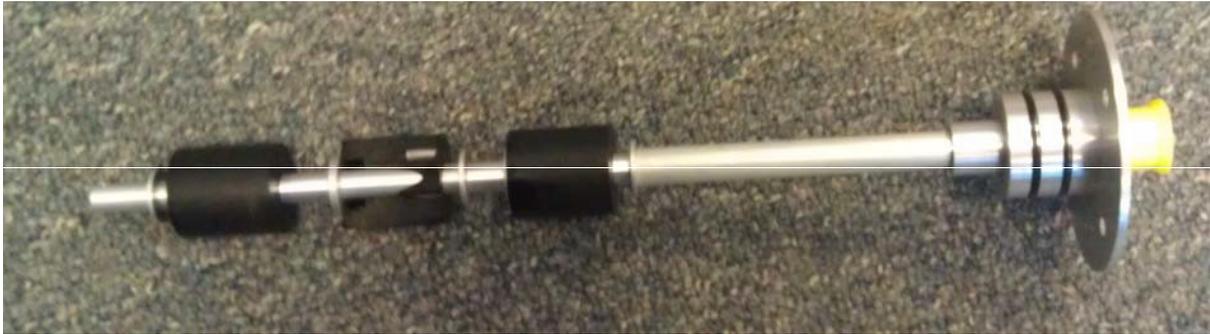
"Maintenance was experiencing erratic indications when servicing hydraulic fluid," states this Air Carrier SDR report. "When serviced correctly per the maintenance manual, hydraulic 'low fluid' or 'over filled' messages from EICAS (Engine Indicating Crew Alerting System) would appear shortly thereafter. There was no evidence of fluid loss, and the mechanics were properly trained and equipped for the servicing task. The hydraulic float switch was removed for troubleshooting—it was found to have one float broken. The float switch assembly (P/N 3L14F17) was replaced with a new unit, and the hydraulic system checked in consultation with Learjet Field Support to ensure the possibility of system contamination was adequately addressed."

Part Total Time: 2,360 Hours
