Mooney M20TN, Loose Engine Isolator Mount Bolts, ATA 7120

July 2012 AC 43-16A

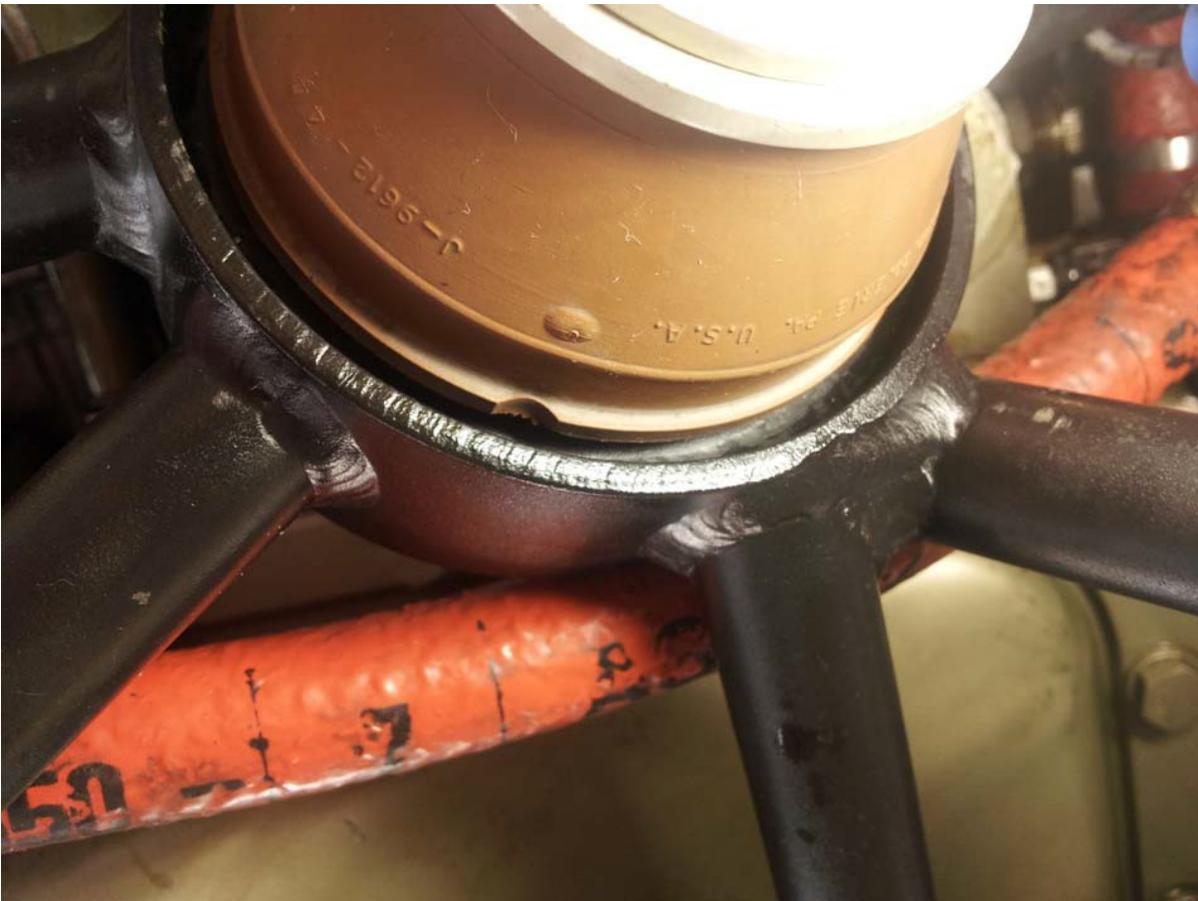
"(I) discovered all four engine isolator mount bolts loose during a 100 hour inspection, noting *(these bolts)* do not have a safety wire or locking provision. I also found several areas of chafing related to the engine not being secured to the engine bed mount. All engine isolators were removed and inspected. I found metal shavings between the upper and lower isolators, and the left aft engine mount bracket thread insert pulled and cross threaded. Both rear engine mount brackets were replaced with new, and the front engine isolator mounts replaced with a new kit. I reinstalled the existing rear isolator mount kit IAW IPC and AMM *(parts catalog and maintenance manual)*.

"I found installing the isolator mounts and bolts very difficult. The engine mount brackets do not align with the engine bed mount focal rings. With all the isolators installed and the bolts torqued, the isolators are displaced from centerline and are laterally loaded. The isolators do not seat on the full circumference of the focal ring. I removed all the isolator mounts for further inspection of the bed mount, and contacted the aircraft manufacturer about the alignment issues. I measured the mount and found the engine bed mount focal ring centerlines are too narrow by 0.2500 inches on all four corners. No deformities of the bed mount were noted." *(Mount P/N: 590030501. A Continental TS10550G sits in this airplane's engine mount.)*
