Piper PA44_180, Cracked Nacelle Angles, ATA 5413

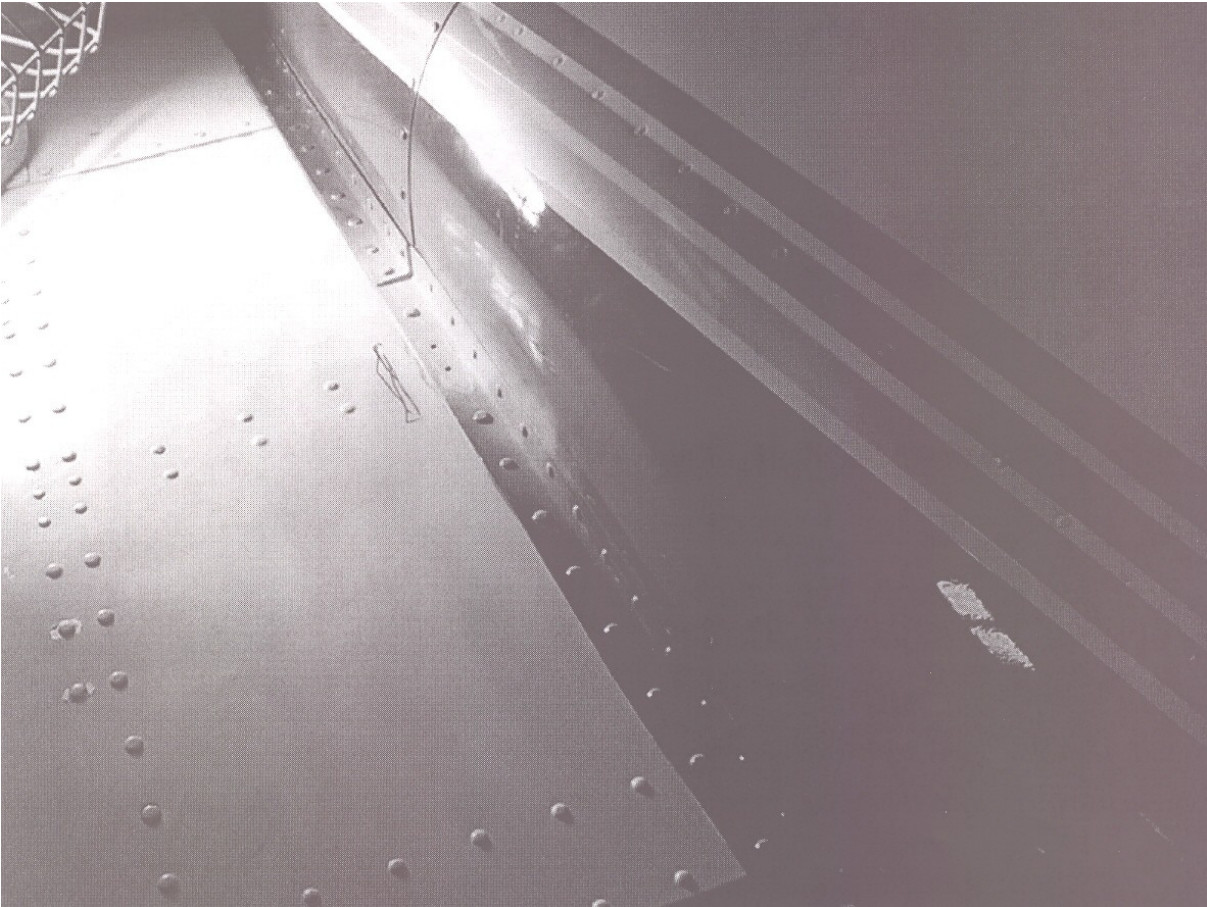
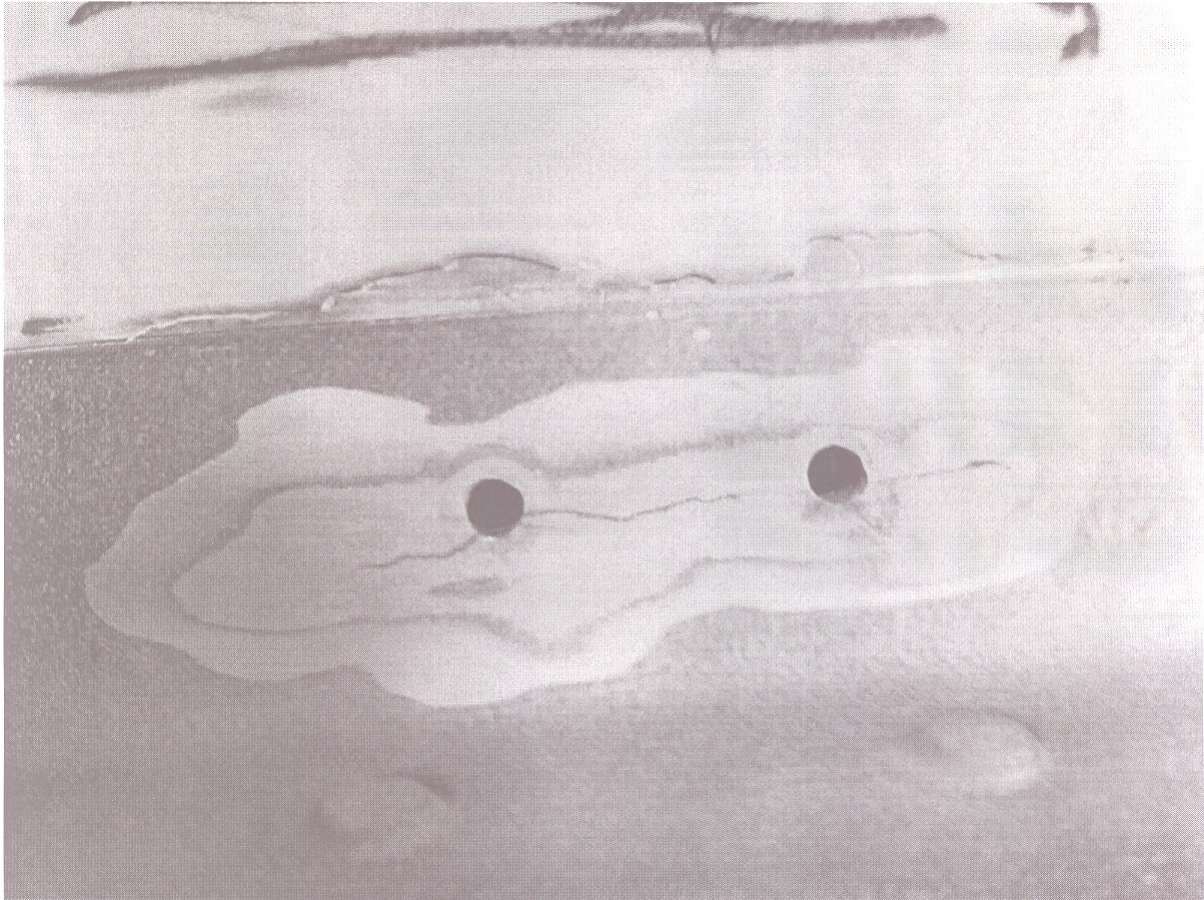
"During a scheduled inspection, a crack was found in the nacelle angle," states this mechanic. "Upon further investigation the crack was found to run between the two rivets that extend through the wing skin into the cap (P/N: 67097-002 or -003), which is attached to a web (P/N 67079-000 or 001). This web is where the main gear aft attach point is mounted.

The mechanic suspects this failure is caused by fatigue."
