## Bell 206B, Cracked Tail Rotor Gearbox Support, ATA 5302

TAIL BOOM PN# 206-031-004-115---TR GEARBOX PN# 206-040-400-013

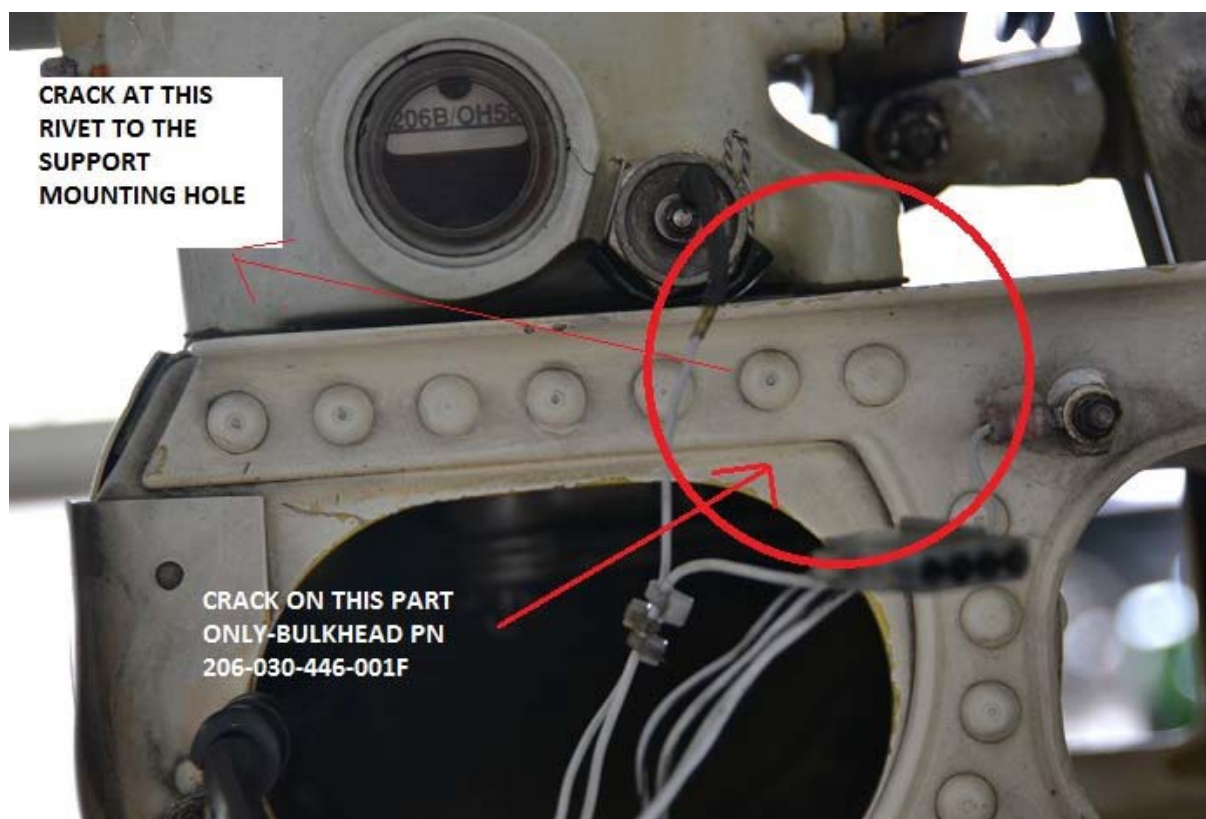
An Air Carrier provides the following defect report. "The tail rotor gearbox support bulkhead cracked at the right-rear mounting hole—(*progressing*) to the second rivet inboard on the gear box support."

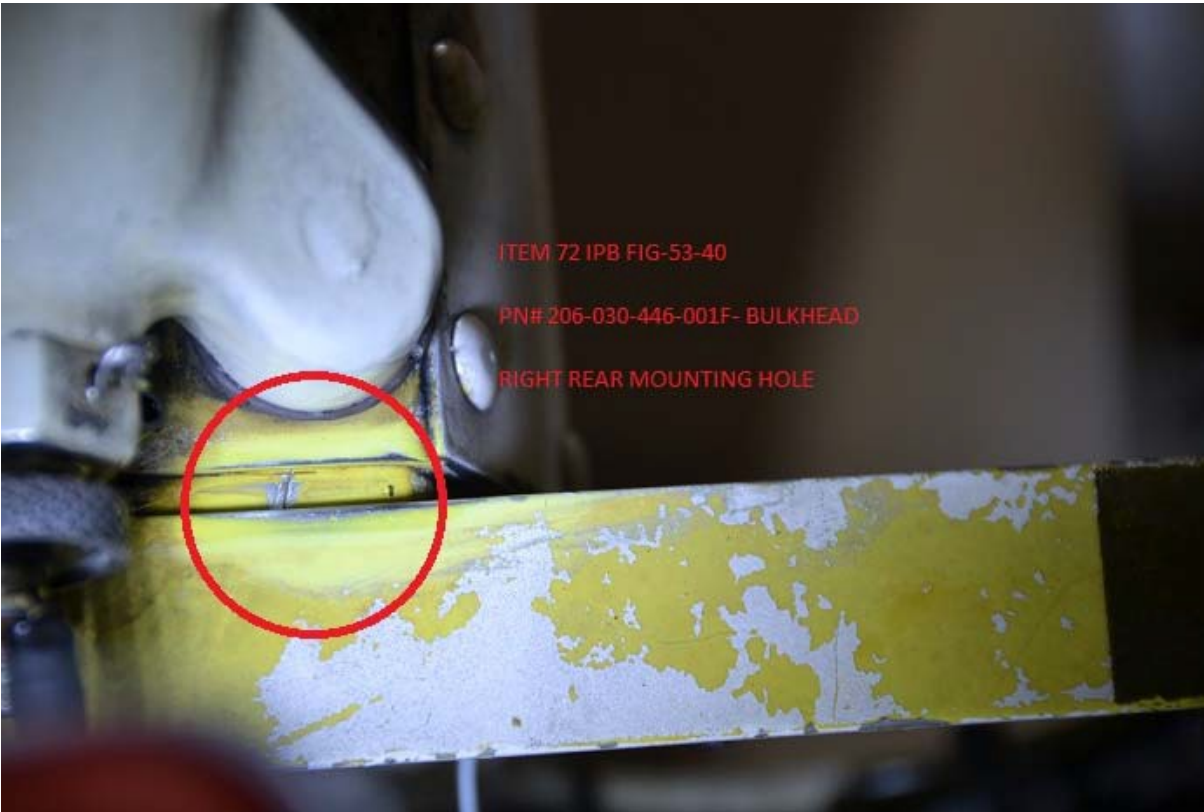
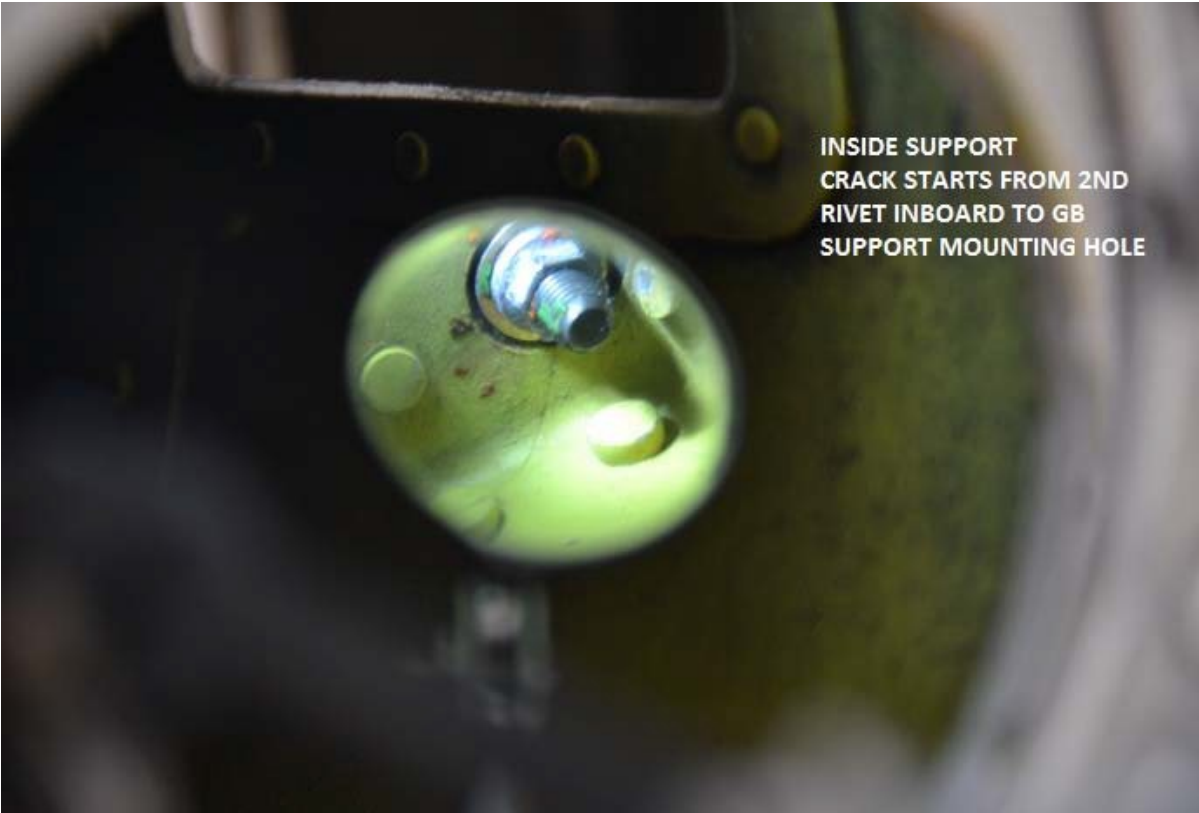
(Bulkhead P/N: 206030446001F. There are seven such entries for this P/N in the SDRS database. This last photo gets a blue ribbon—and the eyeballs too! Ed.)
