## Continental IO550N Cracked Exhaust, ATA 7810

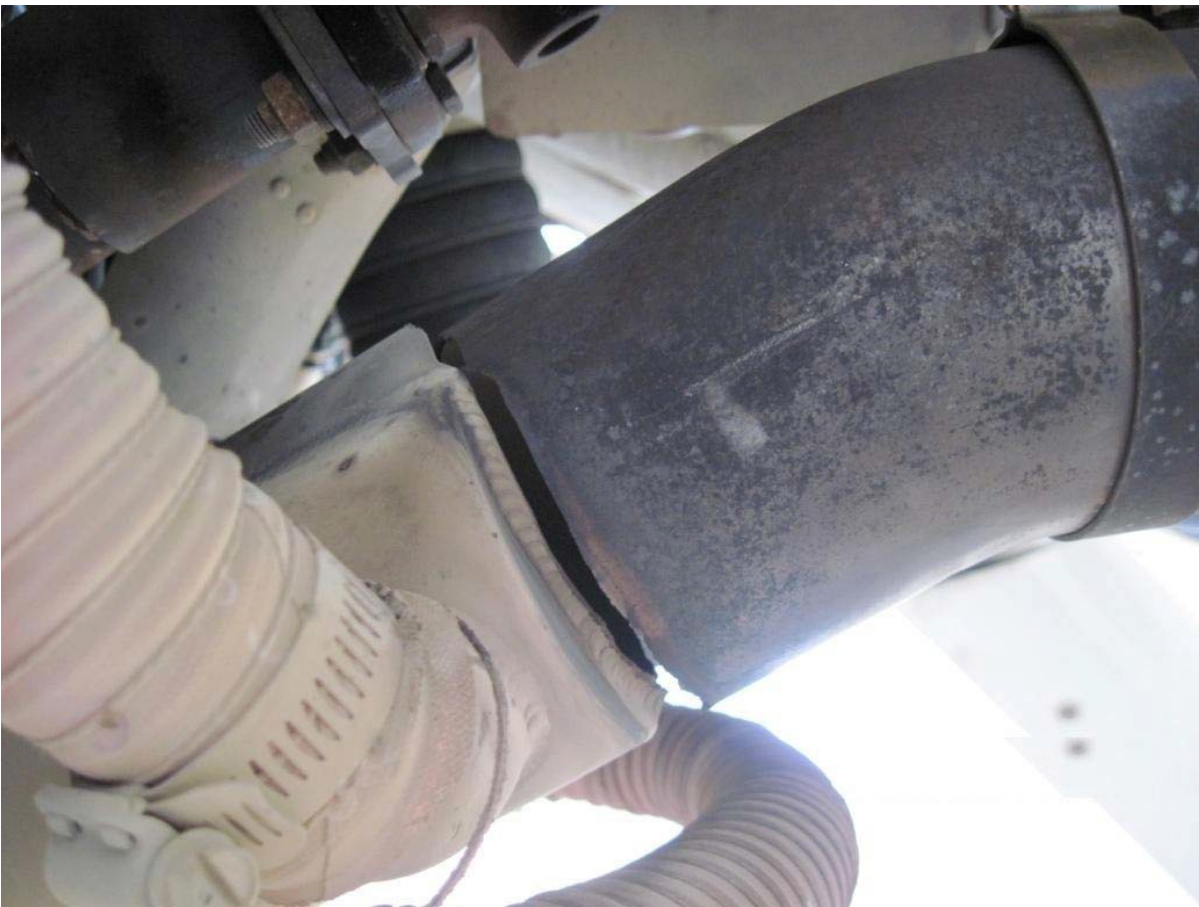
A repair station mechanic says, "This aircraft has a Tornado Alley Turbo normalizing system, installed under STCs SA10588SC and SE10589SC. When the cowling was removed for an unrelated issue, the right tail pipe was found cracked completely in half along the forward edge of the cabin heat exchanger weldment. It is not rare for cracks to be found along the heat exchanger in this type of tail pipe design. Undetected, the crack will eventually propagate around the tube. There is also potential for the crack to compromise the heat exchanger, possibly allowing exhaust gasses to enter the environmental system. Complicating this failure, this aircraft also had a major fuel leak, as detailed under report number 2012FA0000689. This fuel leak could have been ignited by the exhaust gasses entering the cowling from the fracture. Note: there is an improved designed tail pipe available from Tornado Alley—it is recommended any cracked tail pipes not be welded (as has been seen on other aircraft). The (tail pipes) should be replaced with the new design."

Part Total Time: 678.0 hours
