## Continental IO520C, Cracked Crankshaft, ATA 8520

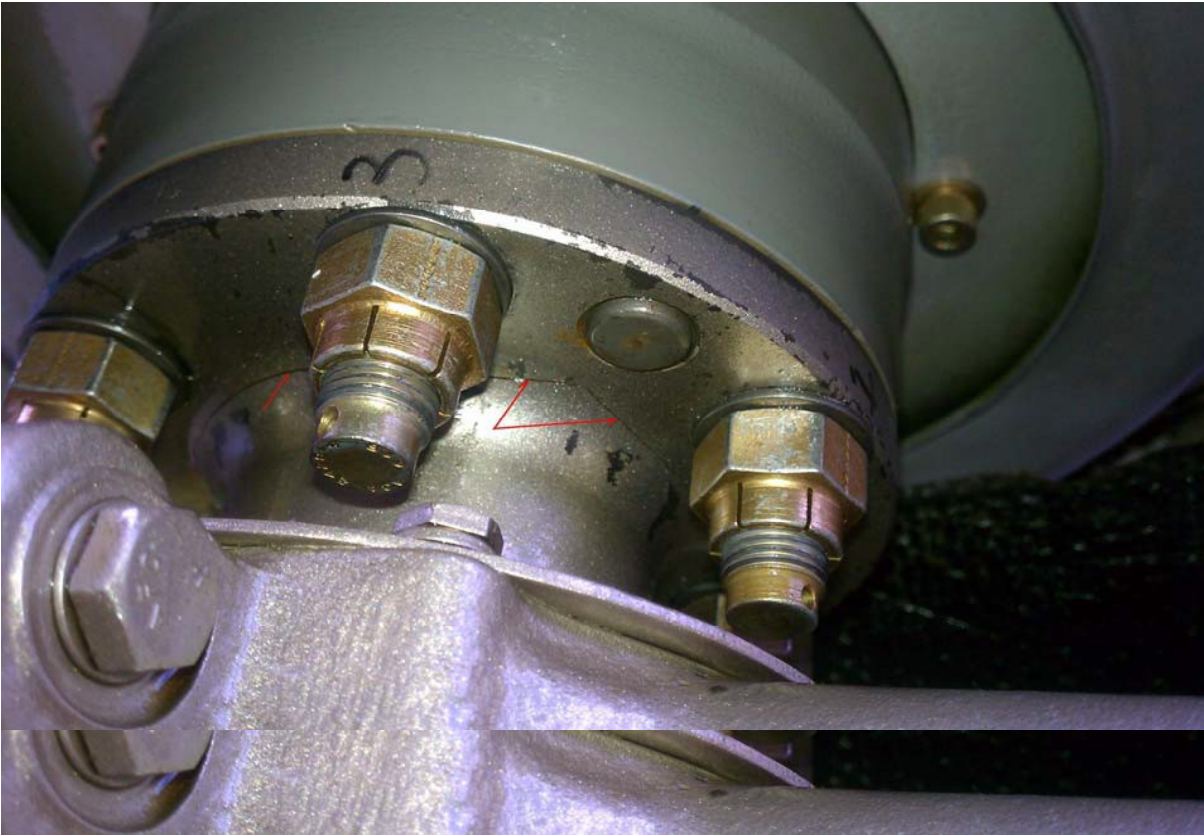
"The crankshaft cracked in the propeller flange at the radius," writes a technician. "The crack (*appeared*) in a 'V' shape. On one side the (*crack*) line was about four inches long, and the other about three inches." (*Crankshaft P/N: 649859.*)

Part Total Time: 4,531.0 hours
