ECI Cylinders TISN712BCA, Failed Valve Guides, ATA 8530

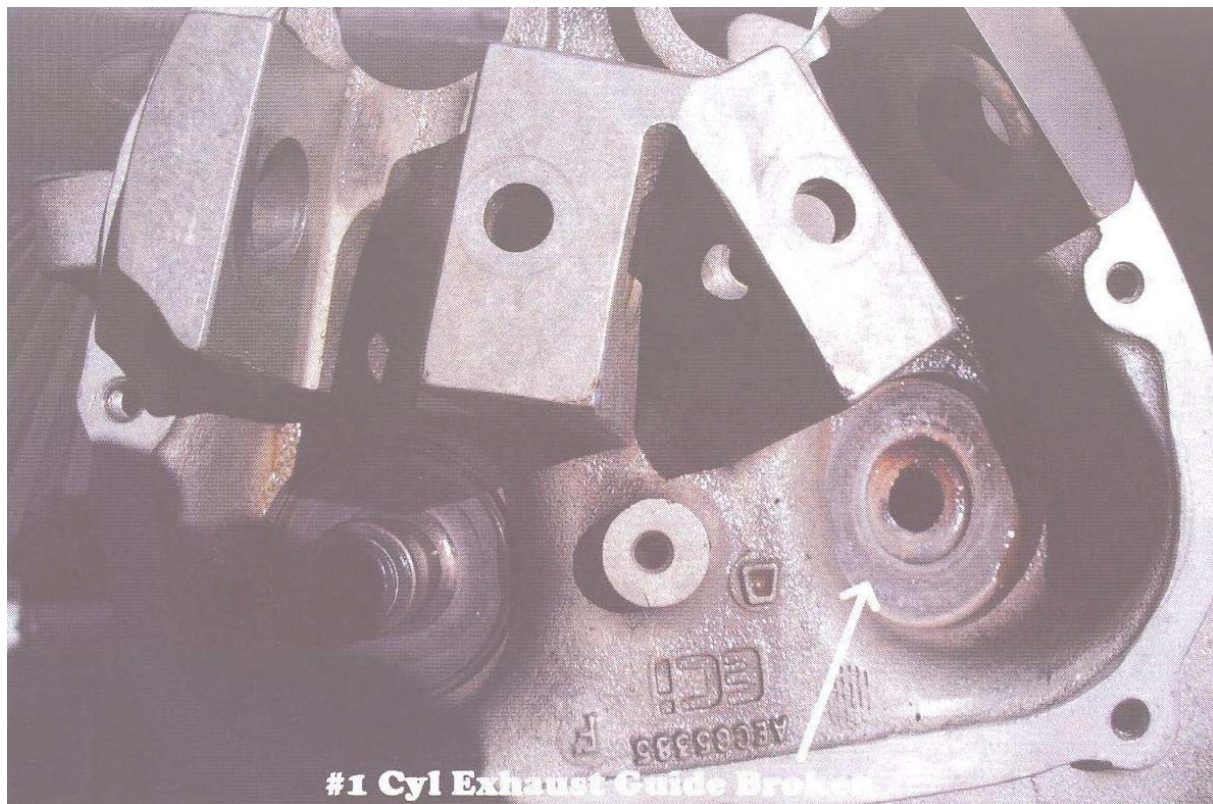
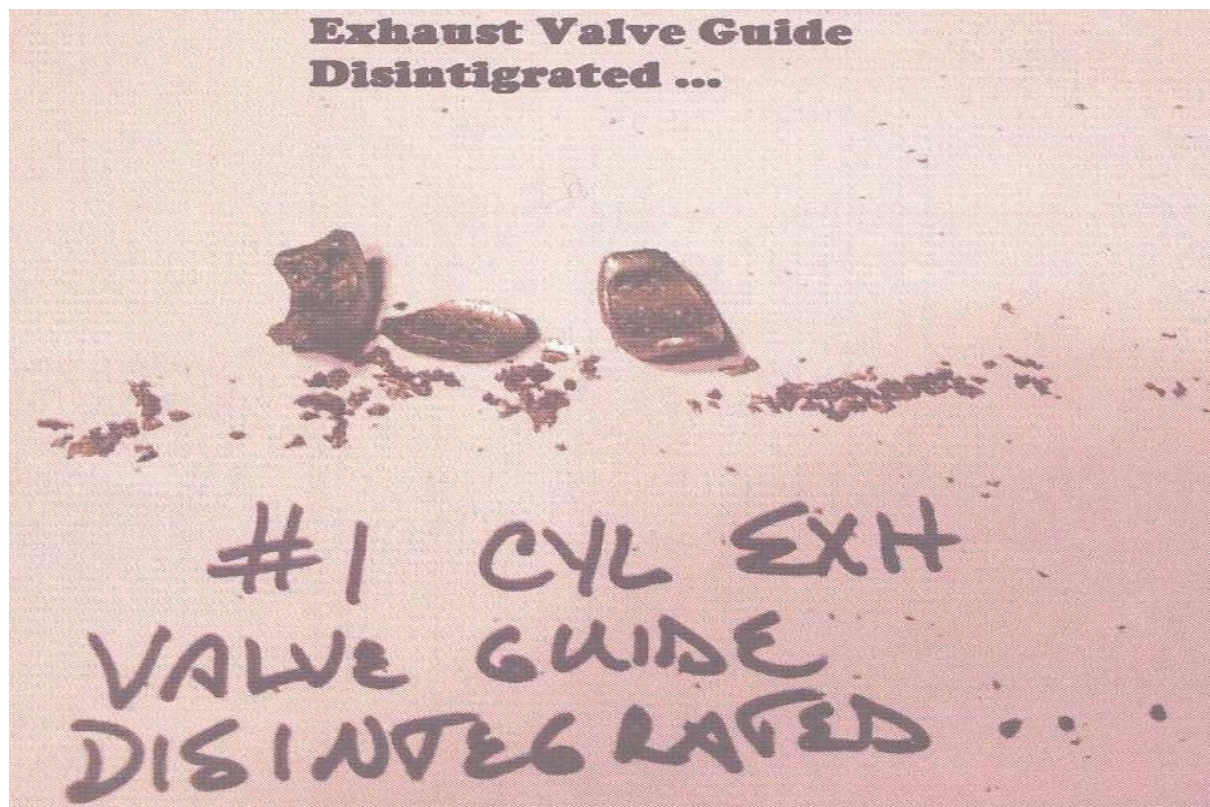
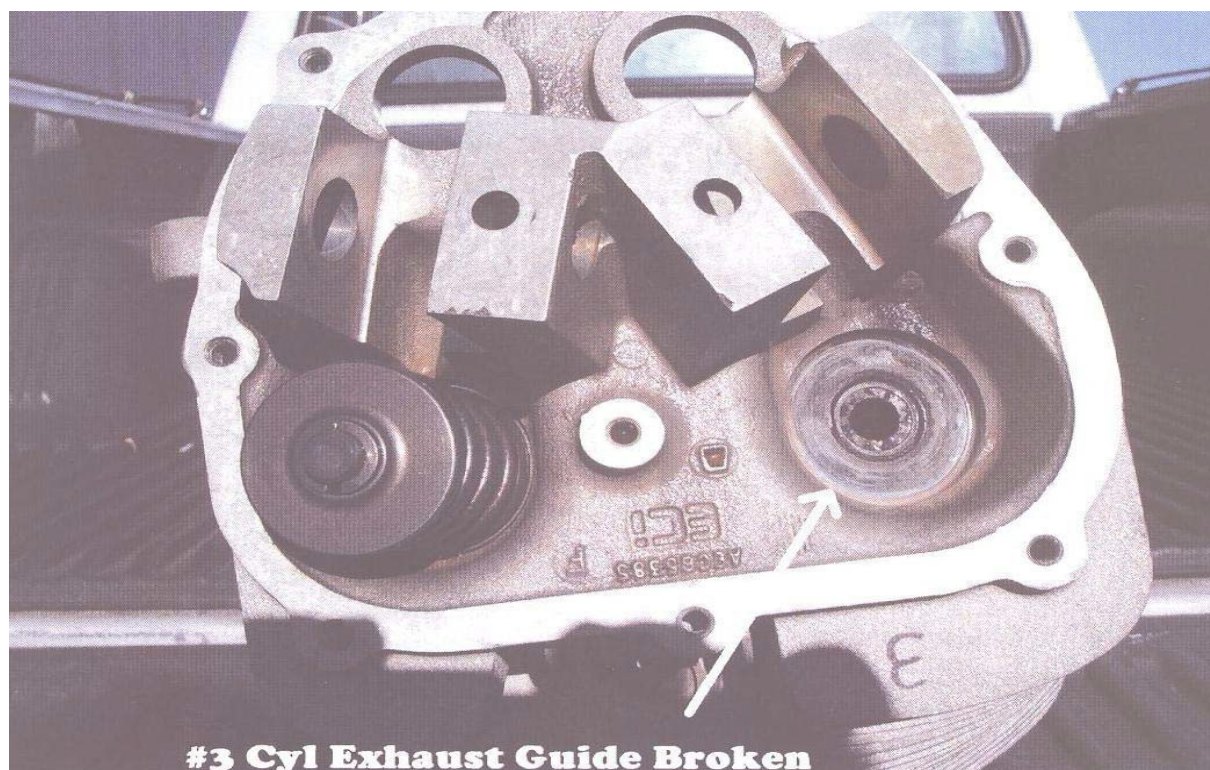
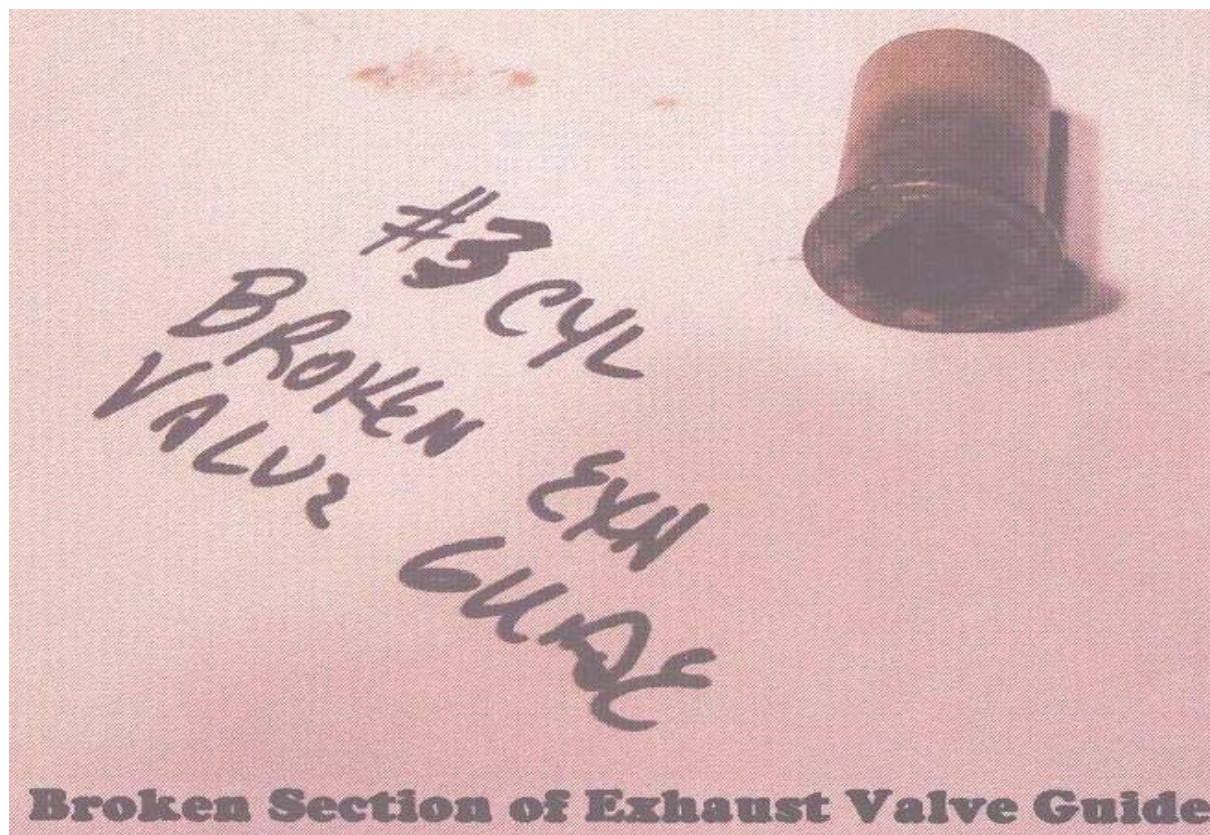
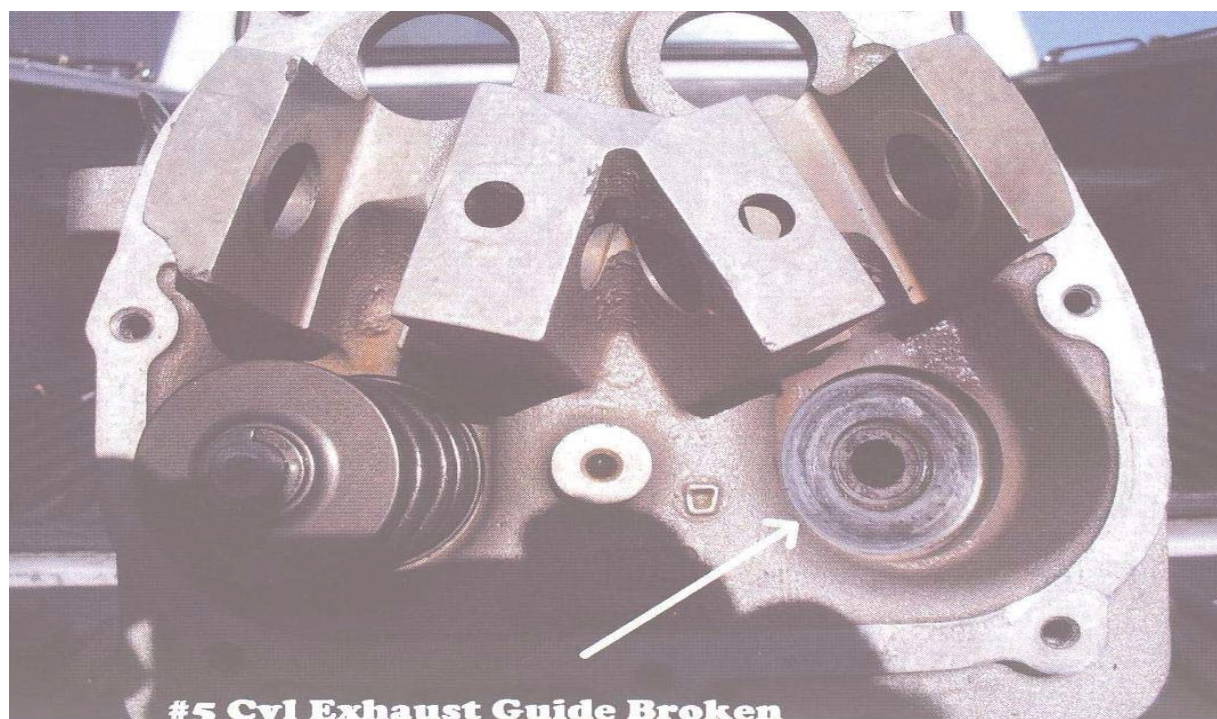
This general aviation report states, "Six new Engine Components, Inc. (ECI) cylinders were installed at 2,812-hours total time. The ECI cylinders experienced a failure of the valve guides on three of the six cylinders at 384-hours of time in service. All three failed valve guides broke off at the insert point (see photos), and one completely disintegrated—contaminating the engine with metal debris. This debris caused chafing on at least two valve lifter assemblies, and damage to the camshaft. The engine will require a complete tear down because of the metal contamination and damage.

"The only initial, abnormal indication noted from the broken exhaust valve guides was excessive engine oil blowing through the engine crankcase breather. This was noted by a significant amount of oil on the belly of the aircraft. The engine operated normally with no apparent power loss or abnormal indications of EGT, TIT, or oil pressure/temperature. Eventually turbine operation became erratic, caused by momentary blockage within the turbine waste-gate controller. This condition was intermittent. Flaws were found by visual inspection after low compression was found on two of the effected cylinders...."

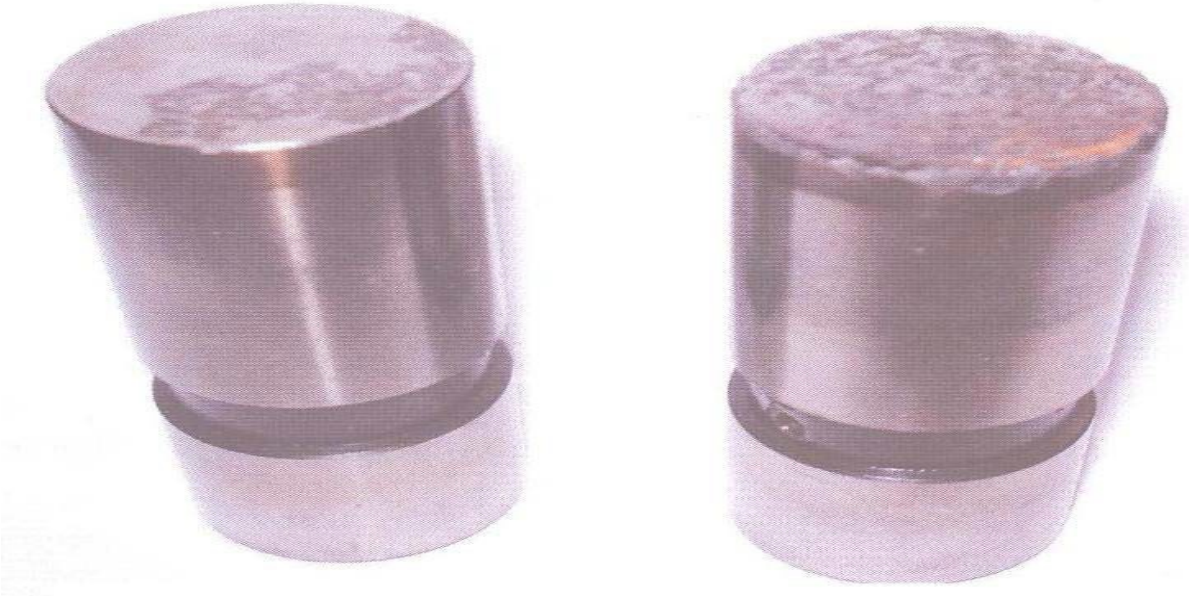
**Damage to Valve Lifters
Due to metal contamination
(Camshaft Damage also)**
