## **Lycoming IO540AE1A5, Failed Intake Valve, ATA 8520**

(The following description references a Robinson R44 Raven II helicopter.)

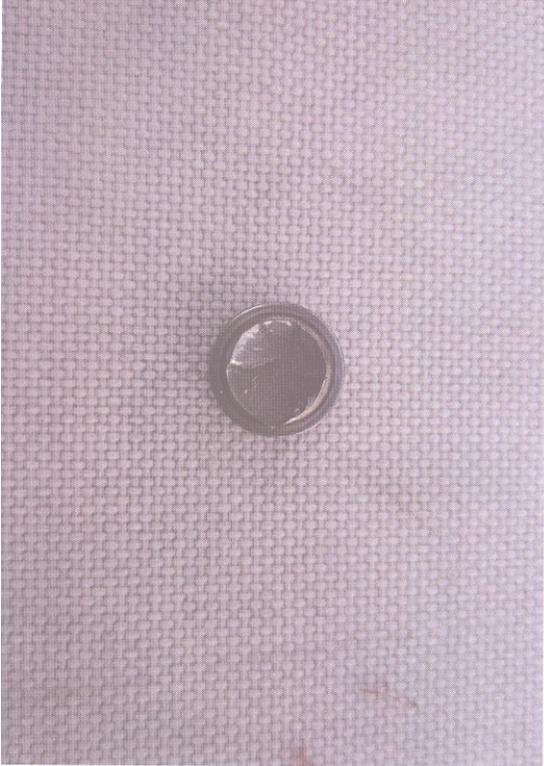
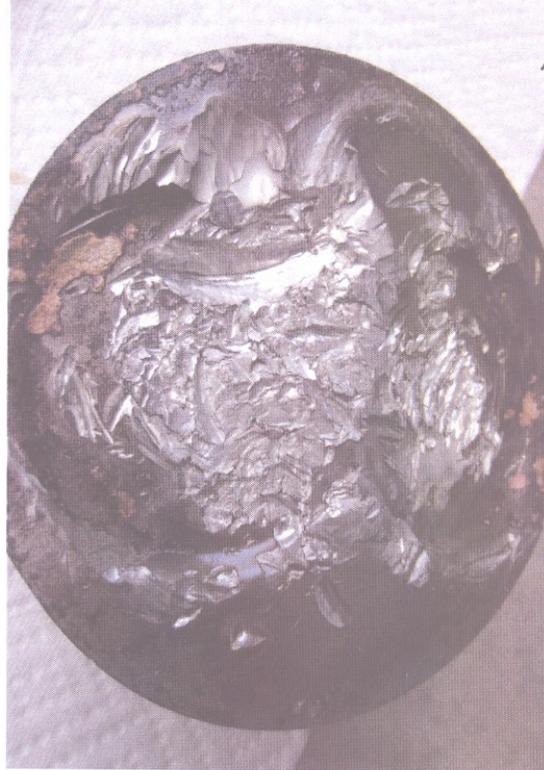
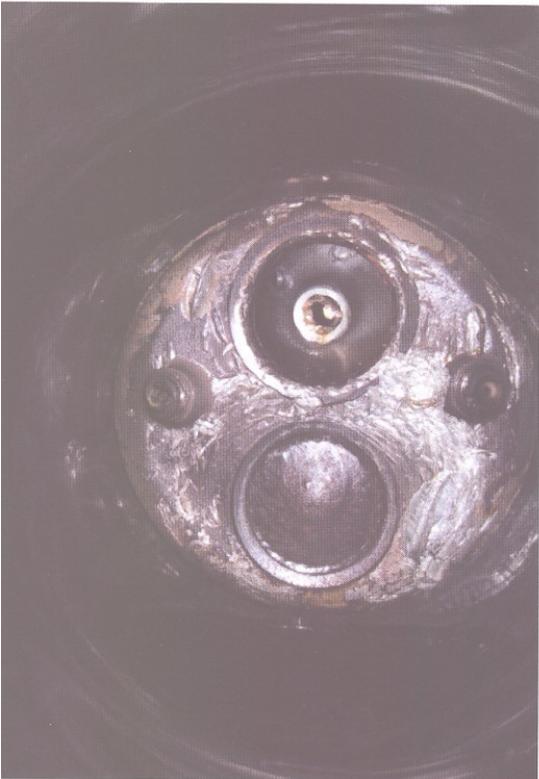
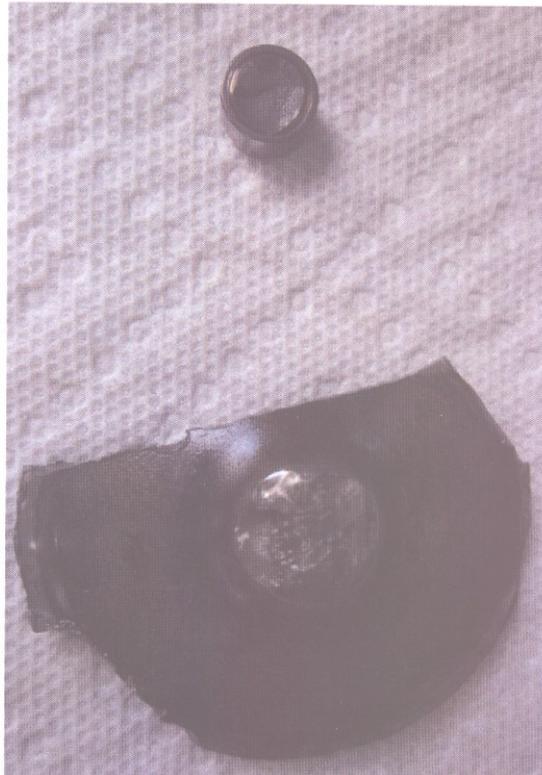
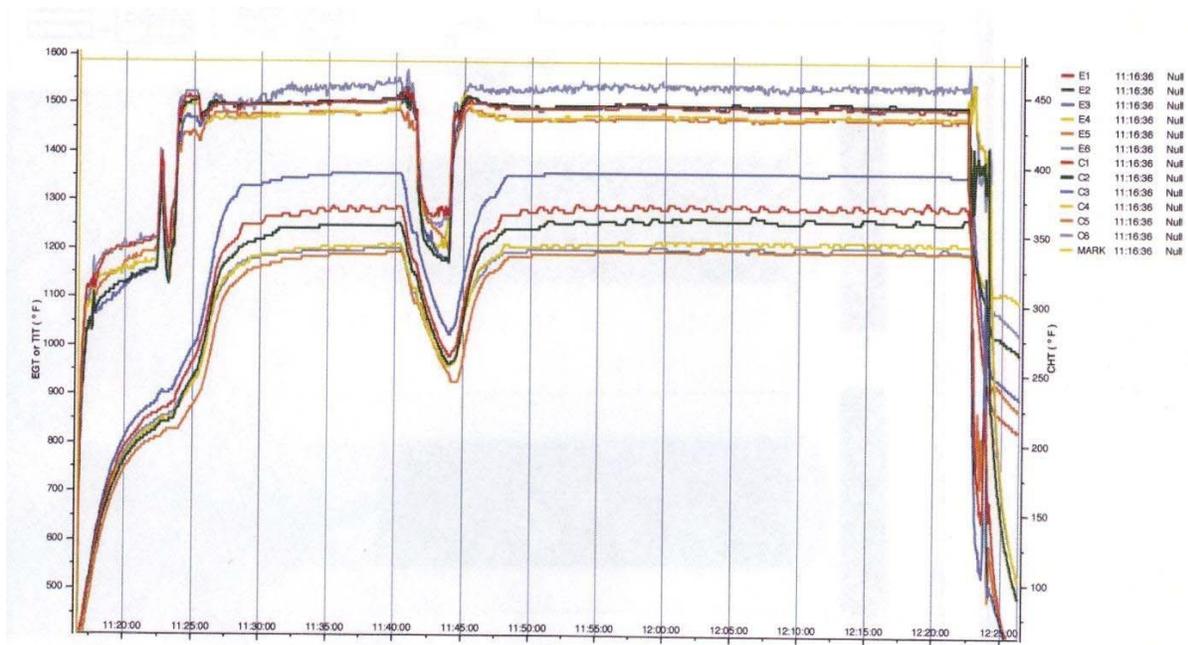
"Removal of the number one cylinder for visual inspection revealed a failure of the intake valve," says this technician. "Subsequent analysis from the data recorded by the JPI graphical engine monitor showed massive ingestion of engine oil into the remaining cylinders, causing loss of power—oil fouling the remaining (otherwise) unaffected spark plugs. Closer inspection of the effected cylinder showed catastrophic damage to the piston and combustion area from (piston/valve/head) multiple contacts. Fractured valve parts became wedged in the induction tube and in the common manifold area. When the intake rocker assembly was removed it was discovered the top portion of the valve stem above the 'keepers' was the area of separation/failure. A 30X power microscope was used for inspection. It is (our) opinion the failure of the intake valve may have been caused from a stress riser created during manufacturing at either the machining, heat treating process, or perhaps at the molecular level during creation of the raw material. It should be noted the aircraft was in compliance with Lycoming Service Bulletin SB388C exactly 85.8 hours earlier. No defect or abnormalities were noted at the time of the inspection."

(Intake valve P/N: LW13622. There are eleven of these part numbers reflected in the SDRS database.)

Part Total Time: 381.0 hours
