Rotax 912SE, Chafed Coolant Hose, ATA 8570

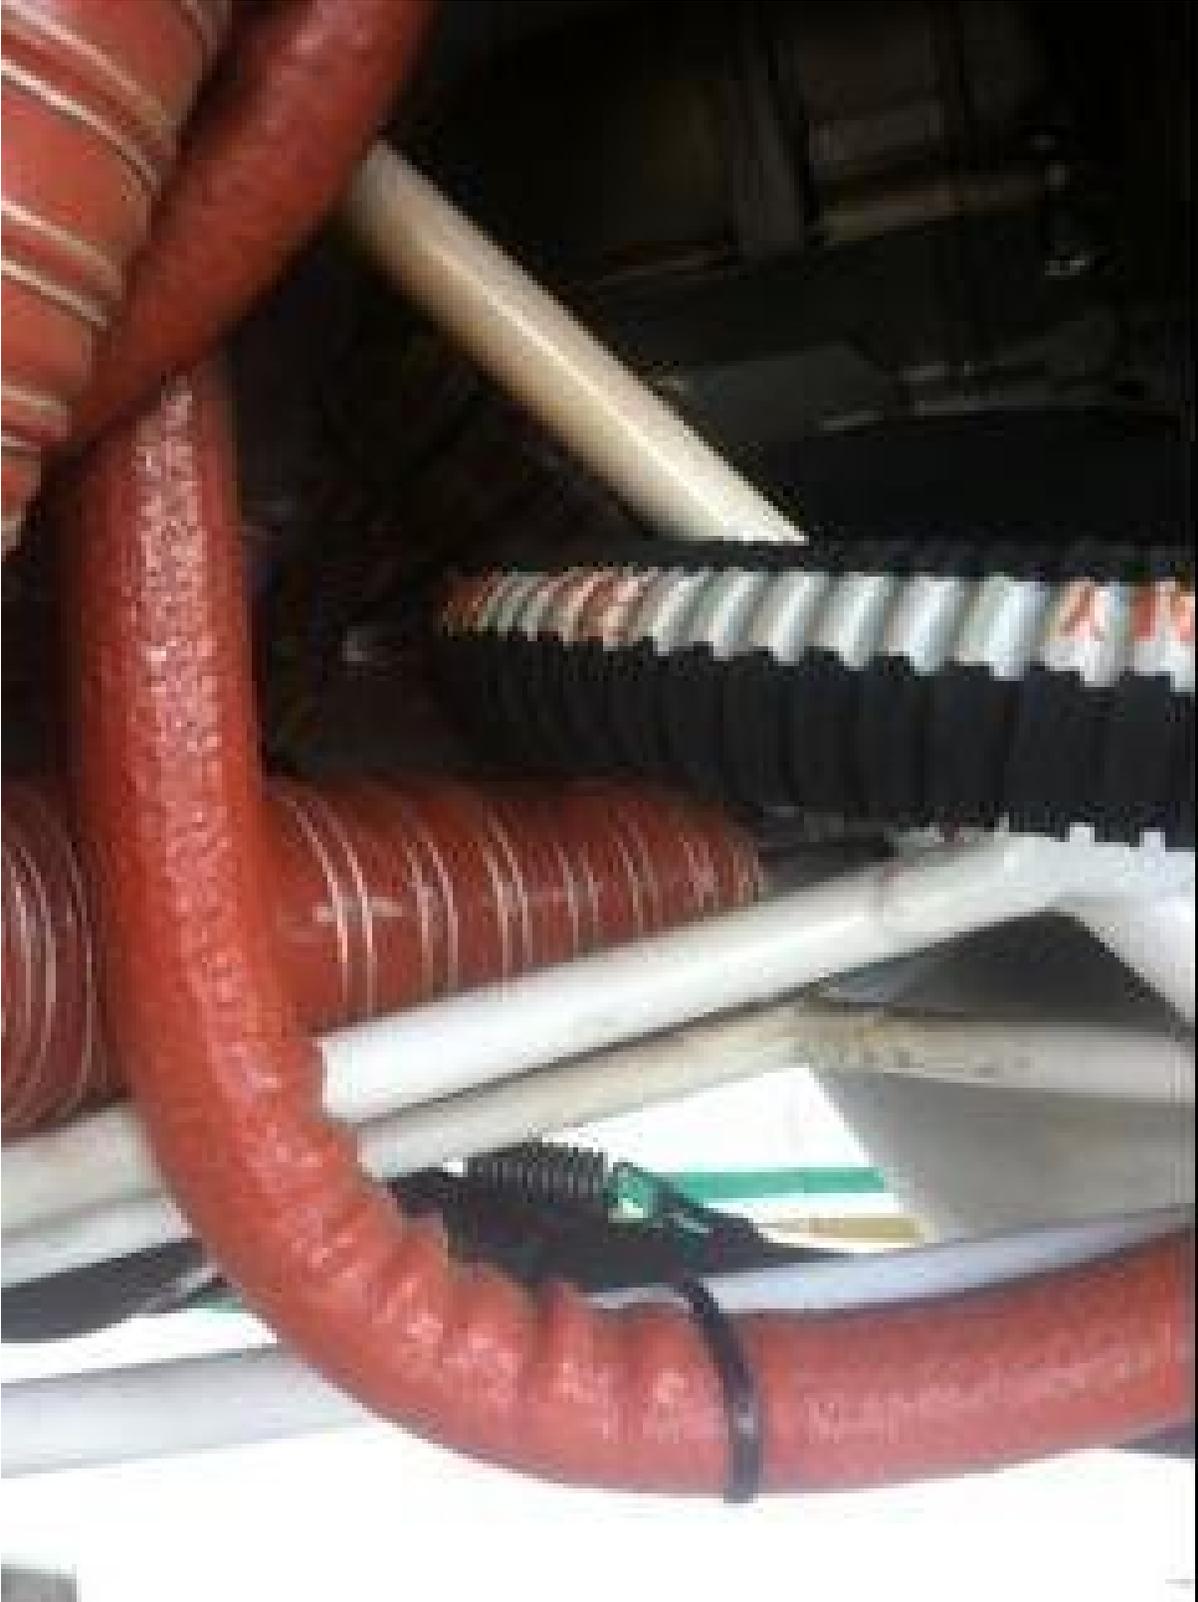
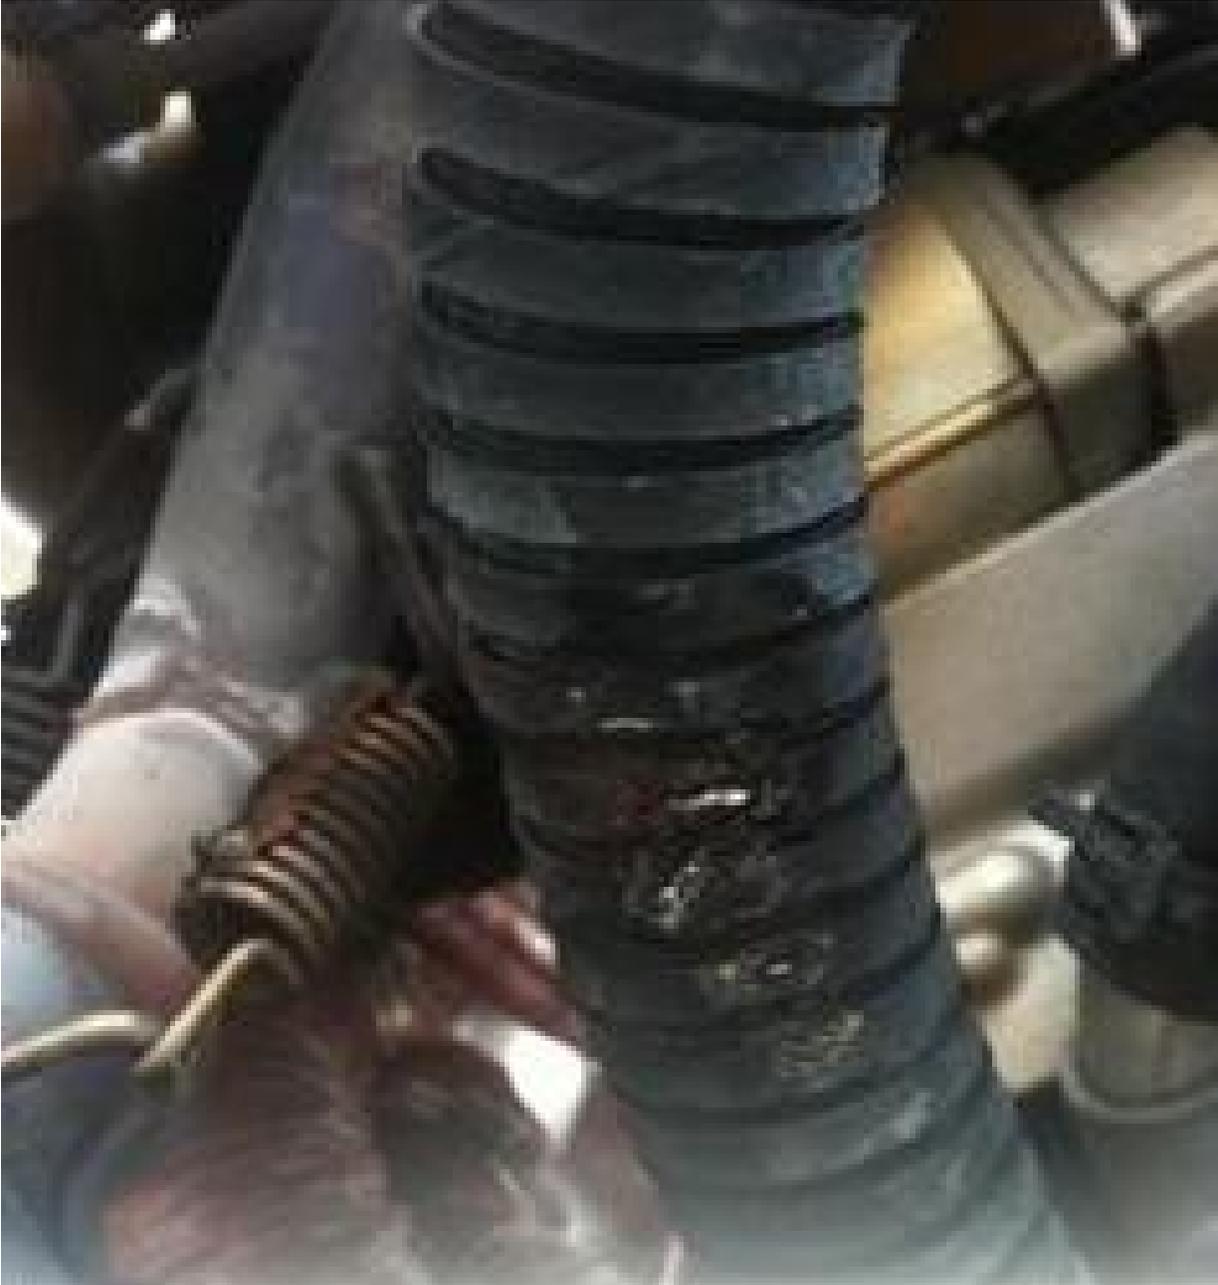
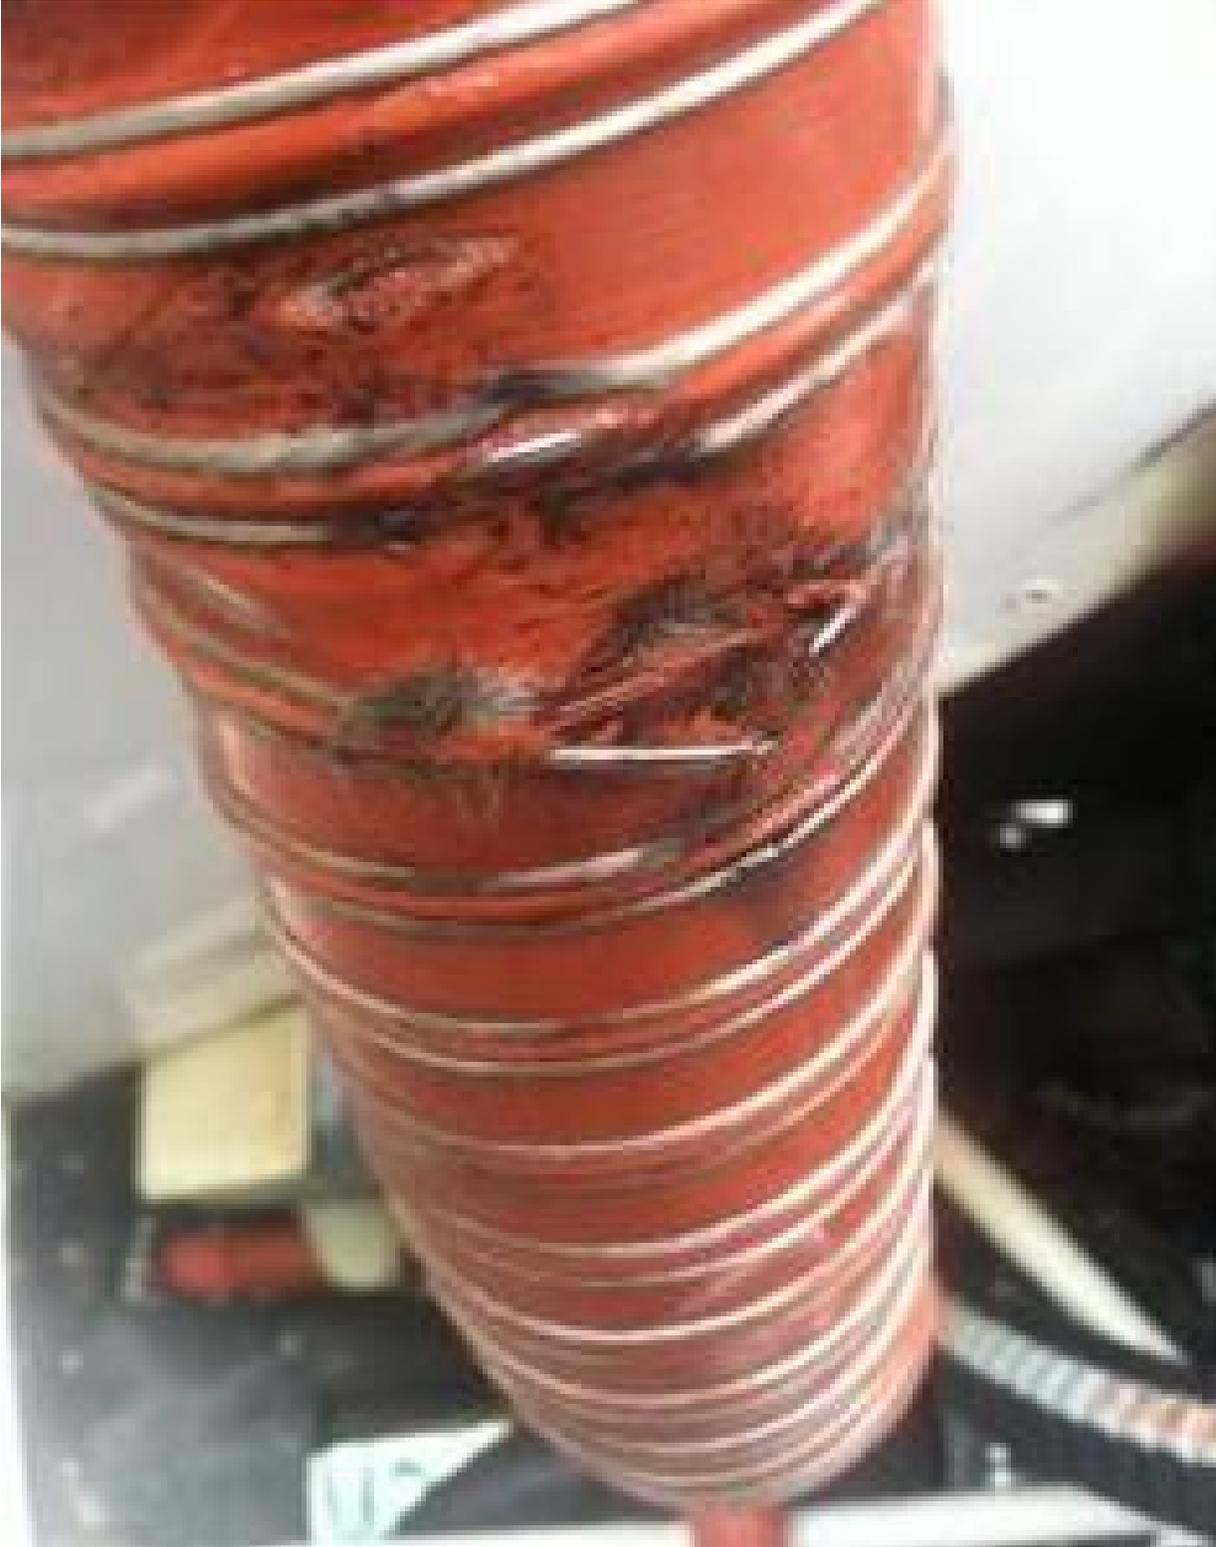
A repair station technician writes, "The lower engine coolant hose and exhaust SCAT hose are in constant contact due to installation design. Chafing caused wire from the SCAT hose to puncture the lower coolant hose. Subsequent loss of all coolant caused engine overheating. While the pilot was determining the cause of a high CHT (*cylinder head temperature*) indication, the CHT gauge went to zero. The engine was making normal power and all other indicators were normal—leaving the pilot (*in doubt*) of the problem (faulty gauge or engine overheating).

"Upon return to the airport and inspection of the engine it was determined the engine became (*sufficiently*) hot to destroy the CHT indicator in the cylinder head. The visual access to the hoses is very limited; the only way to inspect is to remove the SCAT hose. These hoses are in constant contact and need to be re-routed or re-designed. This event occurred on the R/H engine. The L/H engine is routed differently, but these hoses too are in constant contact." (*No P/N's were provided with this report.*)
