(A pilot/mechanic provides this defect report referencing a Cirrus SR22 aircraft with a Continental IO550N engine.)

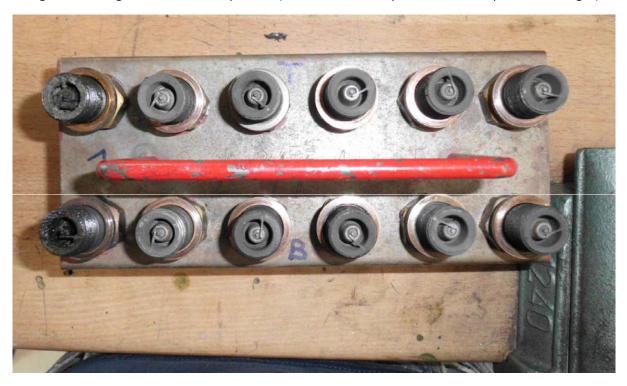
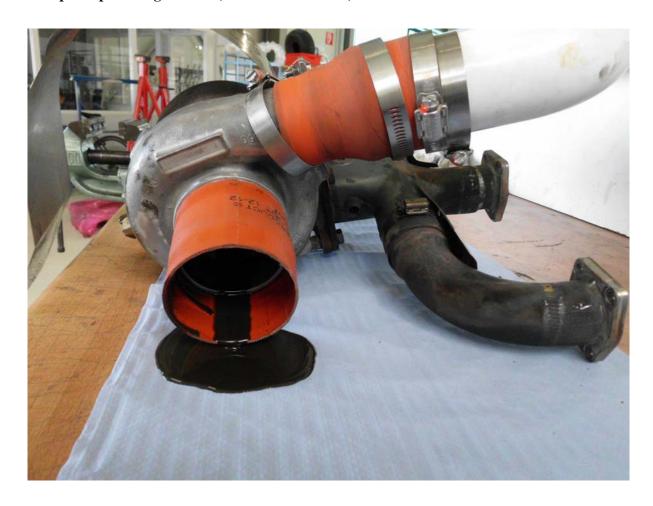
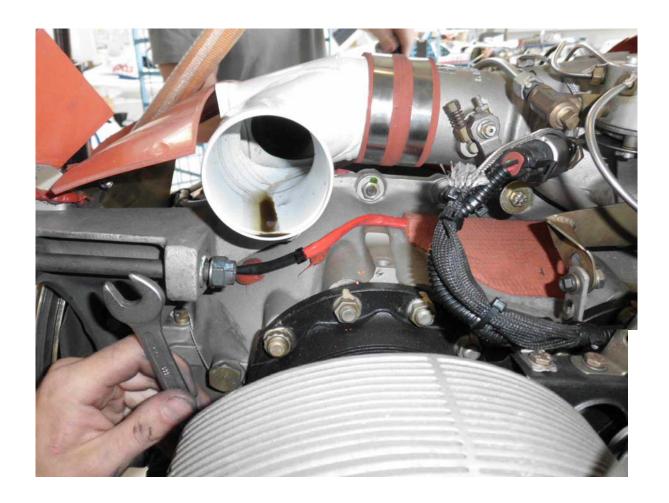
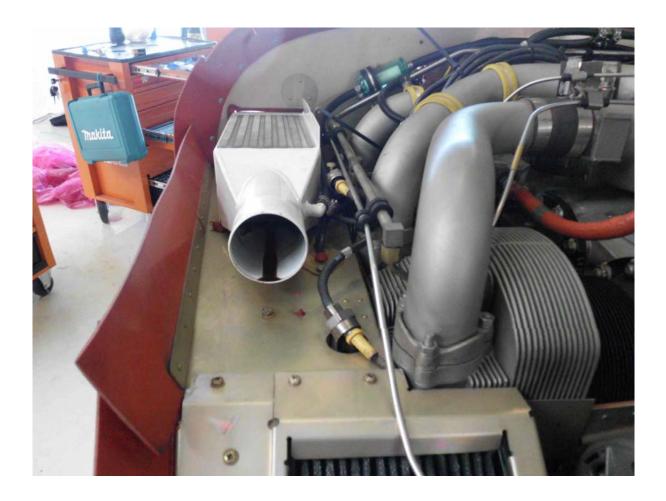
"The engine (ran) rough during climb to 14,000 feet. (I) could not set 17.5 GPH (fuel consumption) for cruise." "CHT (cylinder head temperature) for number one cylinder increased from 340 degrees to 480 degrees and beyond. I had normal EGT (exhaust gas temperature), high and rising TIT (turbo inlet temperature) on turbocharger number two—from 1600 to 1750 degrees. When the oil pressure dropped I diverted (for landing). Inspection revealed no differential pressure on cylinder number two, the oil filter was full of metal, the waste gate controller was missing parts, and the spark plugs had cracked insulators and pre-ignition (indications) on the cylinders. There was metal contamination throughout the engine. An Annual inspection (...had been accomplished 30 hours prior to the flight)."
