## Continental Alternator, P/N 649304, Worn Brushes, ATA 2434

(This report references a Beechcraft A36 sporting a Continental IO550B engine.)

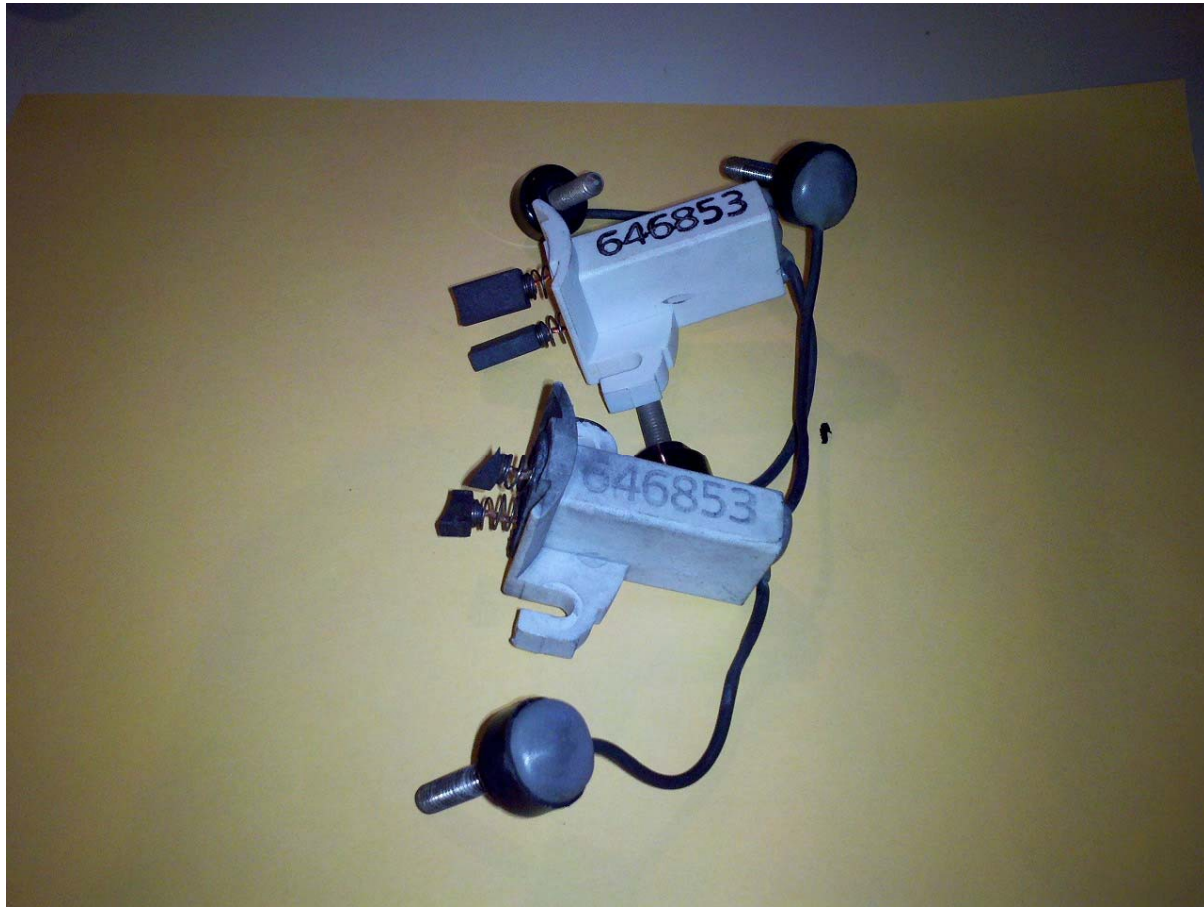
A repair station technician says, "The aircraft owner had casually discussed his (recent) engine overhaul—including the installation of a standby alternator. (I) inquired about the last alternator inspection...none had been (performed) since the installation of a new engine 1,626 hours previously. Inspection followed this conversation. One brush (P/N 646853) was (found) worn well past its limits, the other exhibited imminent failure." "The alternator service support manual (P/N X30531-4) recommends 'The alternator be removed, disassembled, inspected, repaired, and tested...' at 500 hour intervals."

Part Total Time: 1,626.0 Hours
