Continental Magneto, S6RSC-25P, Failed Distributor Gear, ATA 7414 (2)

Continental Magneto: S6RSC-25P; Failed Distributor Gear; ATA 7414

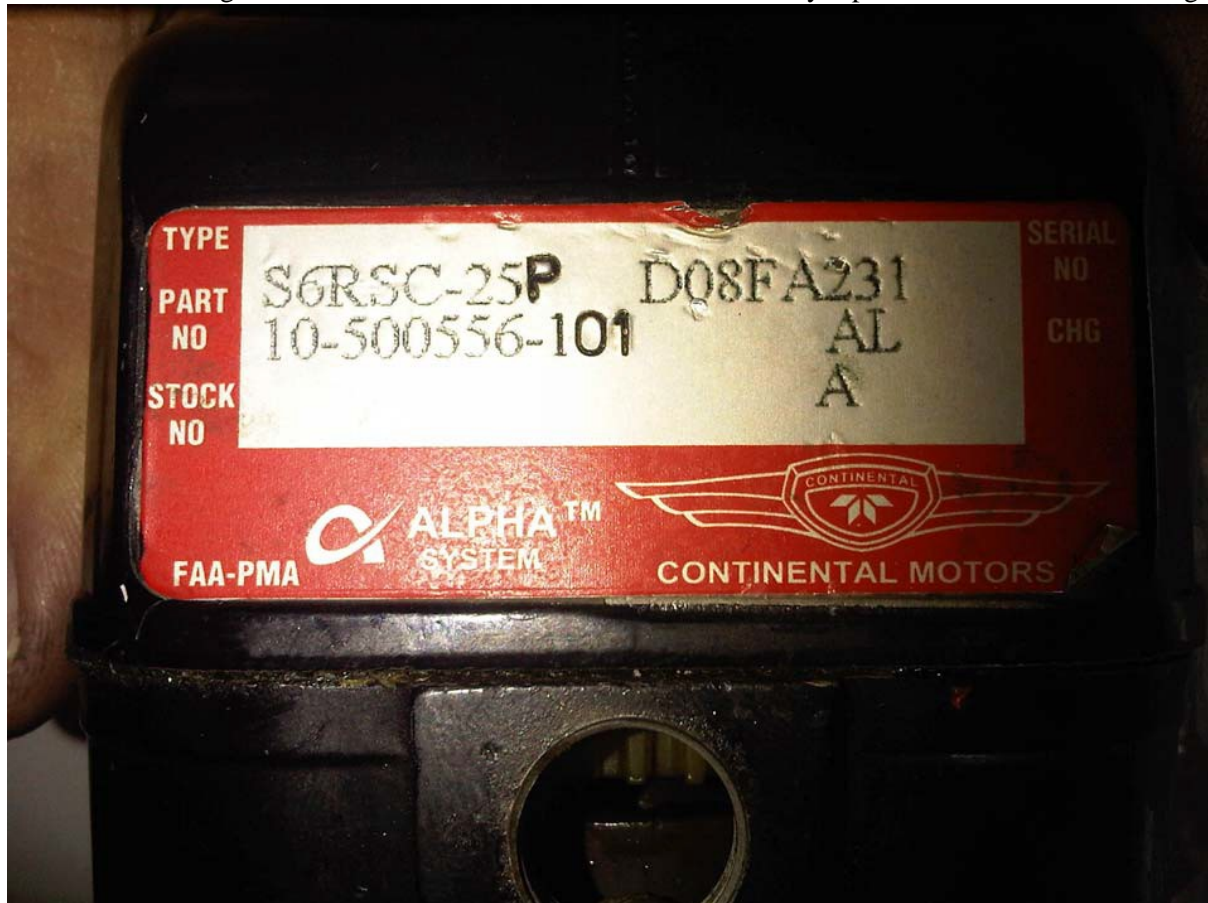
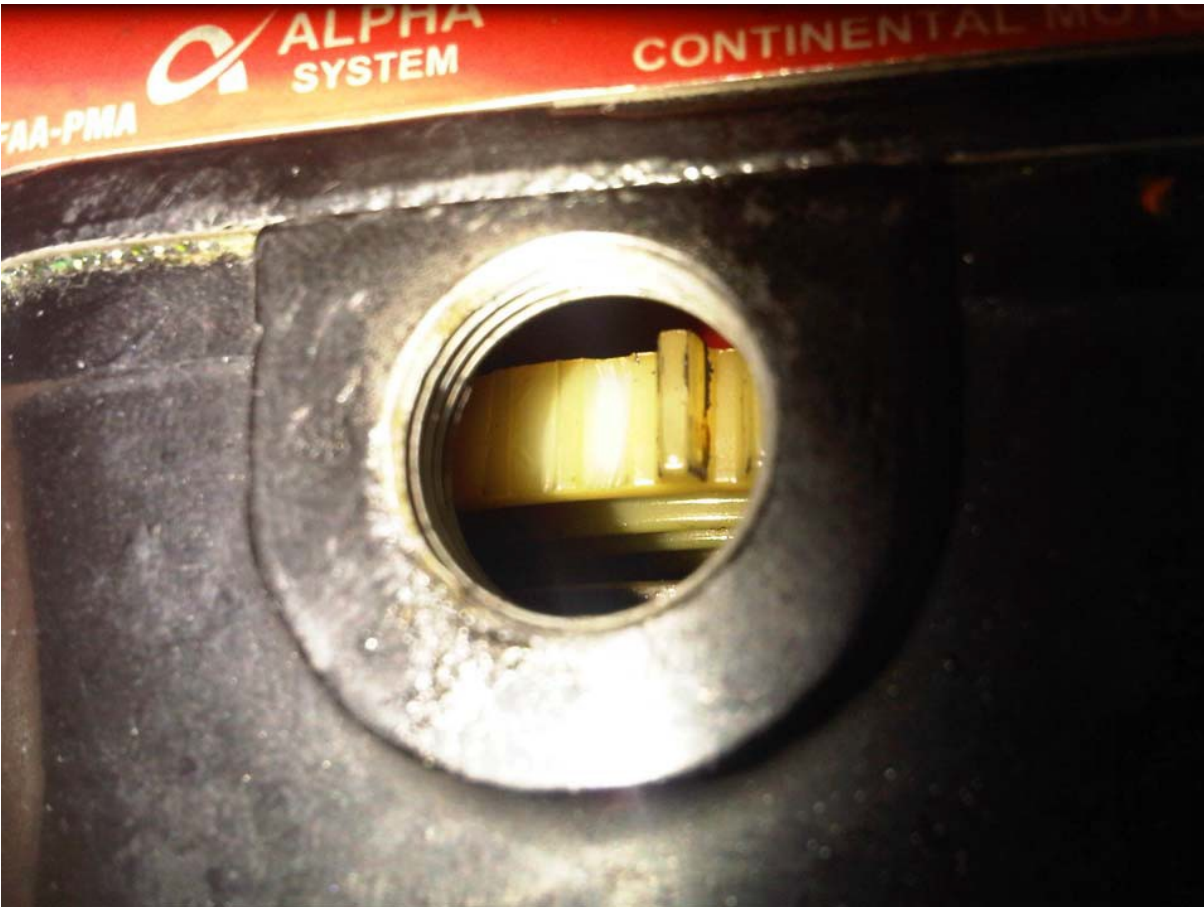
Again our mechanic says, " The crew reported severe engine vibration during takeoff. Quick inspection on the ground revealed the L/H magneto was inoperative. The operator decided to replace the magneto with a brand new one. Disassembly of the magneto (P/N 10-500556-101) found the distributor gear to have failed."

Part Total Time 674.0 hours

"We noted the magneto overhaul manual does not include mandatory replacement of the distributor g

ear.

We highly recommend this suggestion to the manufacturer."
