Kelly Alternator ALU8521, Broken Brush-block Wire, ATA 2421

(This report references a Diamond DA40 aircraft sporting a Lycoming IO360 engine.)

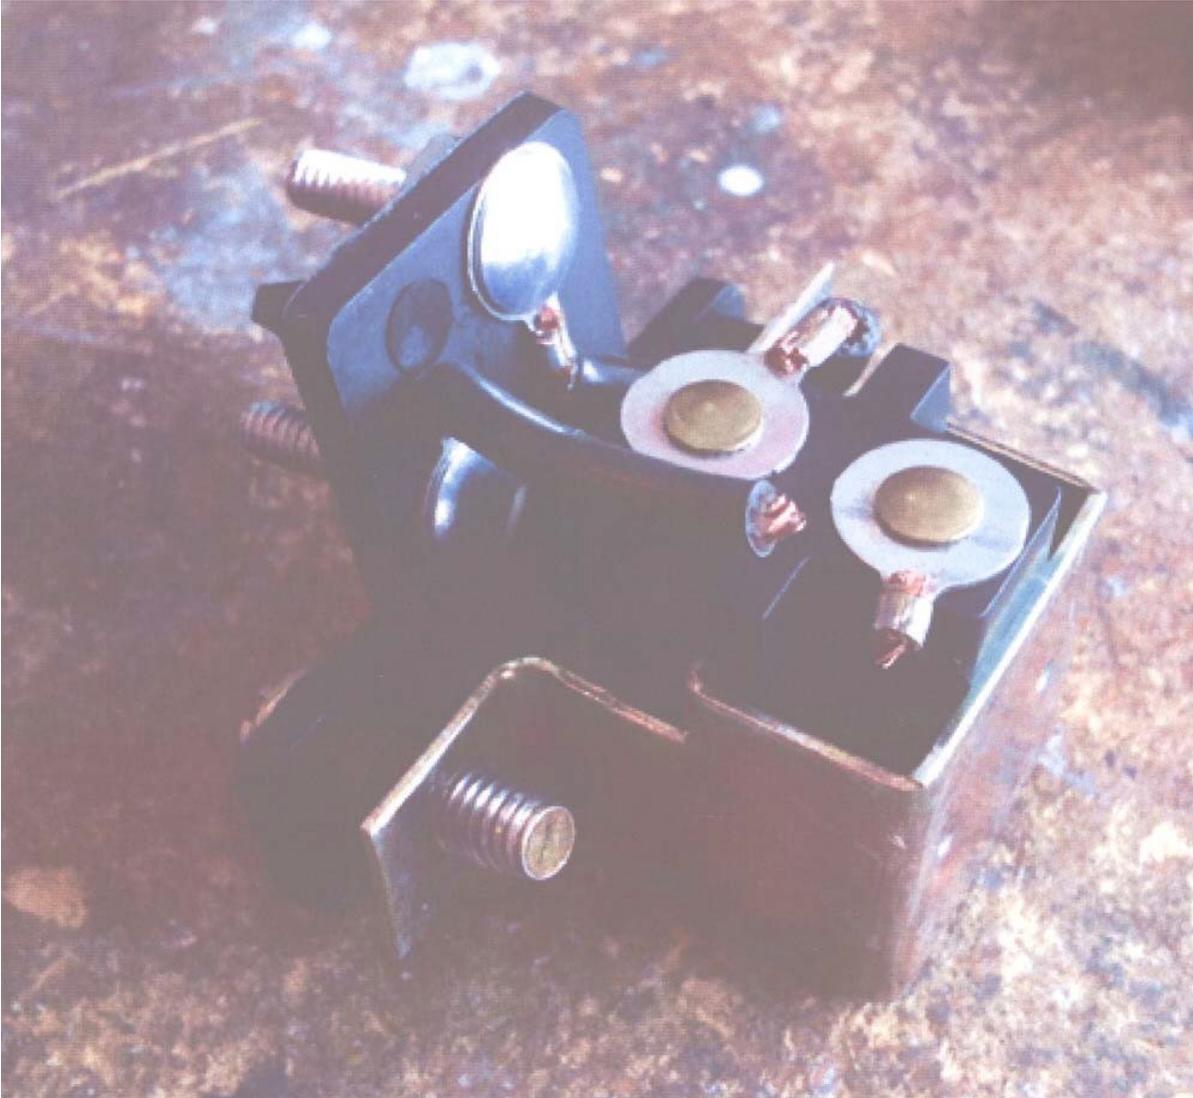
A repair station technician states, "This alternator failed in flight. (I) found the brush-block wire broken."
