Beechjet 400A, Pitch-Trim Electrical Failure, ATA 2797

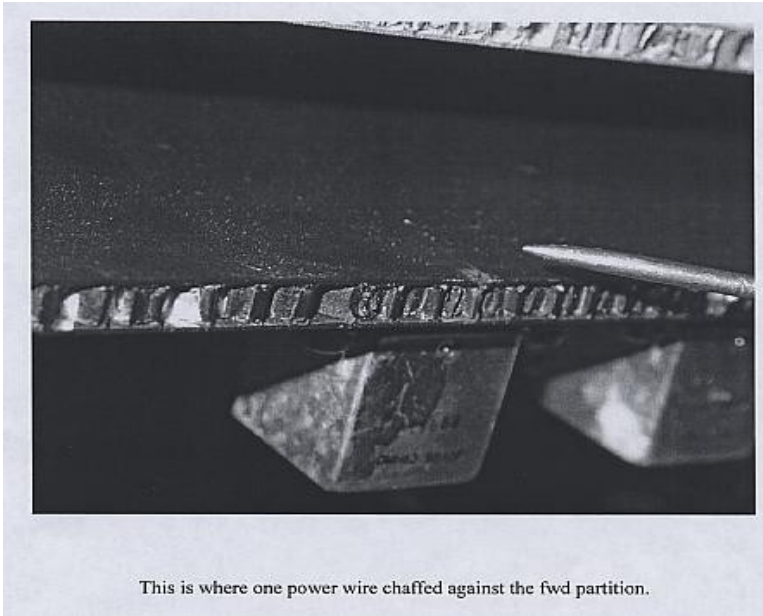
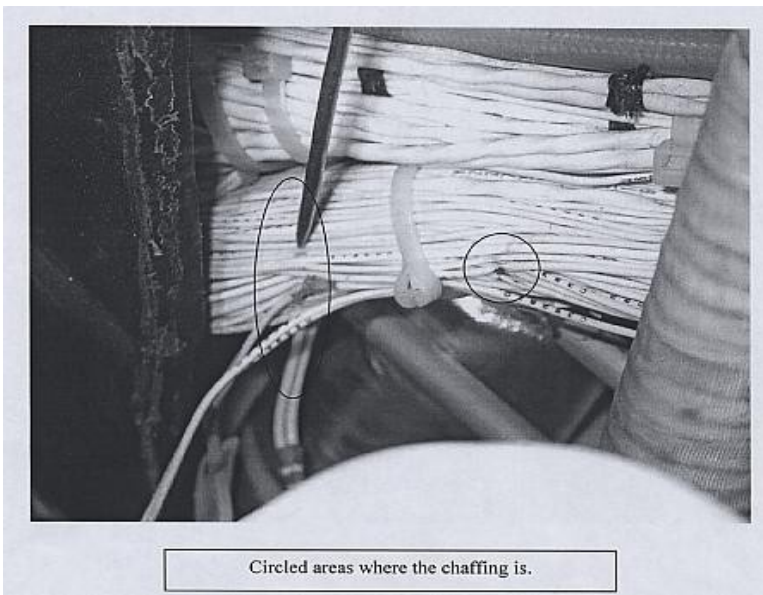
A repair station technician says, "The pitch-trim was not working and I removed the right forward galley and the right forward partition. A wire bundle that was chafed was located behind the partition; the mechanic repaired three wires that were chafed through to the conductors.

At the time of the repair no other components had malfunctioned from the other two chafed wires." (Primary wire P/N: C352B20.)

Clearance between the wire bundle and the partition was established and anti-chafe material was installed.
