Boeing 700 Series, Over-Heating Static Inverter

Aviation Safety Inspector Mona Tindall from the Aircraft Maintenance Division in Washington D.C. provided the following safety article.

The affected Boeing models include series 737-300, -400, -500, -600, -700C, -800,-900; model/series 747-400; and models 757, 767, and 777 aircraft. This writing is published as received. Contact information is available at the discussion's end.)

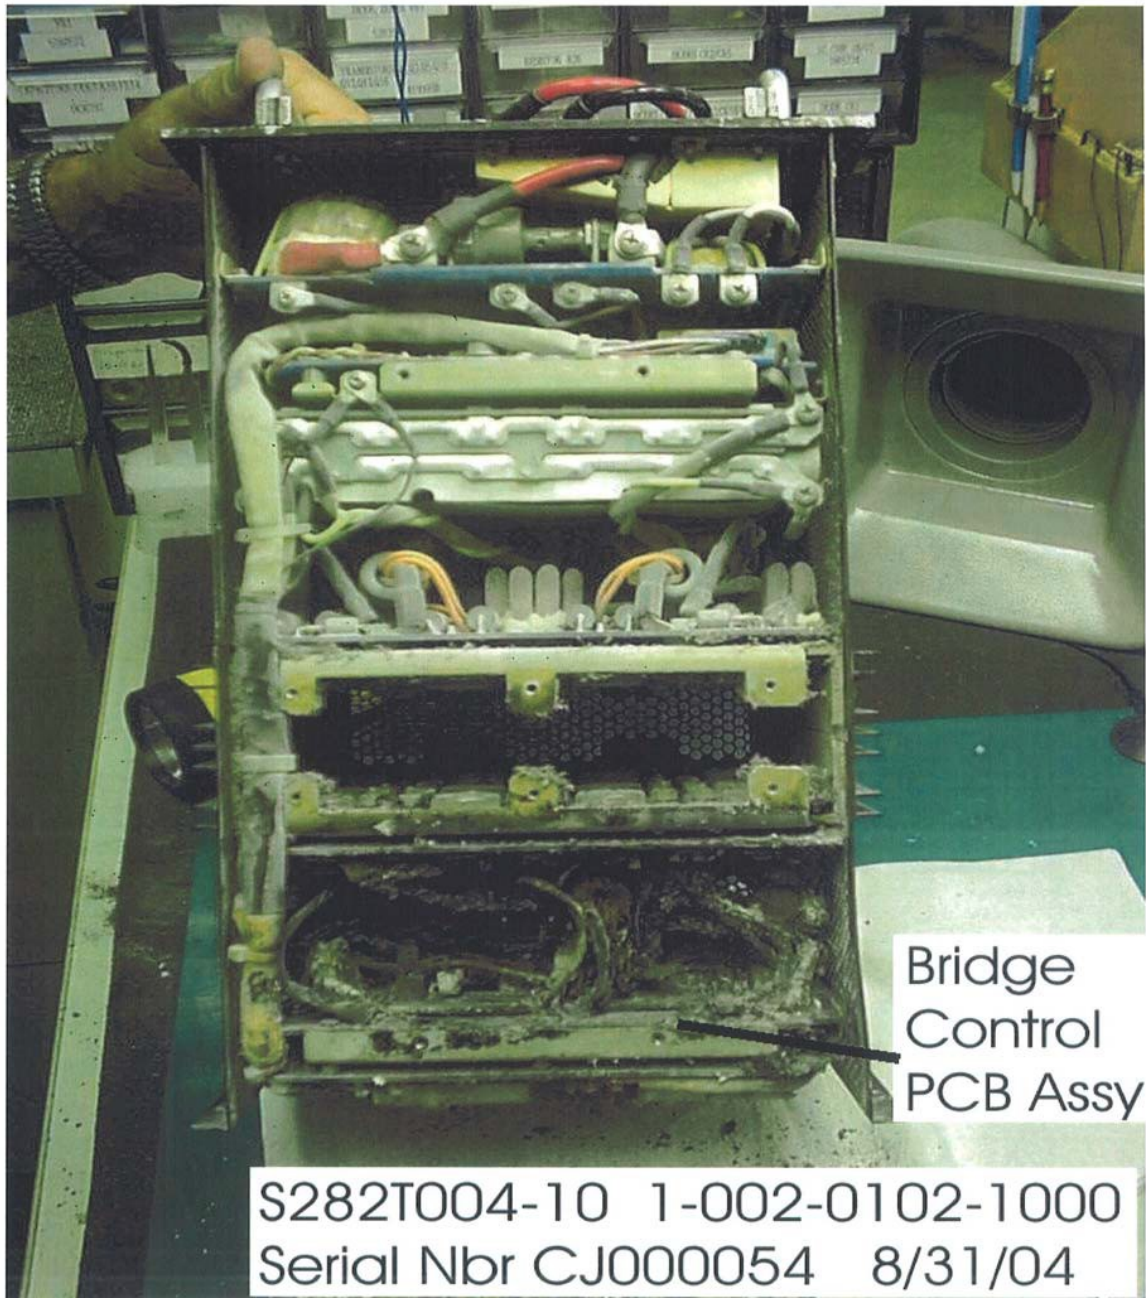
Boeing 700 Series, Over-Heating Static Inverter

The Federal Aviation Administration (FAA) received reports that the static inverter installed on many Boeing airplanes could become overheated, resulting in smoke in the flight deck and cabin, and loss of the electrical standby power system. In one incident, a Boeing 757 airplane experienced smoke in the cockpit and cabin after engine start; resulting in the flight attendants and passengers were evacuated. The source of the smoke was from the static inverter. Maintenance replaced the static inverter and the mounting tray, which high heat severely damaged. Several static inverters from the main fleet exhibited overheating indications when checked. Ready Stock Units were returned to the vendor.

Boeing has issued service bulletins for accomplishing the specified static inverter modification. The service bulletins refer to Avionic Instruments, Inc. Service Bulletin 1-002-0102-1000-24-28, Revision A, dated June 22, 2005; and Revision B, dated July 24, 2006, as additional sources of service information for accomplishing the modification. Boeing's service information may be obtained from

On January 12, 2009, the Federal Register published a revised supplemental notice of proposed rulemaking (SNPRM), docket number 2002-NM-12-AD. This action is intended to address the identified unsafe condition.
