## Beechcraft A36, Broken Aileron / Rudder Spring, ATA 2720

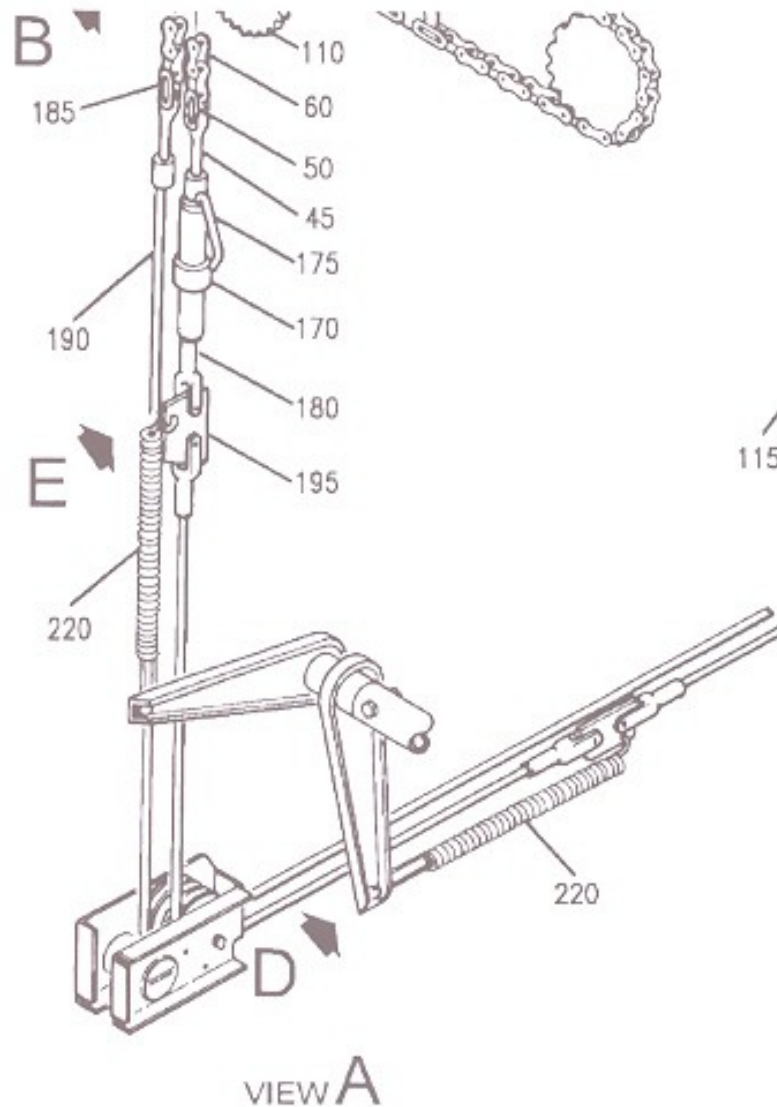
A technician working on a corporate aircraft states, "During flight, the pilot noticed the Aileron control was pulling to the right. The aircraft returned to base without incident. Upon inspection of the Aileron control system, the upper Aileron/Rudder interconnect spring (P/N 35-5524664) was found broken at the end of the bell crank arm (P/N 002-524018-25).

The probable cause for this failure is time in service.

Part Total Time: 10,609.0 Hours
