Bombardier 700-1A10, Loose Power Cable, ATA 2497

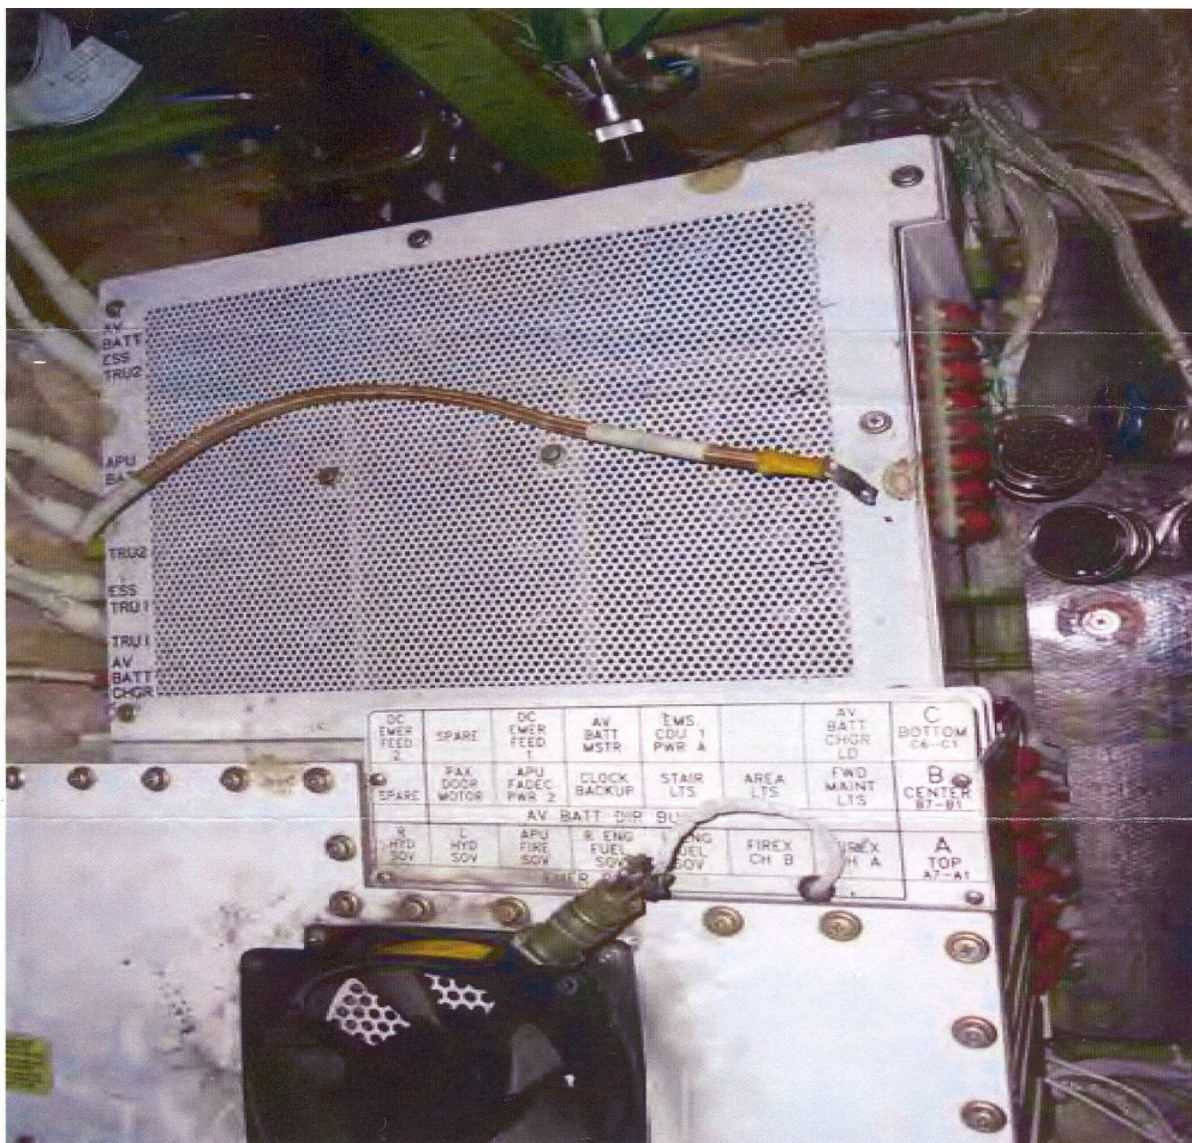
The Customer noticed an amber 'electrical system fail' CAS Message. The inspector found a power cable for the number two TRU (transformer/rectifier unit) had come free. Also found were two charred wire harnesses at the number two SPDU (Secondary Power Distribution Unit)—and 'arcing marks' on the unit (itself). This arcing appears to be caused by the loose power cable.

"The power cable P/N is 3PB189A4. It connects at one end to the TRU2 post on the forward side of the unit labeled 'DC Power Center'. This unit is located under the floorboard of the cockpit entry area. The other end connects to the bus bar of a unit (P/N 7274-11-15), which contains two fifteen amp circuit breakers. This was also found under the floorboards in the same area. The circuit breakers are marked 'Feeder 1' and 'Feeder 2'.

"The charred wire harnesses are P/N's A13P5/A13J5 F230 and A13P6/A13J6 F235. These two harnesses connect to cannon plugs on the SPDU assembly.

No cause has been determined for the power cable coming loose. Bombardier technical representatives were notified and they will evaluate this issue.
