CASA C212CC, Corroded Longerons, ATA 5313

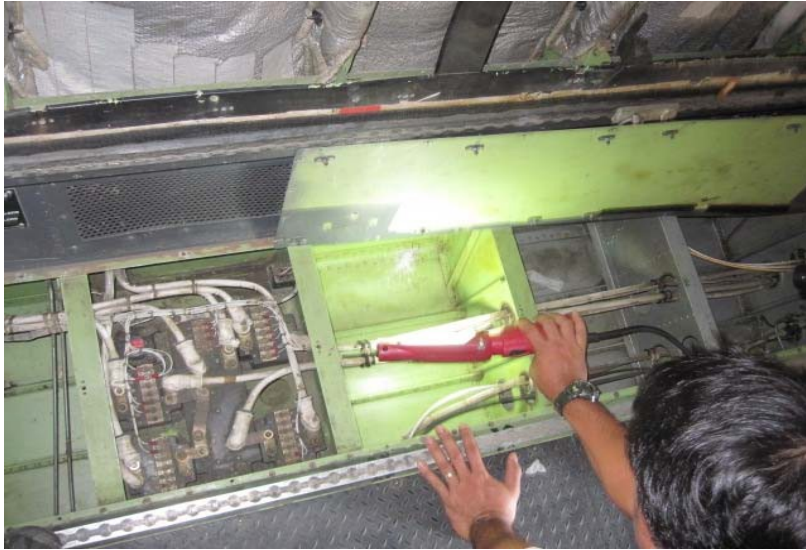
An air carrier submission says, "The Longerons that connects the left fuselage sidewall and belly has one spot of corrosion between frames 3 and 4 at approximate station 4100.

The Longerons is 3.2 MM thick, and is formed as an angle. The corrosion damage extends at least halfway into the beam (thickness) and moves into the bend radius. This corrosion spot is about 0.50 inches in diameter."

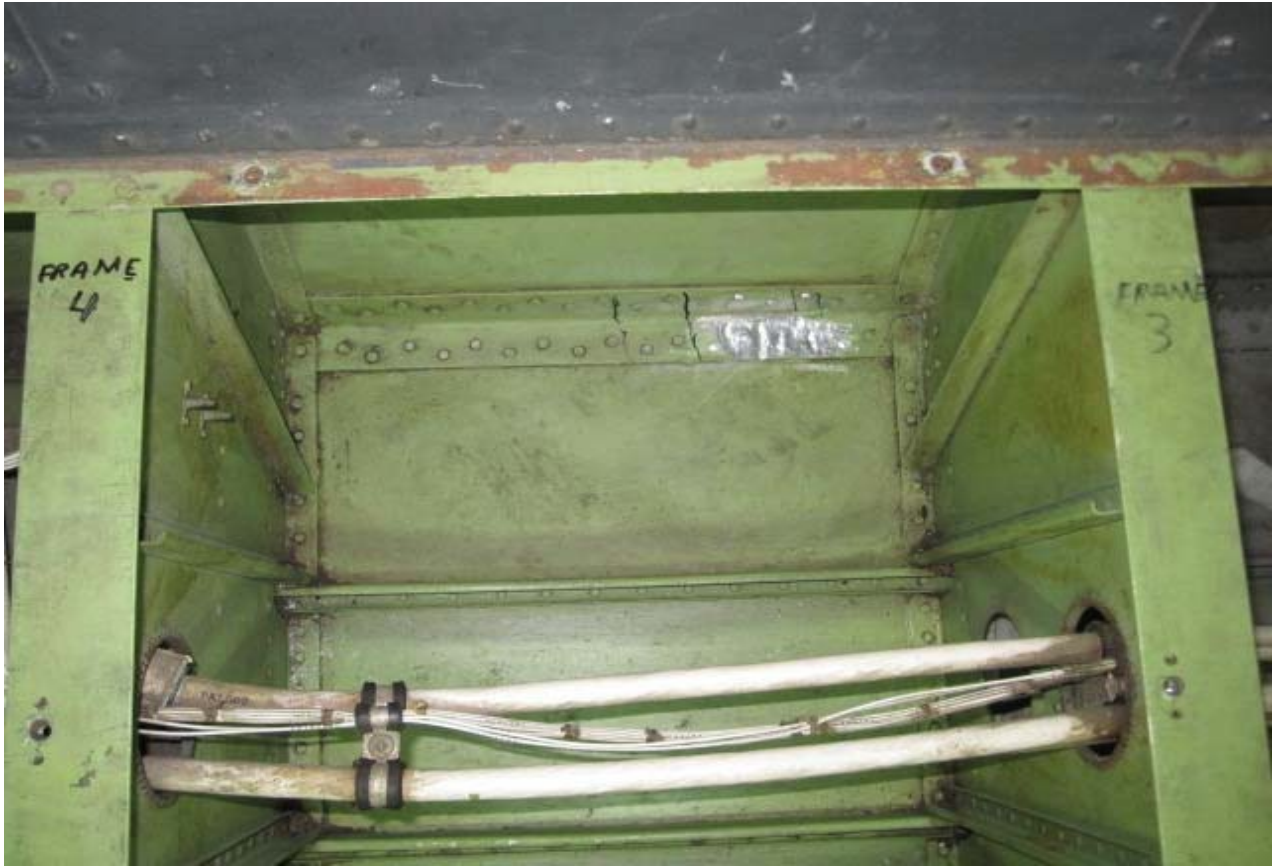
(Part number for this Longerons: 21221000541).

Part Total Time: 16,761.0 Hours
