Cessna 525B, Main Landing Gear Corrosion, ATA 3213

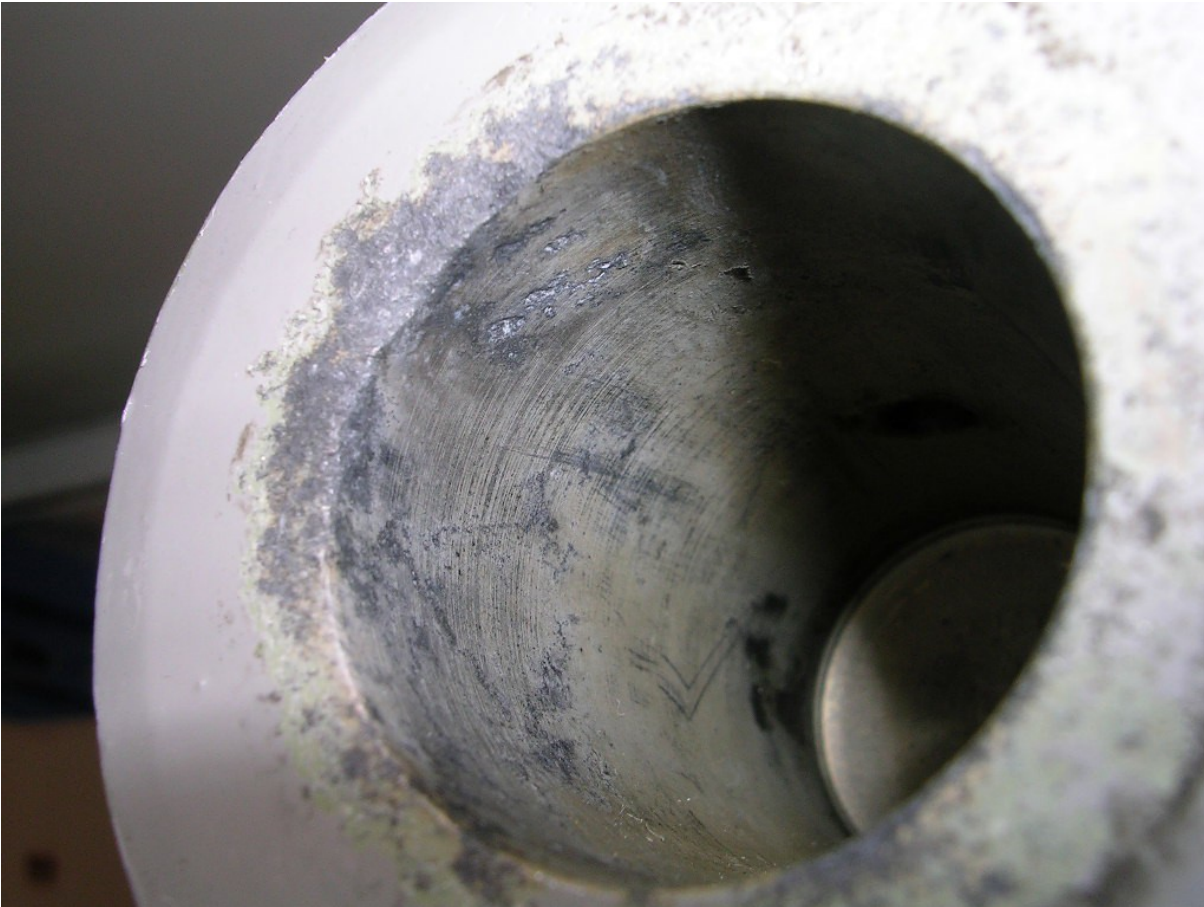
The Submitter states that Corrosion was found at the left side, aft main landing gear Trunnion pin's bore and face while performing the Cessna 48 month/2,400 inspection. We used a mixture of ferrous and non-ferrous parts in the affected areas. We lubricate this area at 12-month intervals. The lubrication process is to apply WC-393 to the forward and aft pivot points with a squeeze bottle." *(Trunnion P/N: 63413211.)*

Part Total Time: 1,333.0 Hours
