Bellanca, 1730A, Failed Nose Landing Gear, ATA 3230

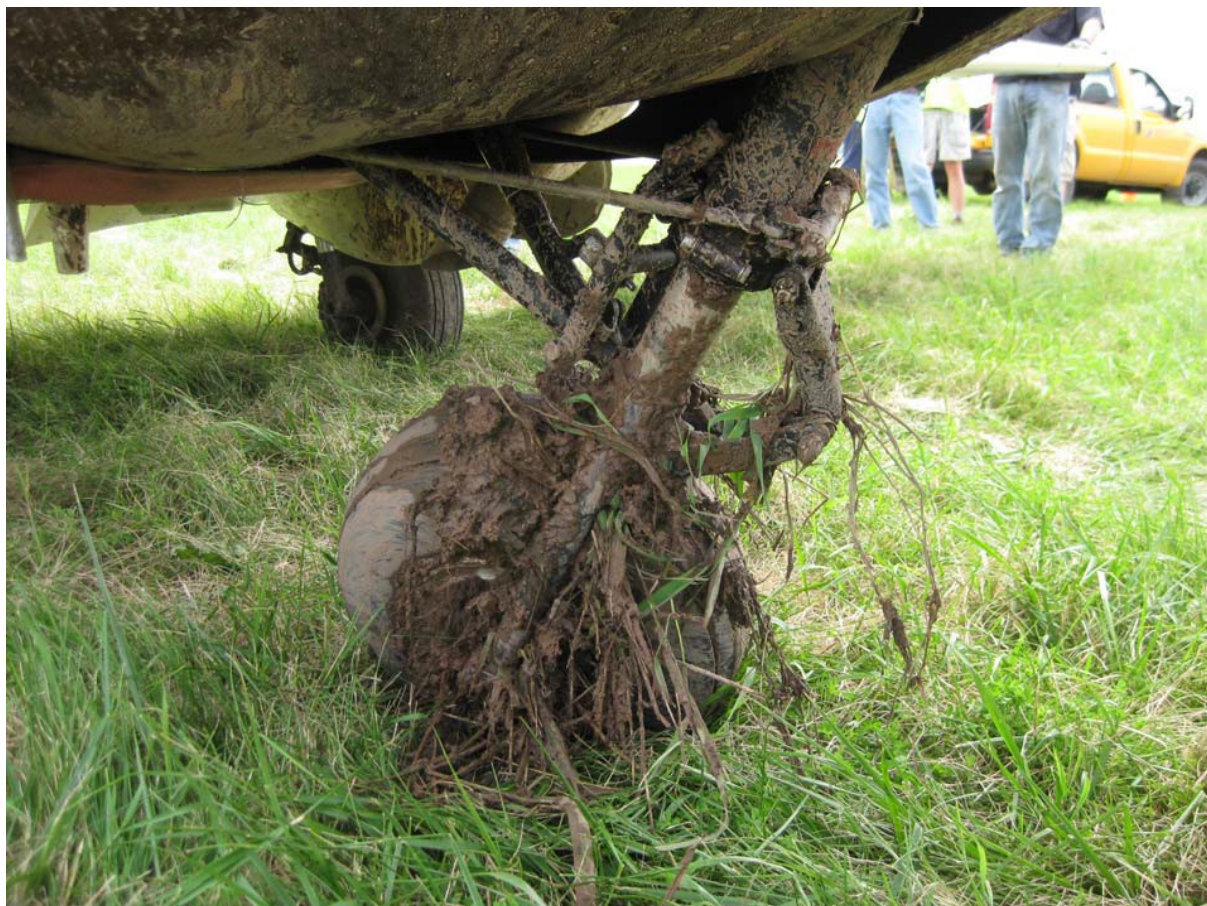
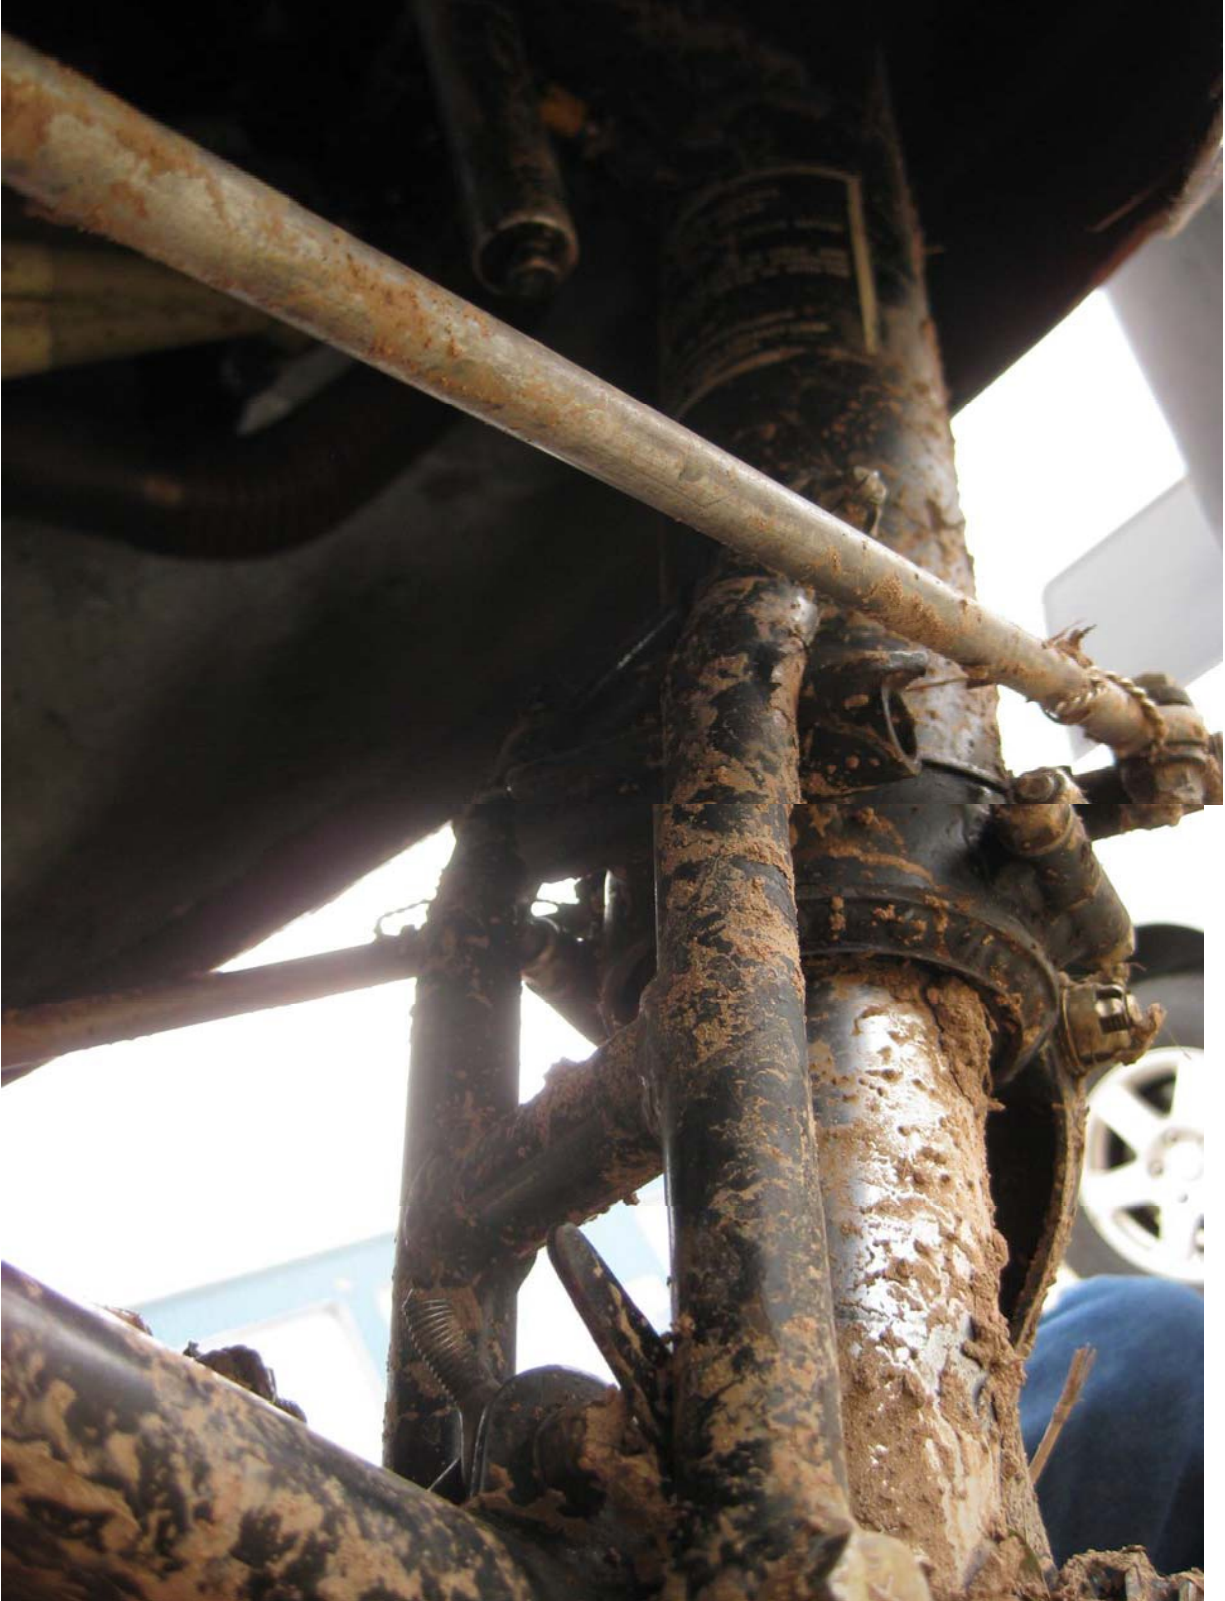
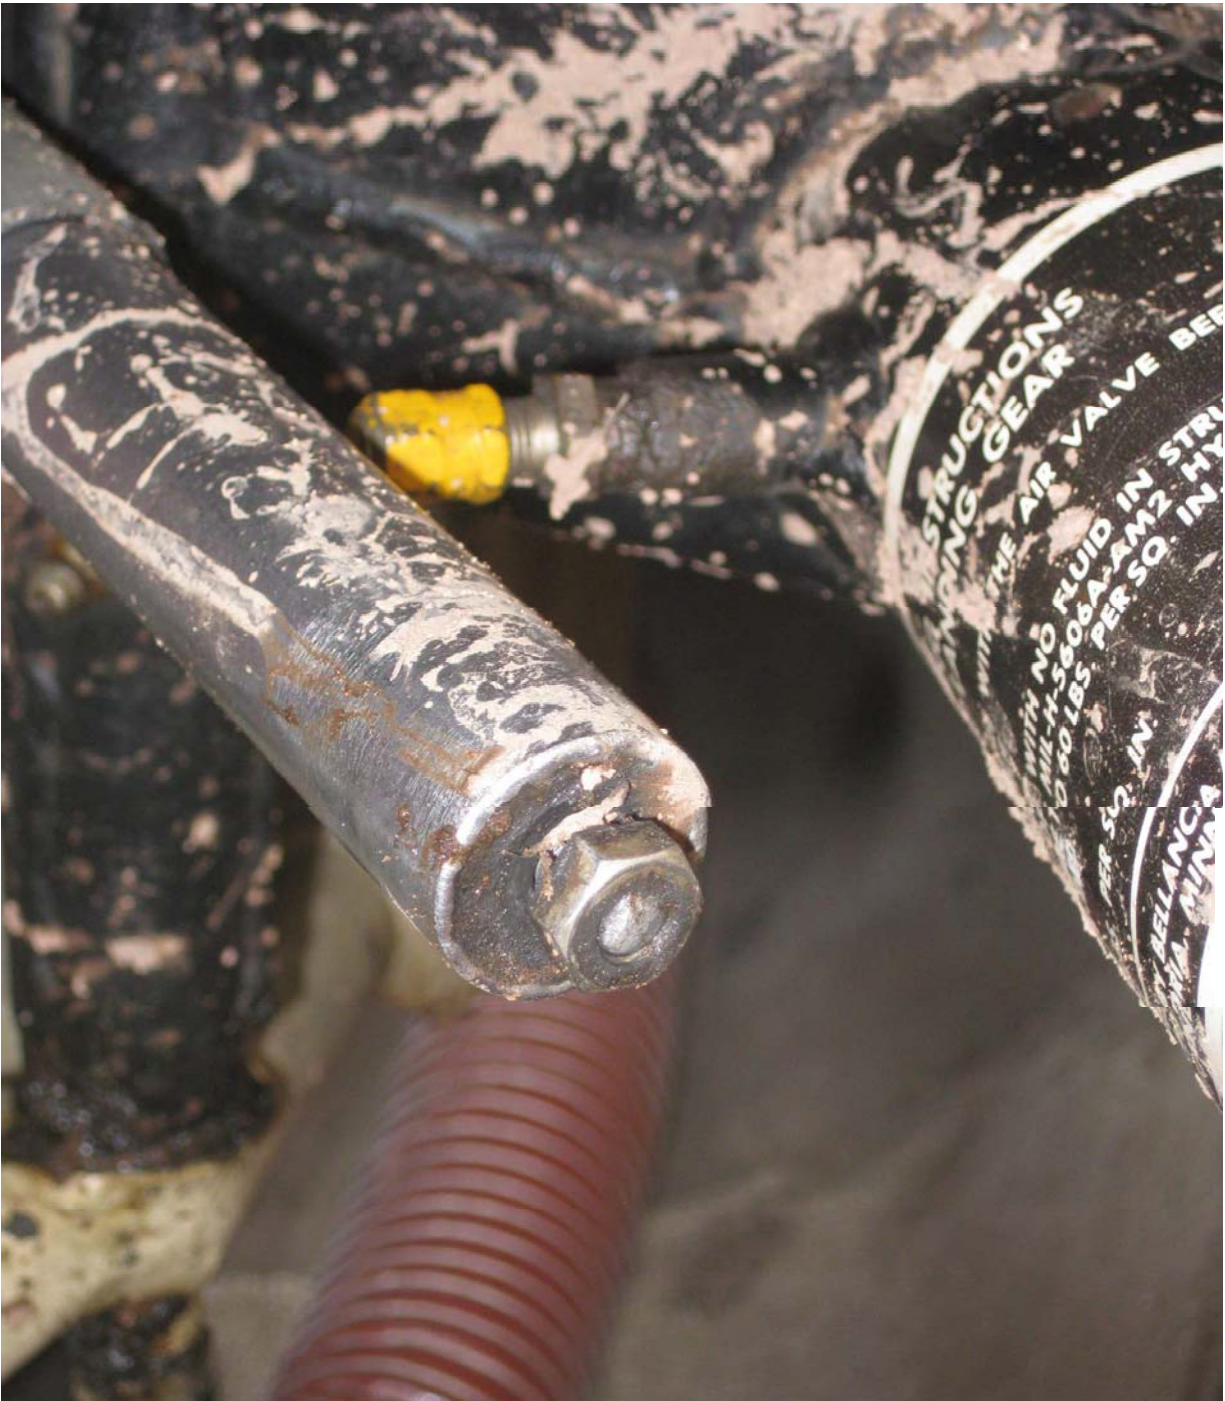
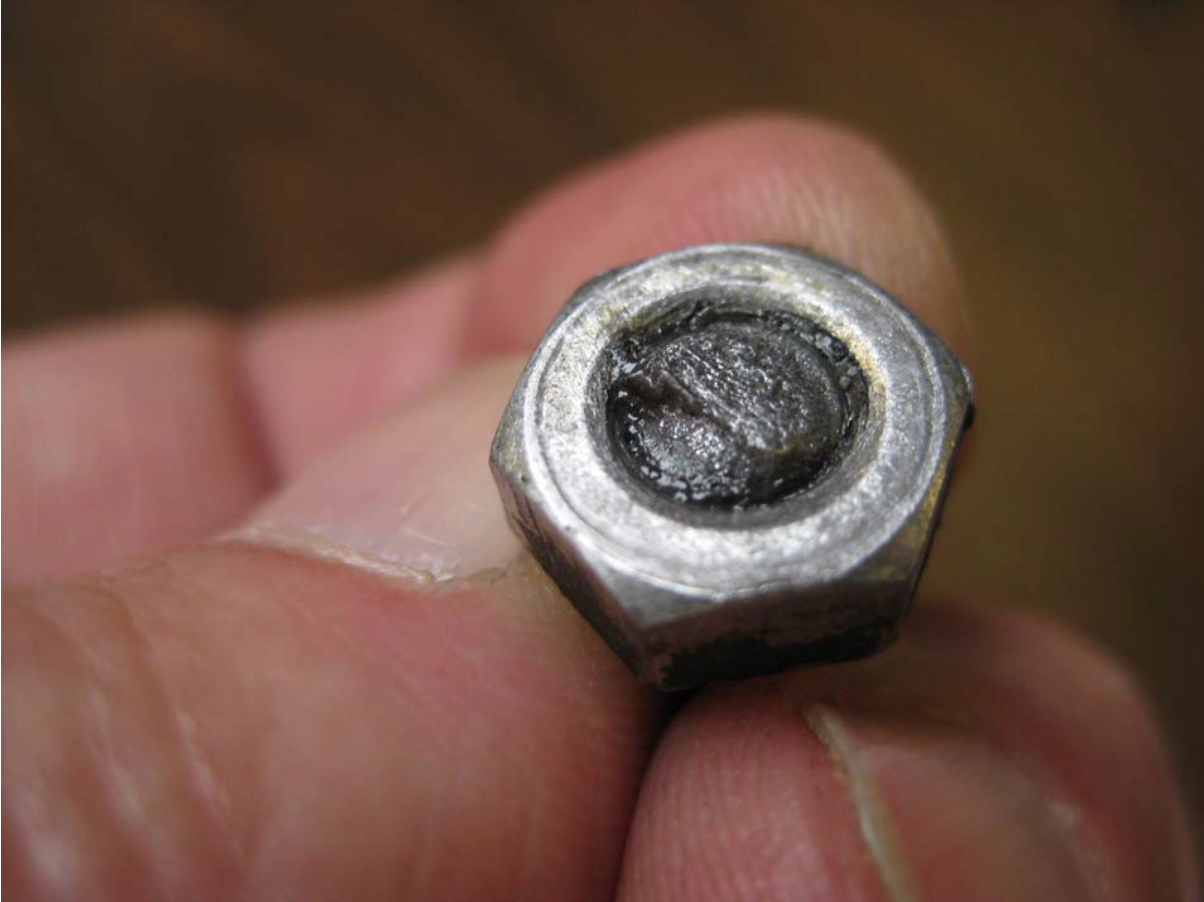
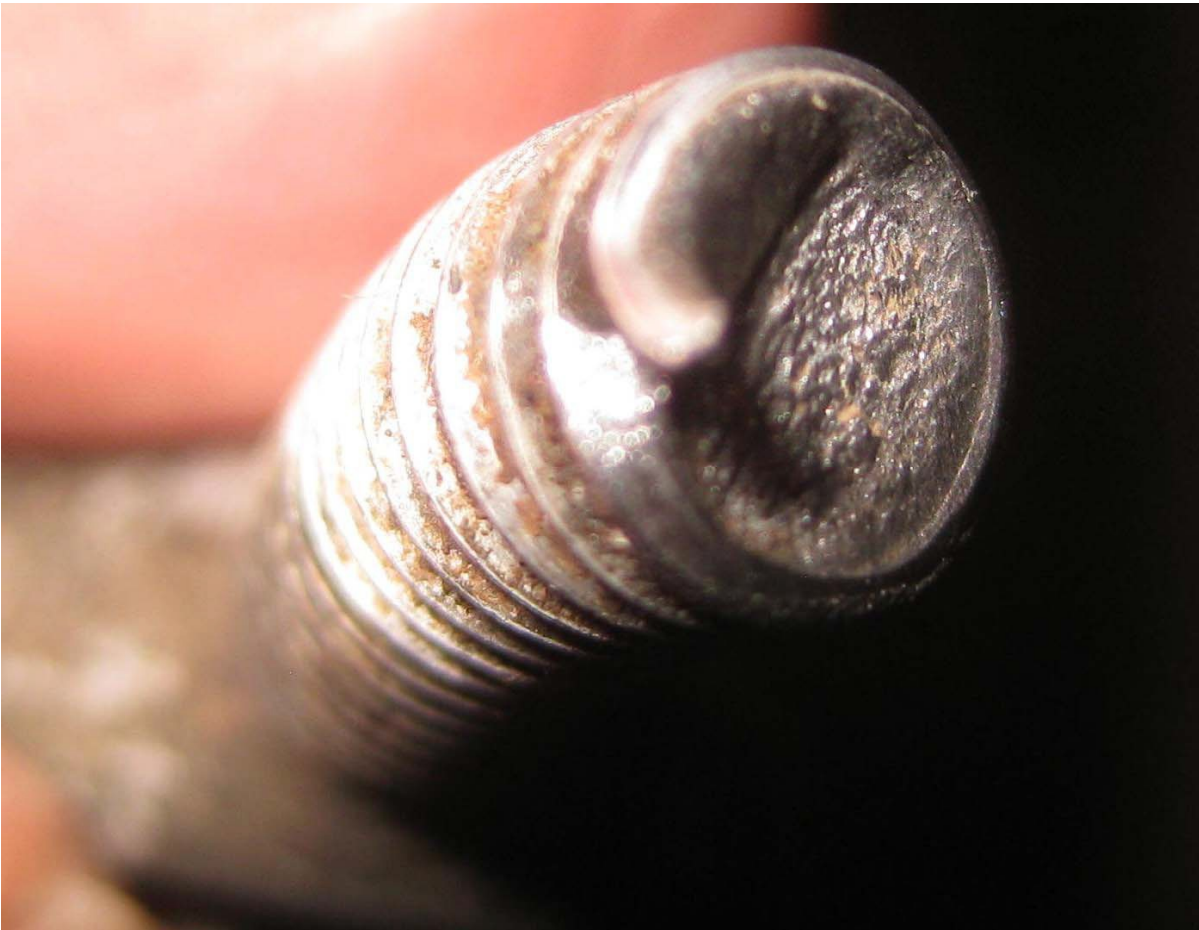
During touchdown on runway 36L, the submitter states, "the nose landing gear failed and partially collapsed upon contact with the runway. It appears from our investigation, the nose gear linkage bearing rod-end (P/N 198001-2) to the gear extension assembly experienced a fatigue failure. Based on the fracture signature, the failure appears to be a mild-to-high stress concentration, from a one-way bending load. The rod-end failed at a point where the threads and nut meet, shearing even with the nut face (AN316-4R). These threads were stretched and bent at a fifteen degree angle with about one-half inch of thread showing. The rod-end bearing movement was satisfactory.

When the NLG tire contacted the runway, the over-center extension assembly to the forward and aft drag struts failed at the rod-end. This allowed both struts to travel beyond their proper horizontal positions, allowing the nose wheel to move aft at touchdown. This forced the aft drag strut to pin the forward strut against the wheel cylinder, preventing the nose wheel steering with the rudder pedals. The wheel went slightly to the left at contact with the runway and jammed.

The aircraft veered sharply left and moved off the runway, across the grass, on to and across the left taxi-way and its grass, and into a ravine where it came to rest." (The extension assembly/component number is P/N 194317.)
