Beech C90, Flap Rib and Bearing Damage, ATA 5753

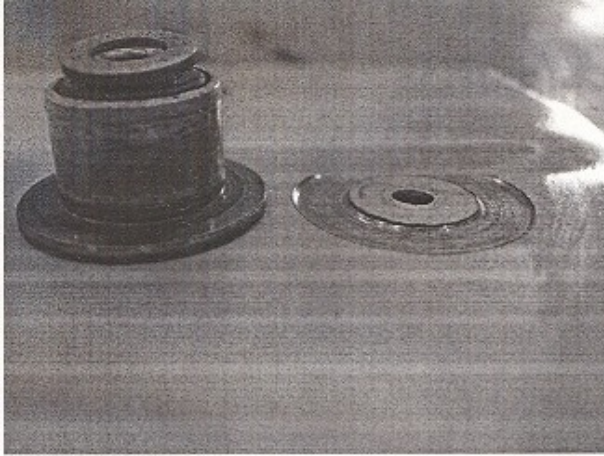
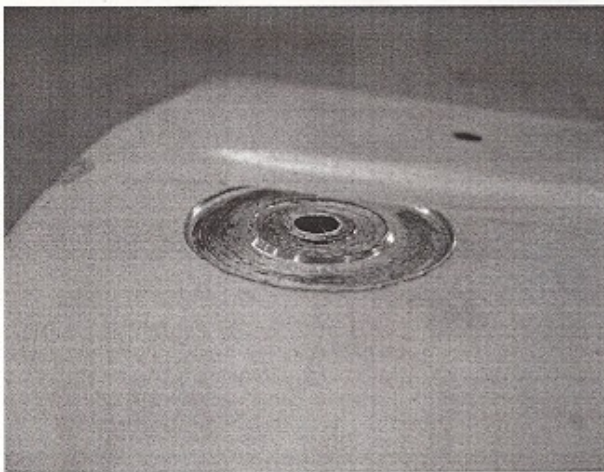
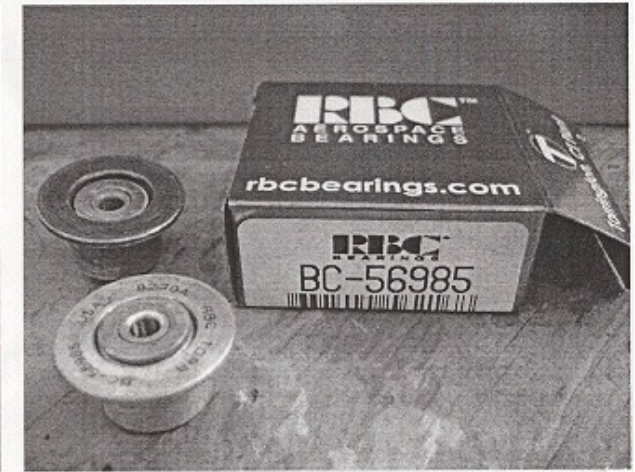
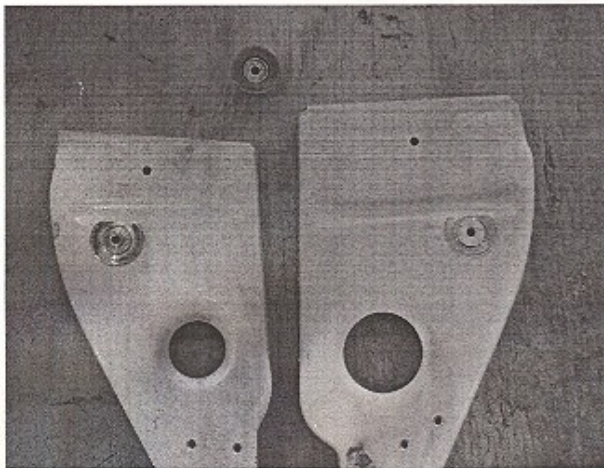
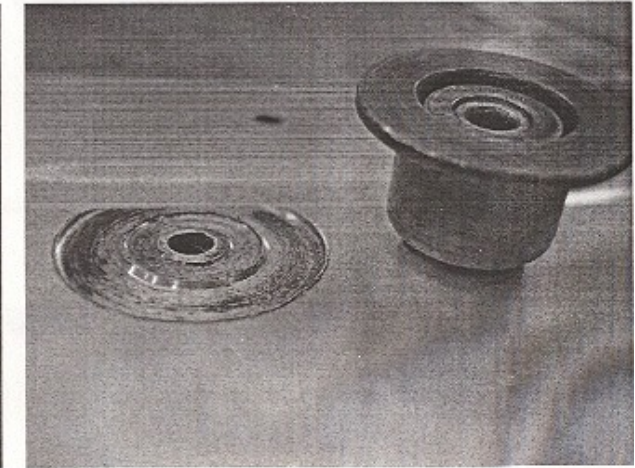
Beech C90, Flap Rib and Bearing Damage, ATA 5753

A mechanic described a flap problem on this Raytheon King Air. The left flap's aft roller bearings have very little side clearance between the bearing and the flap's rib. As the bearing wears, the side play increases to the point where the bearing flange contacts the rib.

Raytheon has not provided any chafe protection on this side of the bearing; therefore, the bearing begins to cut into the rib as it rolls fore and aft.

A small, thin Teflon washer would prevent contact and allow the bearing wear to be detected before damage occurs (RBC Bearing P/N: BC-56985).
