## Boeing A75N1, Broken Engine Mount Bolts, ATA 7120

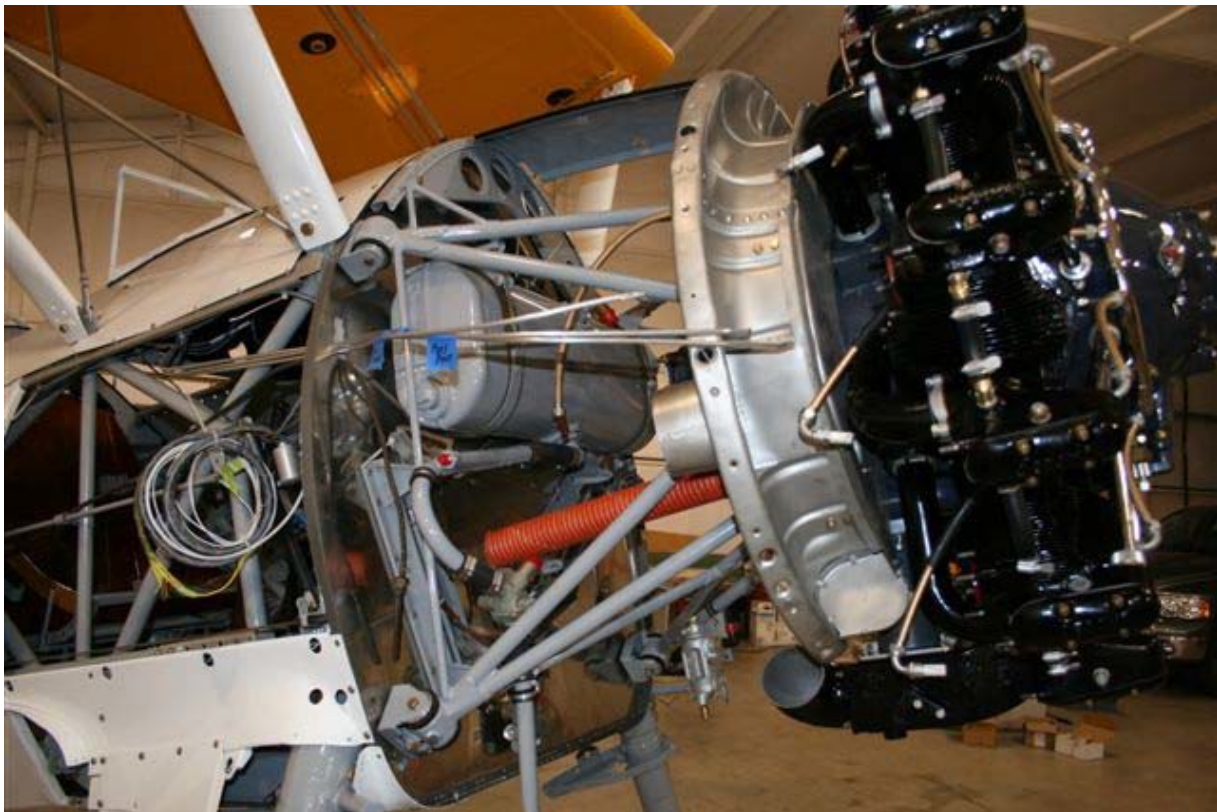
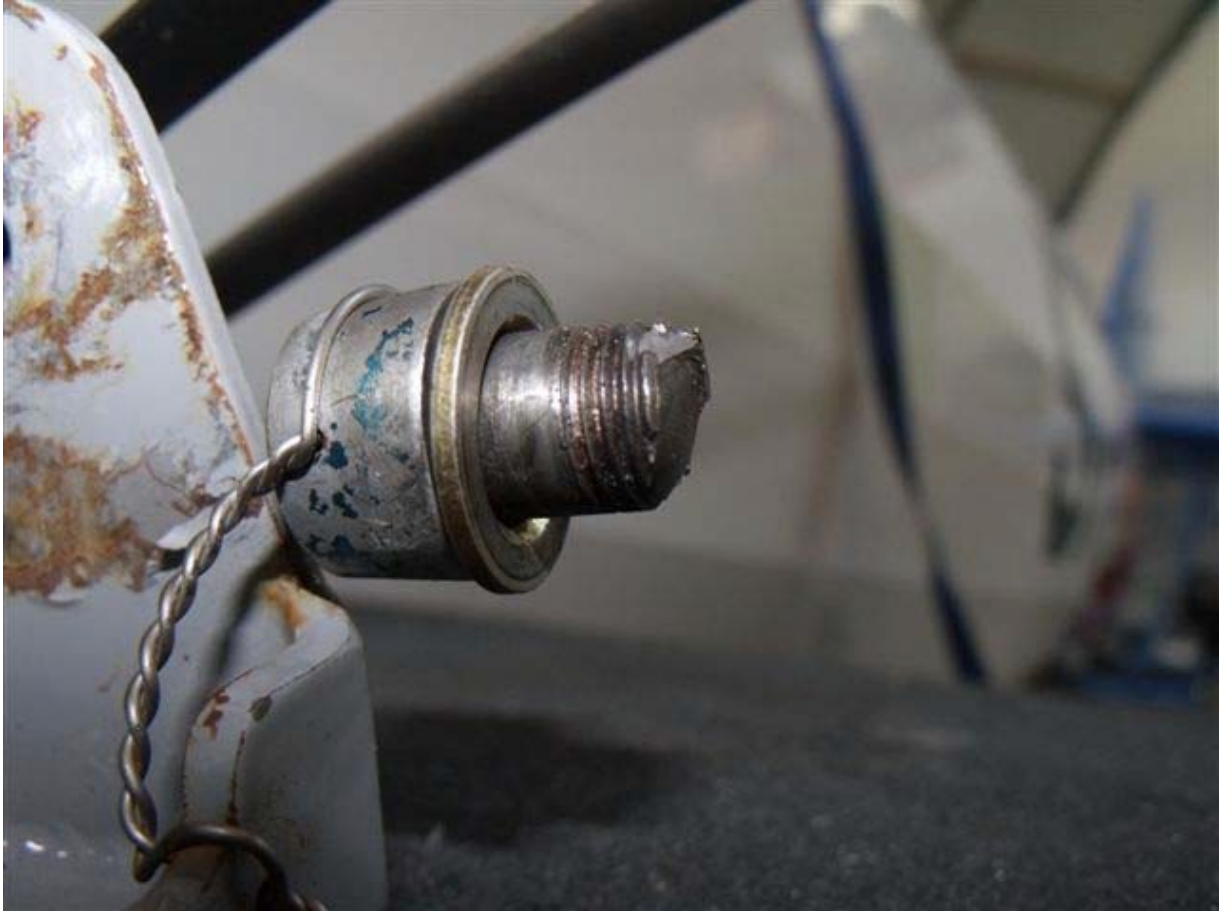
**Boeing A75N1, Broken Engine Mount Bolts, ATA 7120**

A mechanic states, "During the inspection of the engine installation on this aircraft, it was determined that one of the four high strength NAS-148 bolts that hold the engine mount to the fuselage was fractured completely through -- under the head of the bolt". This bolt has 100 hours total time in service. After informing the STC (supplemental type certificate) holder of the failure, he informed the mechanics they should have re-torqued these bolts after 25 hours of operation. This information was not included in the STC. According to the STC holder, this data was referenced in the original aircraft maintenance manual where it states the original engine mount 'studs' should be re-torqued to 450 to 500 inch-pounds after the first 25 hours.

The manufacturer removed the original engine mount studs from the STC aircraft and the entire assembly was replaced with a different mount and hardware assembly. The replacement bolts are NAS 148 (internal wrenching) and are larger than the original studs. The original maintenance manual torque values would not be sufficient and the inspection team received no additional instructions.

The bolts are hidden and the removal of the engine is required in order to re-torque them. We believe a critical safety issue exists, as the failure of these bolts will result in a catastrophic accident.

See accident report CA18/2/3/8321 where the failure of an identical bolt in a similar STC caused the separation of the engine and a fatality accident. The STC is inadequate in its description for maintenance to ensure continued airworthiness."
