## Cessna CE750 Disconnected Flap Linkage, ATA 2750

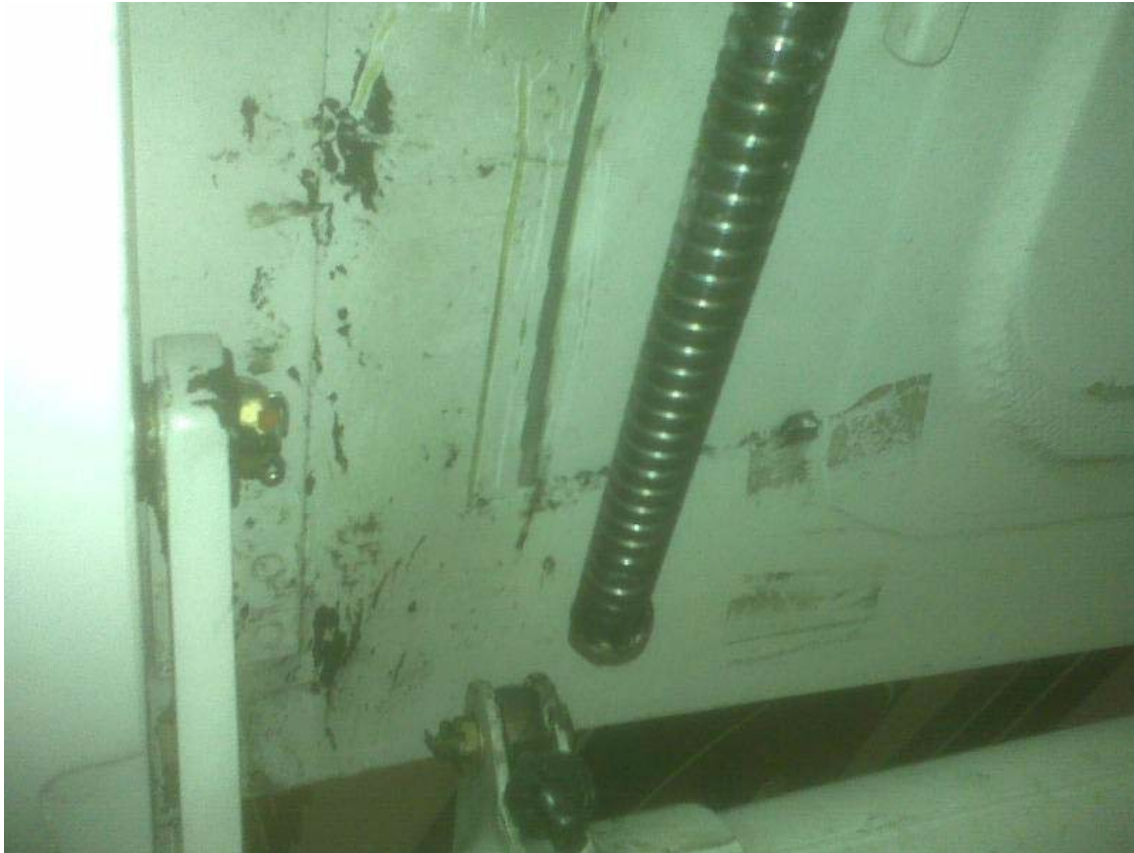
An unidentified submitter writes, "On visual approach, the copilot complained the aircraft was 'out of rig' and it wanted to roll right with flaps at 35 degrees.

On post flight, the mechanics discovered the right flap was extended full, and *its drive* linkage was not connected."

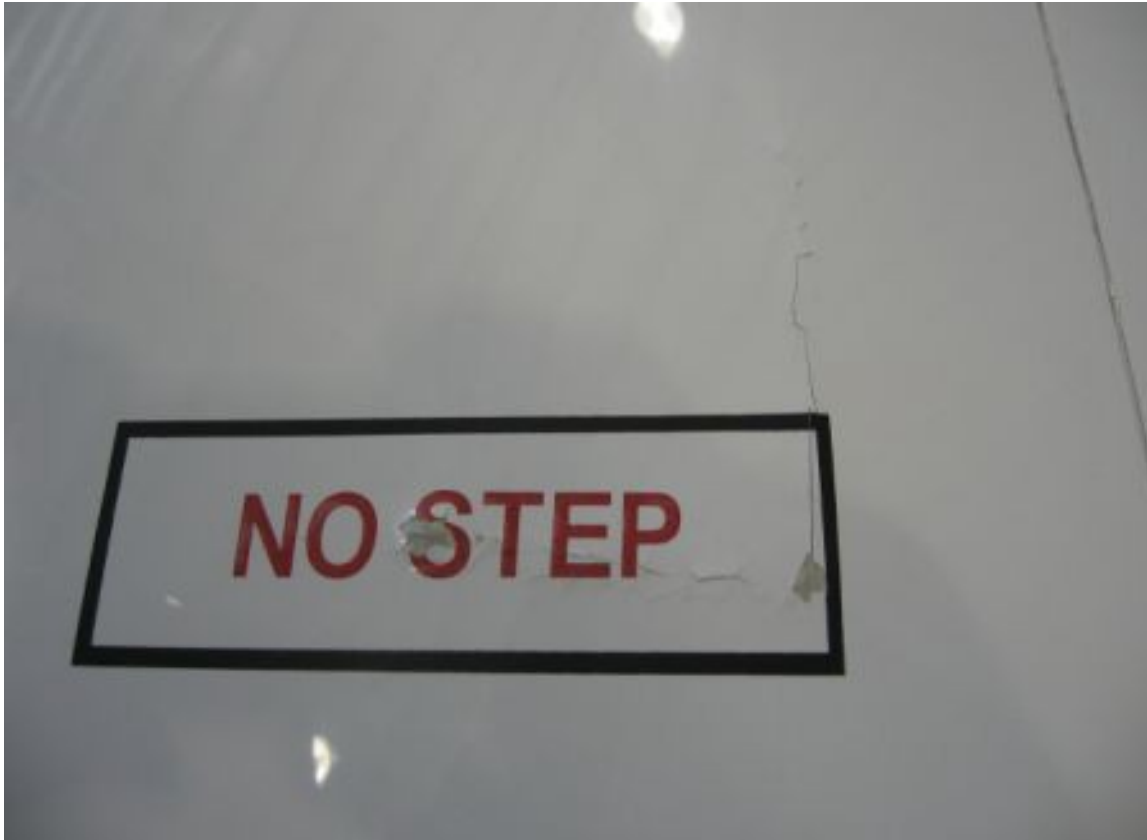
## Cessna CE750 Disconnected Flap Linkage, ATA 2750

**EDITORS NOTE:** Great.... I've got a detective's proverbial 'dead body'...but no plot. Does the male rod-end have mangled threads on the OTHER side? Is this mechanical or mechanic failure? How are we going to repair that wing skin?
