# AIRWORTHINESS BULLETIN

Aircraft Circuit Breaker Maintenance &  
Operation

**AWB** 24-011 **Issue :** 1  
**Date :** 27 April 2016

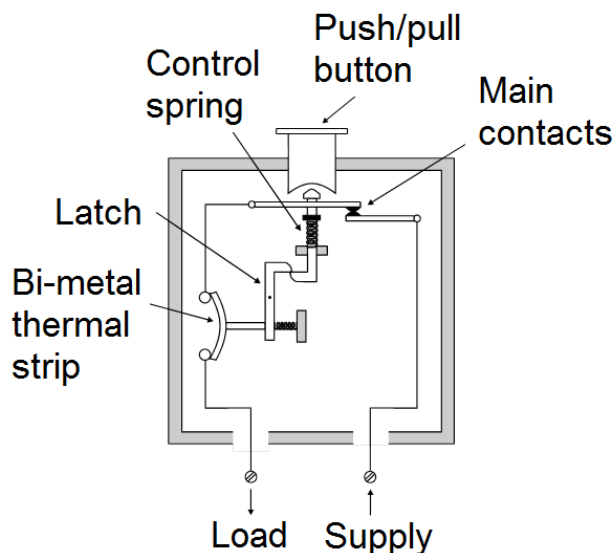
Figure 1 - Thermal CB mechanism

Thermal CBs are composed of a thermal actuator and mechanical latch. The actuator is made of a bimetal strip that carries the current and responds to heat. Because the two metals have different rates of expansion, heat causes the bimetal to flex until it triggers a spring-loaded latching mechanism. The design can distinguish between safe in-rush and temporary current surges and harmful sustained overloads. A typical thermal circuit breaker will trip within one hour at 140 percent of its rating. The mechanism is prone to different failures such as corrosion of metallic elements, spring failure and other discontinuities.

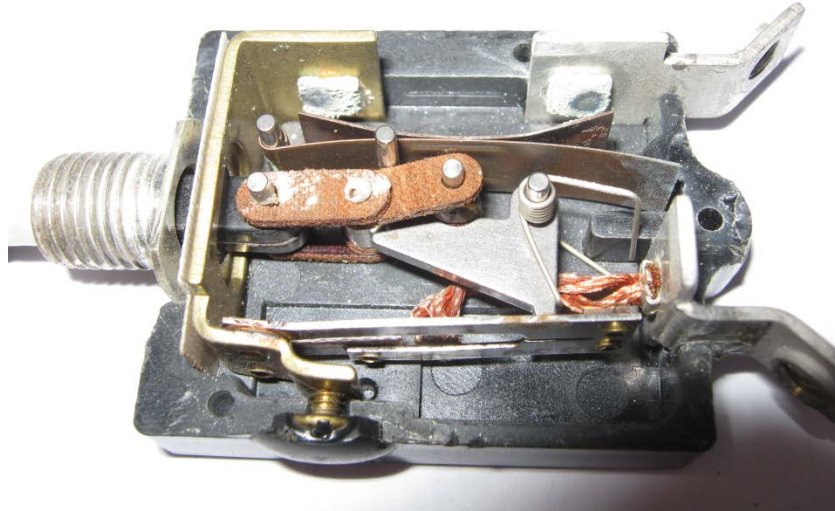
High hour CBs have been found with pitted contacts which can cause high resistance or open circuits. Pitting can occur due to electrical arcing and worn or deformed contacts.

Corroded contacts have been known to cause high resistance connections (see Figure 2). This CB was used to power AC inverter in a Piper 31-350 aircraft. The high resistance resulted in strong burning electrical smell and smoke in the flight compartment. This causes low voltage delivery to the equipment and heating at high resistance connections which can result in a fire in high ampere loads. The output voltage had reduced from approximately 27VDC to 6VDC as a result of the corrosion. In extreme cases the contacts have been known to weld together preventing the CB from tripping.

Figure 2 - Corroded contacts

Exercising (cycling) of circuit breakers under no load will assist to remove any possible internal surface corrosion and is therefore strongly recommended as part of the aircraft's scheduled maintenance either:

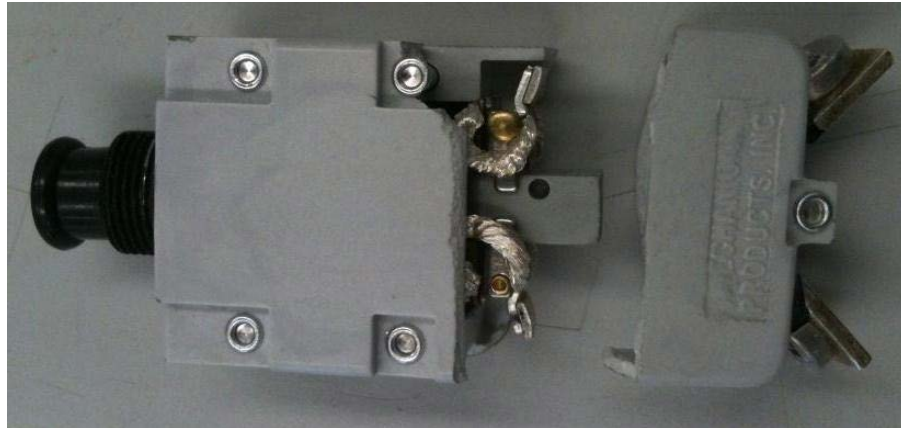
In the CB shown in Figure 5, the problem was caused by the position of the CB on the panel fitted to a Bombardier DHC-8402. This CB for the propeller auxiliary feather power is located on the most forward position on the panel. The damage occurred when the associated panel was opened for maintenance, the CB caught on the structure. This could have been a major problem as there was no way to tell there was a problem if the need to use the Aux Feather controls in flight was required. CBs that are improperly placed are prone to damage.

Figure 5 – Propeller Auxiliary feather CB damaged by placement on panel

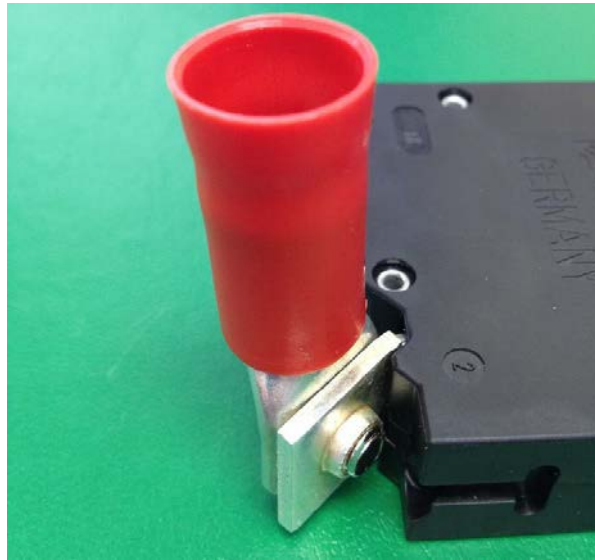
In the difficulty reported in Figure 6, the CB part number 452K14LN2, the power wire had not been correctly crimped. This CB was fitted to emergency medical equipment in a Pilatus PC12. This could cause intermittent arcing or sparking of wiring with associated fires and possible loss of patient life in service. For further information on crimping see the current applicable maintenance data on standard wiring repairs or in the absence of this information see [Chapter 6](#) of AC 21.99.

**Figure 6 - Improperly crimped CB fitted to emergency medical equipment**

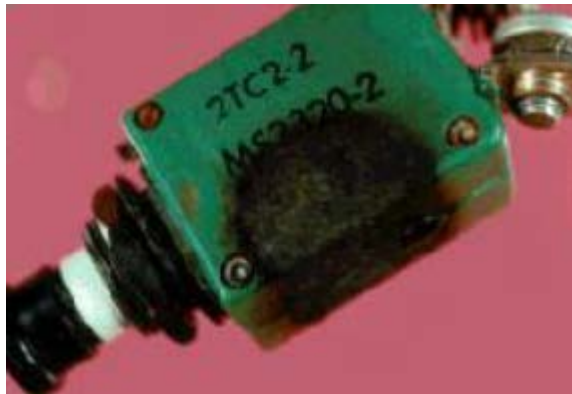
There are risks associated with inappropriate resetting of tripped CB's see Figure 7. CASA recommends exercising caution in resetting tripped CB's and adhering to general safety practices.

Figure 7 - Heat damaged CB

Resetting a tripped CB is often thought to have no adverse results. However, a review of Service Difficulty Reports involving tripped and reset CB's reveals that the opposite is sometimes true. Smoke, burned wires, electrical odours, arcing, and loss of related aircraft systems have been reported as a result of resetting tripped CB's. These findings are supported by other National Airworthiness Authorities.

Do not reset a tripped CB in flight unless allowed in the approved operating manual used by the flight crew. A pilot in command can reset a CB if they believe that a catastrophic event could occur if it is not reset.

Do not reset a circuit breaker unless the nature of the fault is positively confirmed and no further risks will occur. CASA recommends following OEM procedures for resetting CBs. In the absence of this information, the guidance in this AWB can assist in the development of procedures and/or approved manuals.

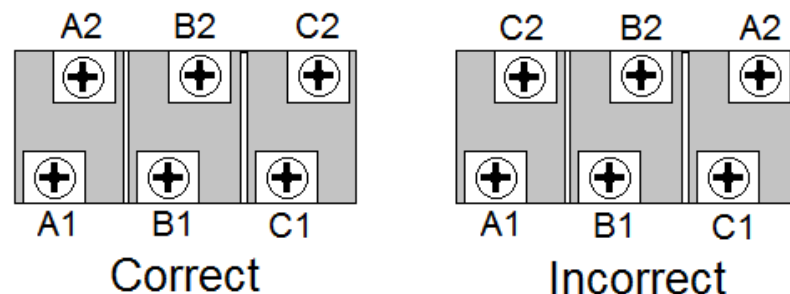
Hydraulic pump motor CBs were found with incorrect phase labelling. If not picked up in time, motors on hydraulic pumps would cause the pump to run in the opposite direction, fans in Transformer Rectifier Units would direct air in the wrong direction against incoming ram therefore air reducing air flow and causing overheating and premature failure.

4330 series CBs manufactured by Mechanical Products Inc. were previously found with manufacturing defects caused during labelling of the terminals (see Figure 8). Investigation by the supplier of this item revealed a number of similar anomalies over a range of these products. These issues have not been an issue recently; however stocks may exist that have not been removed from potentially entering service.

The faulty C/B had the phasing identifications interposed on the line and load sides of the C/B see Figure 88.

Figure 8 - Faulty circuit breaker phase identification

The faulty CB's were found included as part of service bulletin kit supplied by Bombardier. Bombardier produced notification to inspect the circuit breakers prior to use and to inspect those in service.

CASA recommends that all aircraft Registered Operators and Maintenance Organisations, quarantine all affected stock as per Figure 8 and Figure 9 of this AWB.

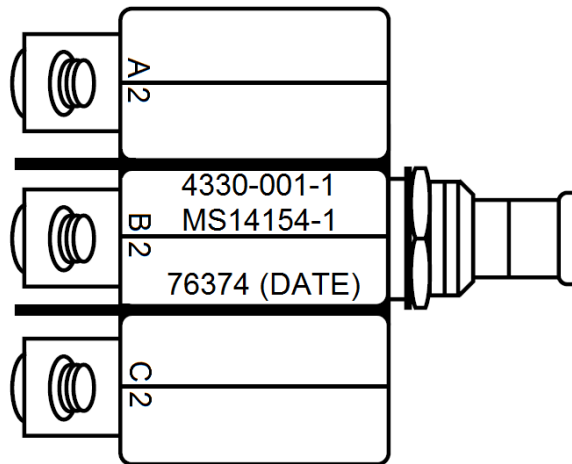
Figure 9 - Product and date code identification

On the side of the breaker stamped with the part number you will find the date code see Figure 9, it is printed immediately after the "U.S. Government Cage Code" 76374.

The first two digits are the year of manufacture; the second two digits are the week of manufacturer. So "0046" indicates the breaker was manufactured in the year 2000, in week forty-six. The faulty products of which Mechanical Products is aware of are limited to week 46.

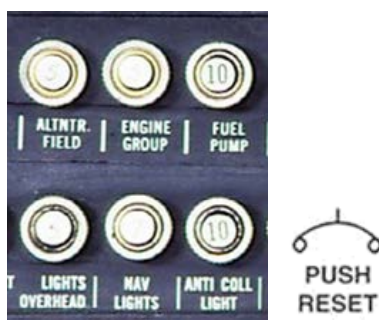
Push-reset CBs cannot cycle due to their design see Figure 10; therefore it is difficult to test these CBs in-situ and replacement is considered appropriate after a period of time in service.

Figure 10 - Push-reset CB

In the absence of hard replacement times from the OEM it is recommended to replace the CBs. FAA has put out [Special Airworthiness Information Bulletin CE-13-22](#) which recommends discarding CBs every 2000 hours.
