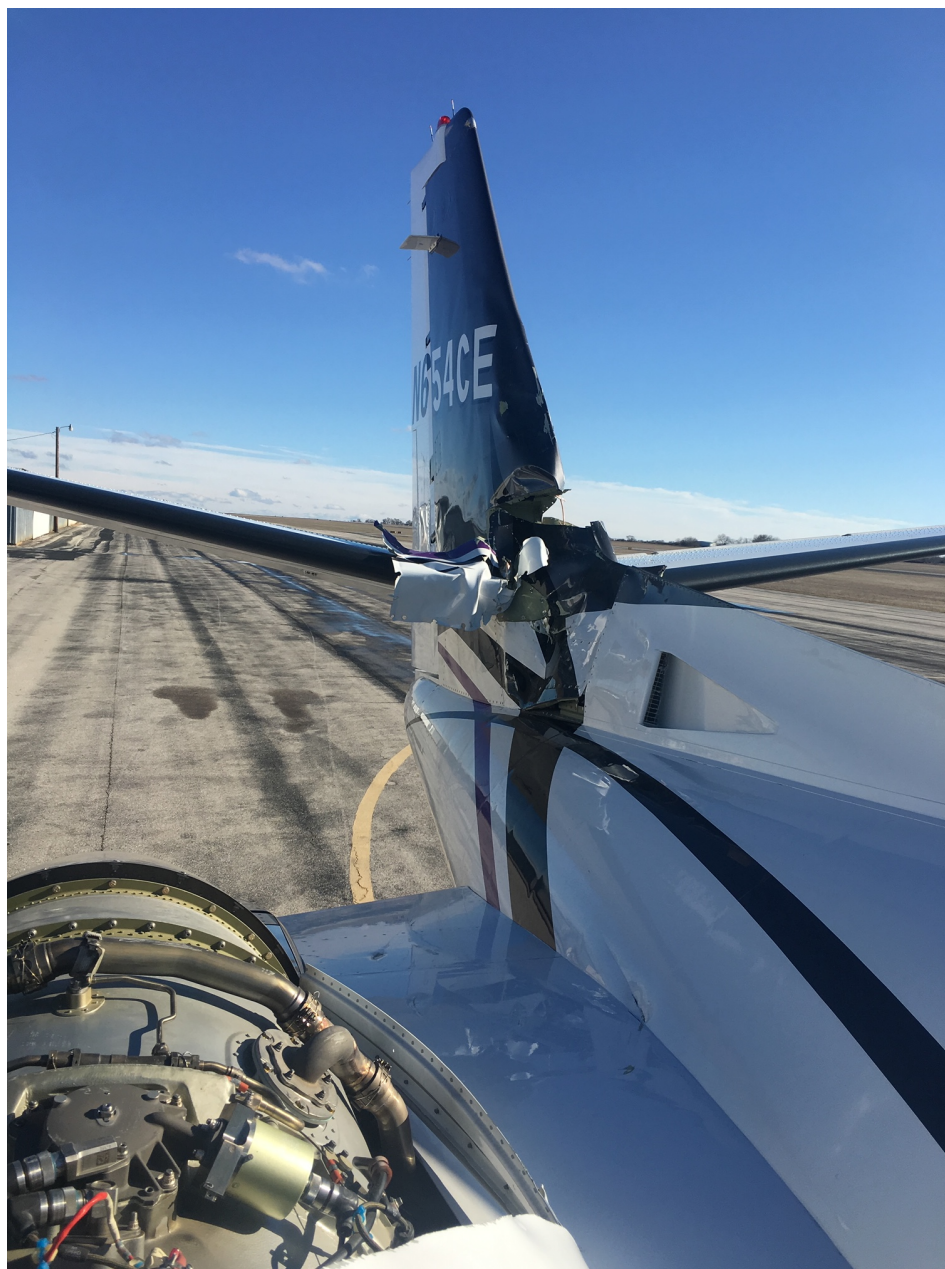
Photo 1 – Elevated view of the damaged empennage (courtesy of the operator).

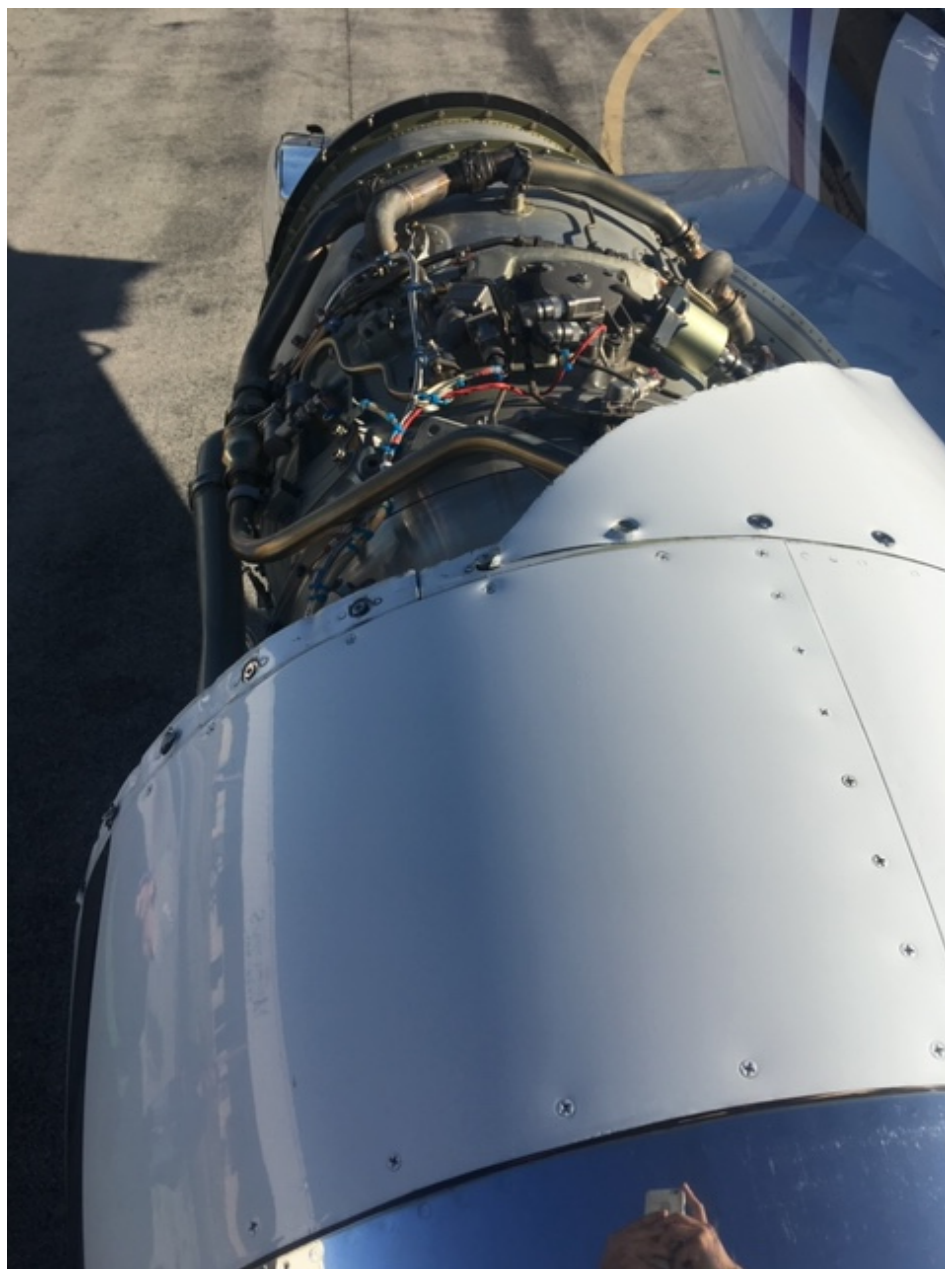
Photo 2 – Elevated view of the right side engine and fractured upper cowling (courtesy of the operator).

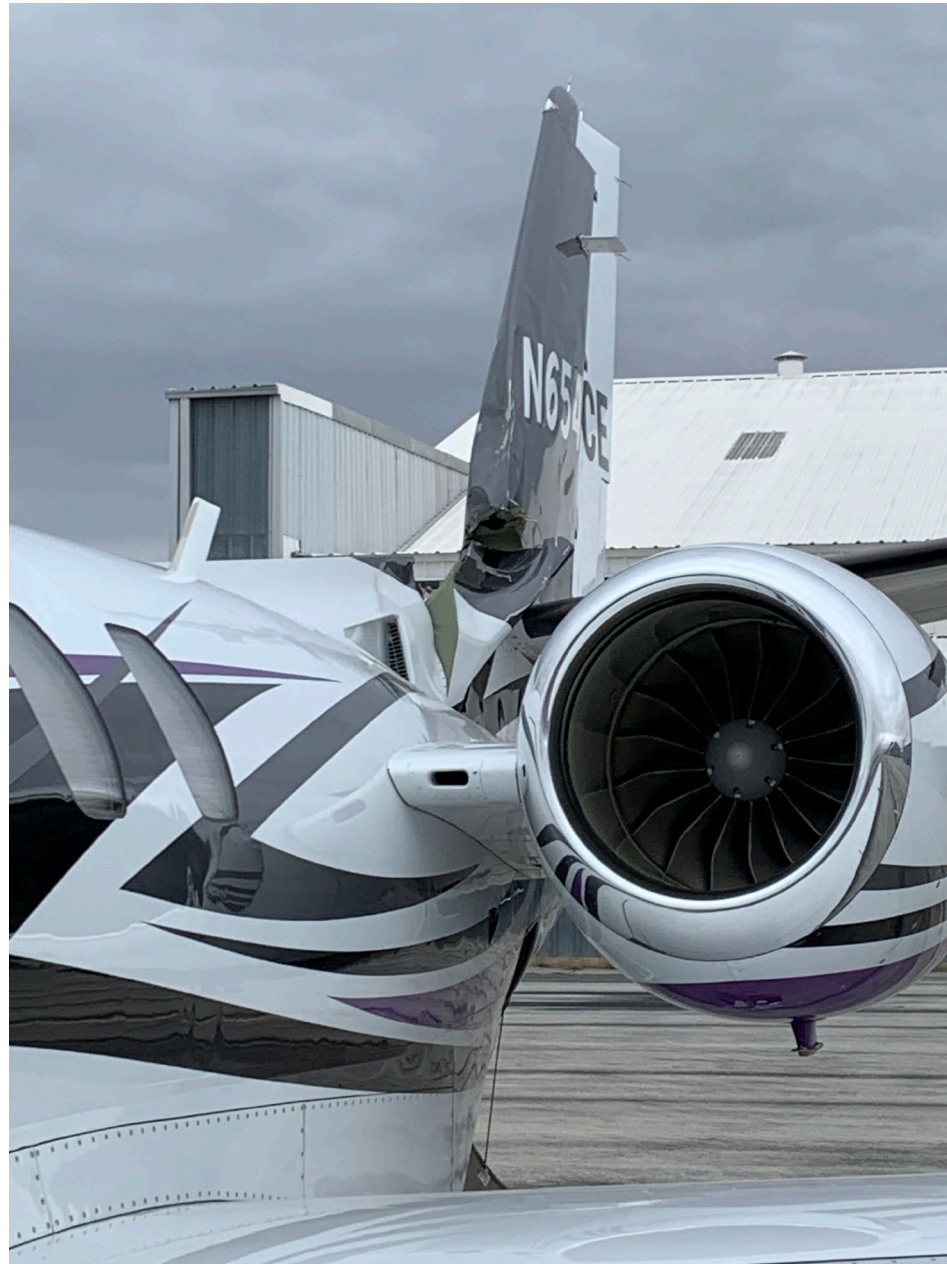
Photo 3 – Ground view of the damaged empennage (courtesy of the Federal Aviation Administration).

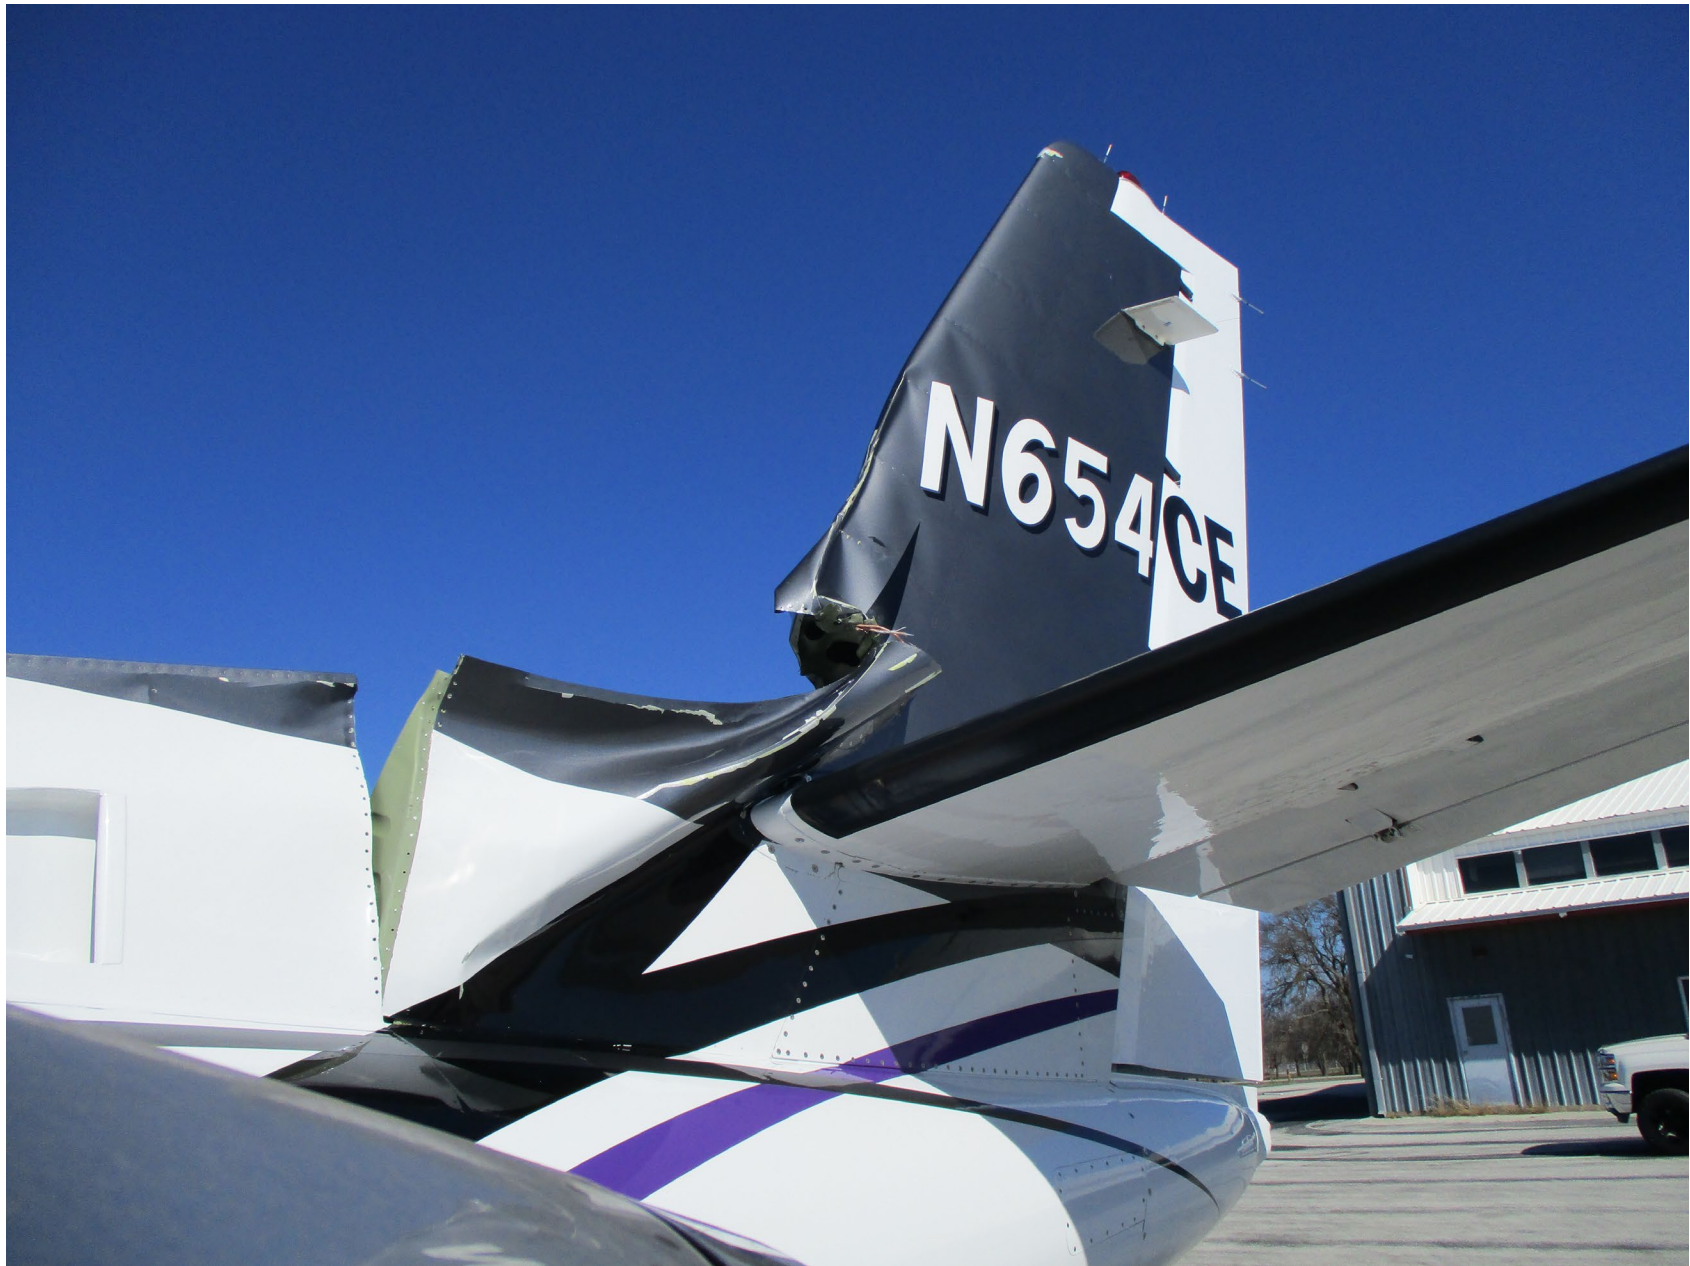
Photo 4 – Ground view of the damaged empennage (courtesy of the Federal Aviation Administration).

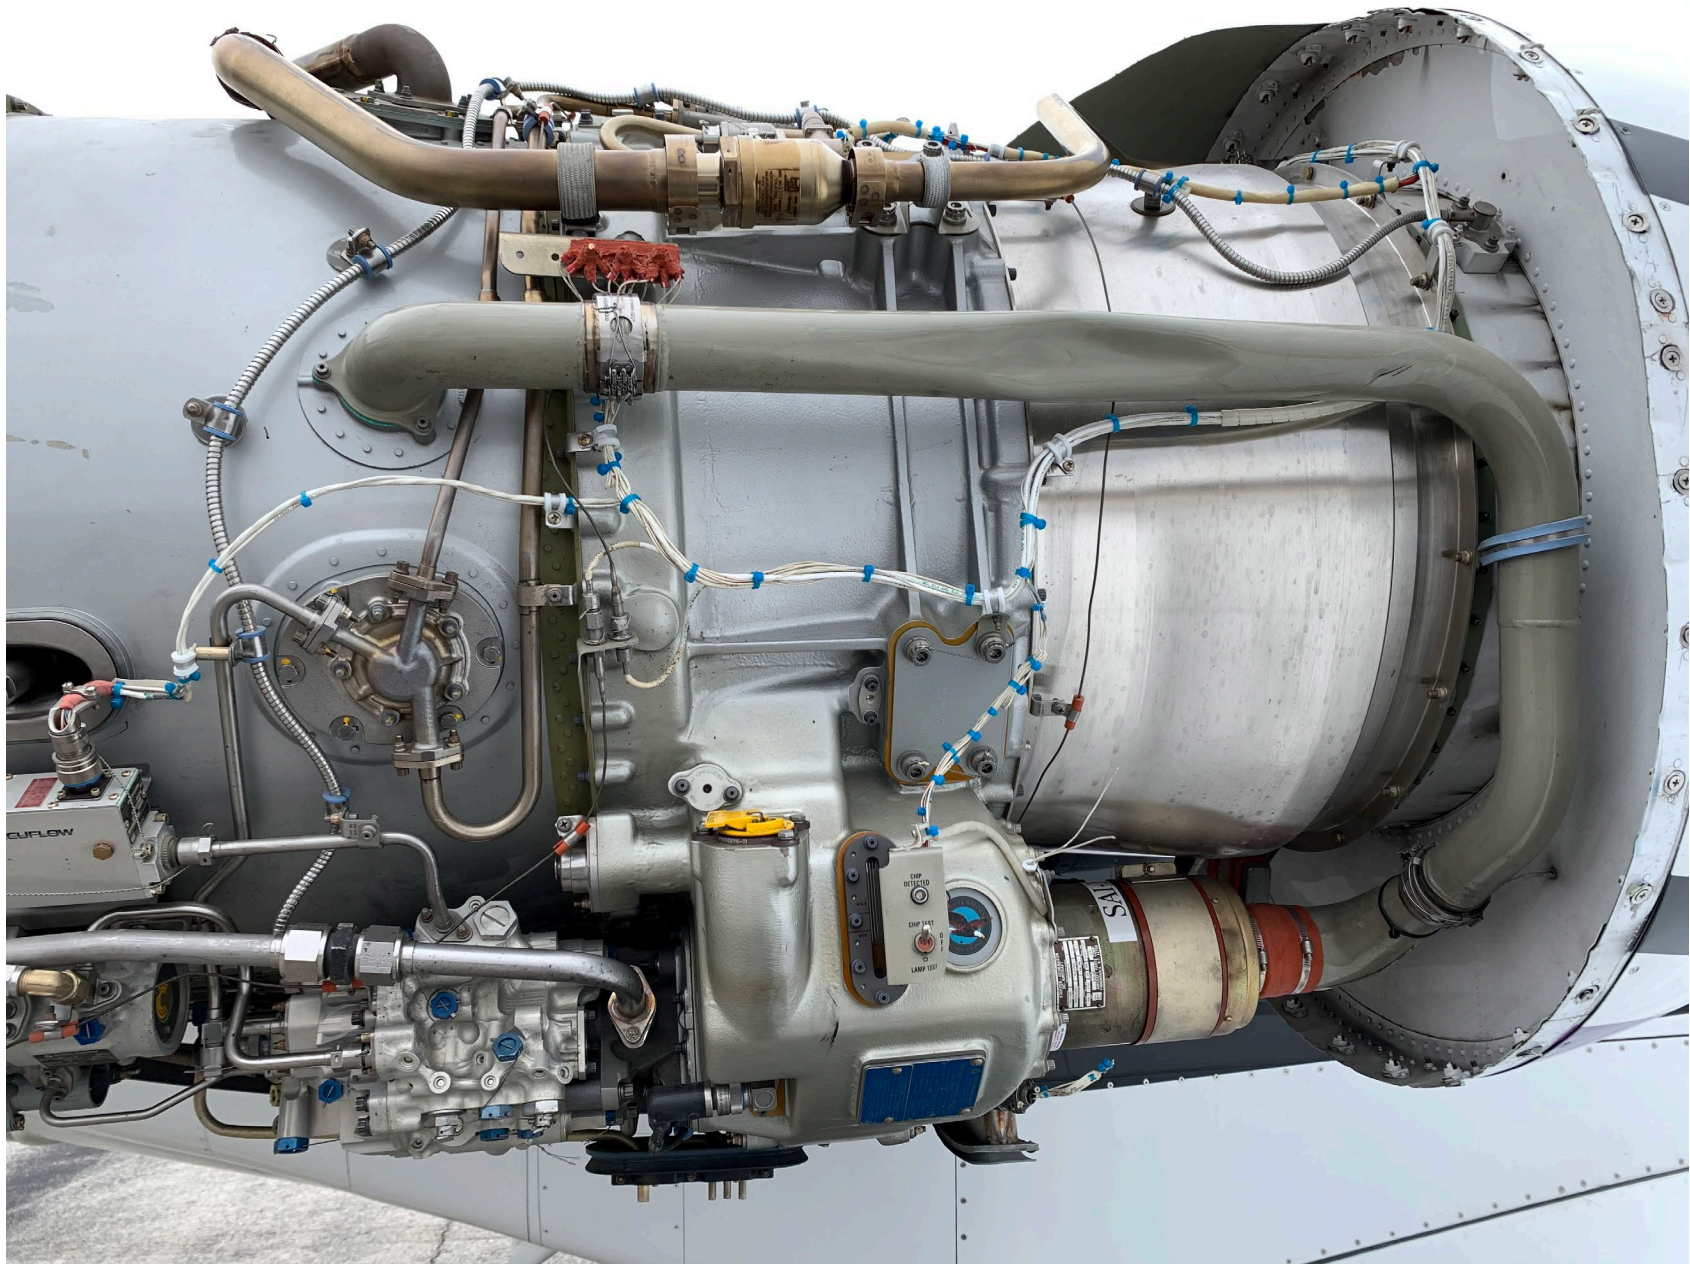
Photo 6 – View of the fractured upper and missing lower right side engine cowlings (courtesy of the Federal Aviation Administration).
