NATIONAL TRANSPORTATION SAFETY BOARD

MATERIALS LABORATORY FACTUAL REPORT

Report No. 50-051

Place : Benbrook, Texas
Date : February 12, 2020
Vehicle : Cessna 560, N654CE
NTSB No. : CEN20LA082
Investigator : Michael Hodges, ASI-CEN

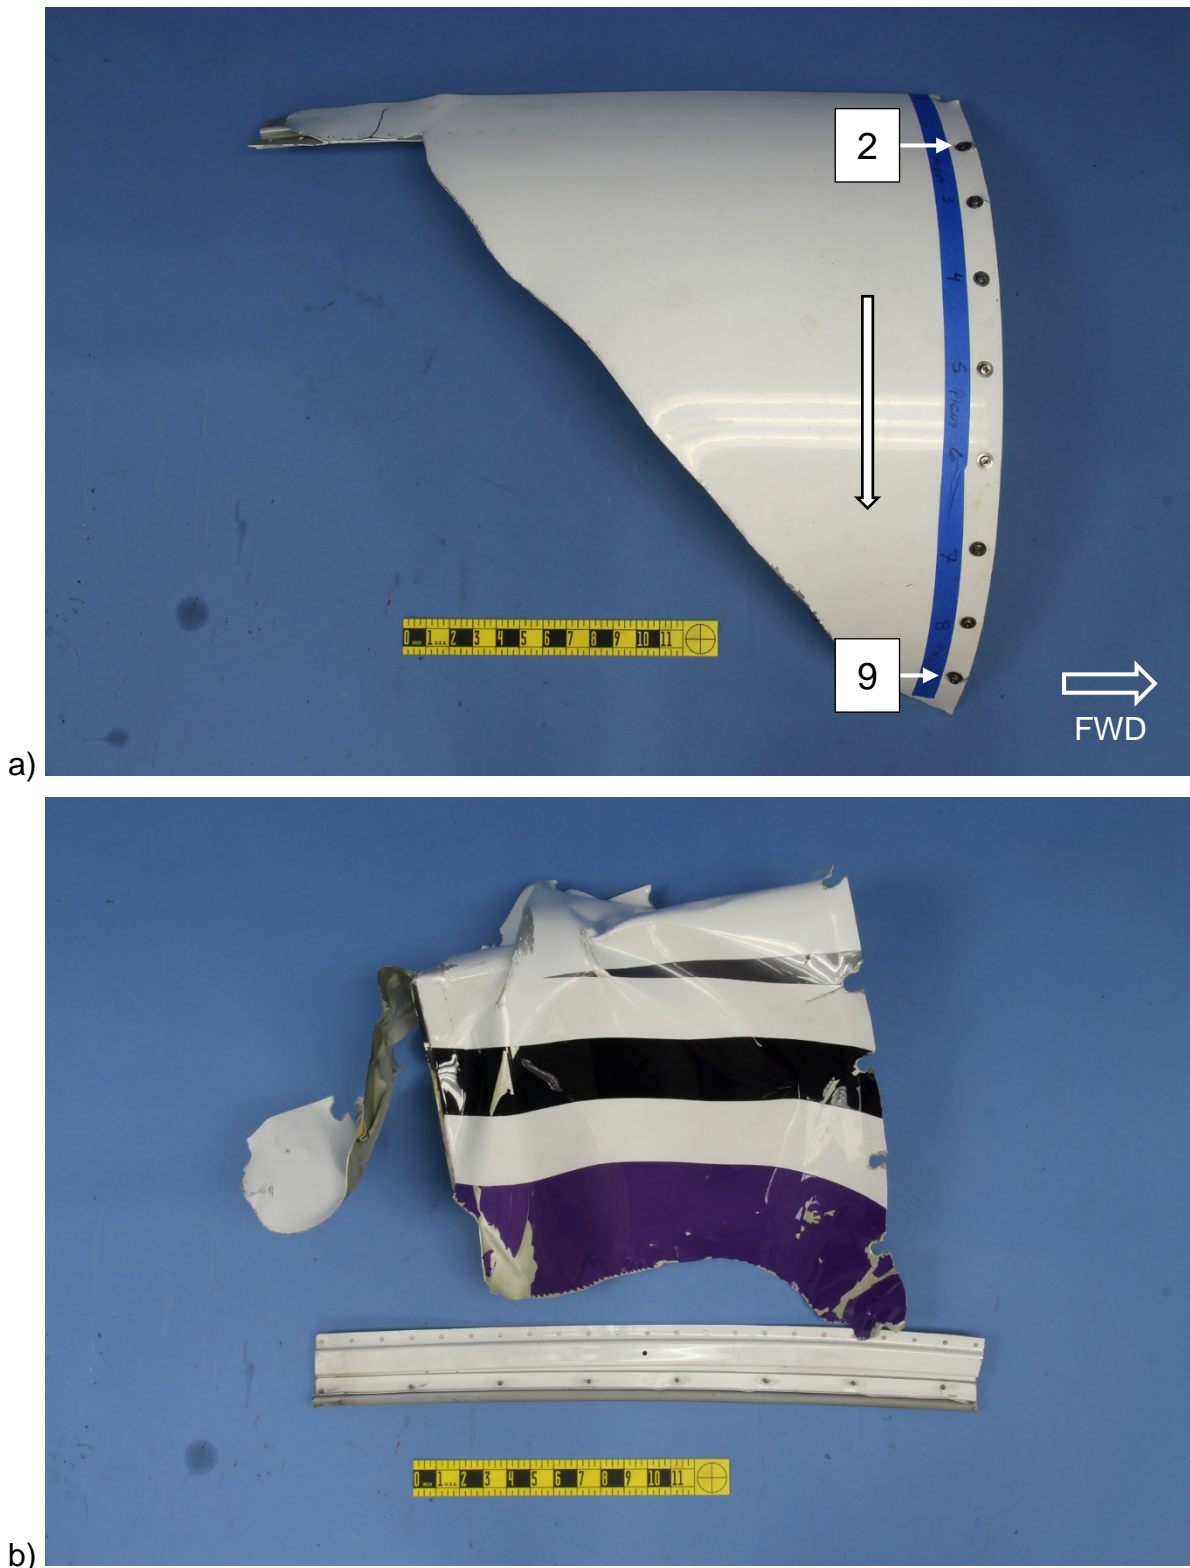
for examination as shown below in figures 1a – d. The piece of the upper cowl door (see figure 1a) was the only piece of either cowl door that remained attached to the aircraft. The piece of the lower cowl door (see figure 1b) had impacted and wrapped around the inboard section of the right-side horizontal stabilizer. The fracture surfaces of both cowl pieces were examined and exhibited 45° slant fractures and occasionally 90° fractures with transverse shear lines that were consistent with a mixture of tensile and shear overstress.

Figure 1: Images of components from the accident aircraft: a) piece of the upper cowl door with studs, grommets, and snap rings from receptacles 2 – 9 still attached; b) piece of the lower cowl door that struck the right-side horizontal stabilizer along with a piece of the seal assembly;

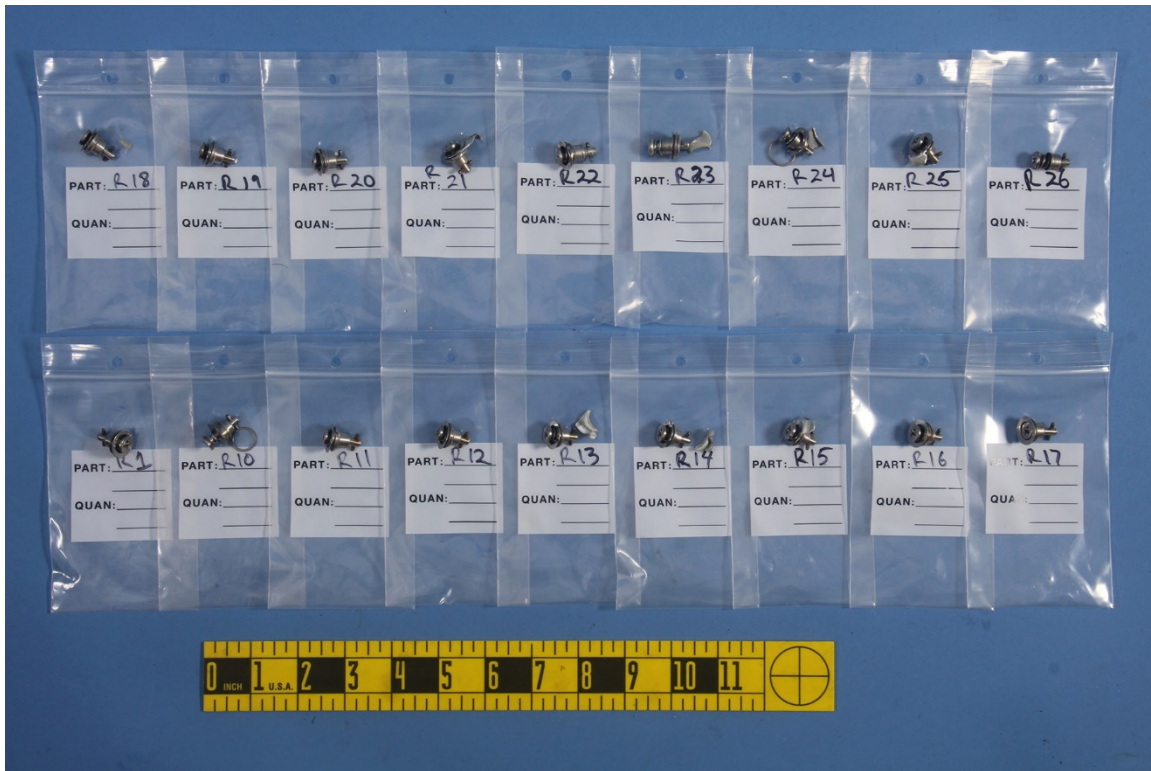
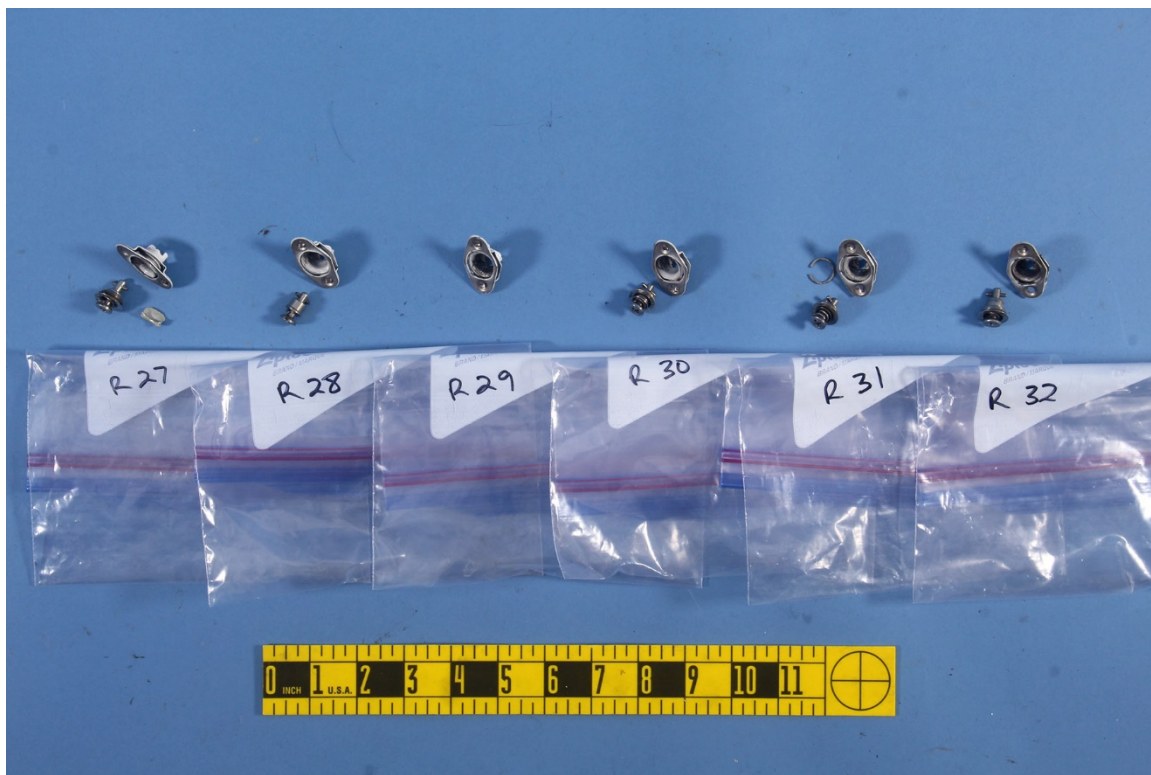
The forward attachment flange fastener assemblies that were received by the Materials Lab are shown in figures 1a, c, and d. In the field, each receptacle and its associated hardware were given a number from 1 to 32. When viewed from the aft end of the engine looking forward, the numbering was started at the 9:00 position (the inboard side of the engine) and proceeded clockwise. Using this numbering system, the studs, grommets, and snap rings for receptacles 2 – 9 were still attached to the upper cowl door and are shown in figure 1a. The studs, grommets, and snap rings for receptacles 1 and 10 – 25 were sent without their corresponding receptacles and are shown in figure 1c. On scene examination of the aircraft indicated that the stud at receptacle 26 was missing its grommet and snap ring as seen in figure 3a and 1c. Receptacles 27 – 32 and their associated hardware were sent to the lab and are shown in figure 1d. On scene examination of the aircraft indicated that the stud at receptacle 28 was missing its grommet and snap ring and that the stud, grommet, and snap ring were all missing from receptacle 29, as shown in figures 3b and c, respectively. Those pieces were not recovered and were not examined by the lab.

Figure 1 (cont.): c) stud assemblies, grommets, and snap rings from receptacles 1 and 10 – 25 and the stud assembly from receptacle 26; and d) receptacles 27 – 32 with stud assemblies for 27, 28, and 30 – 32, and grommets and snap rings for 27 and 30 – 32.

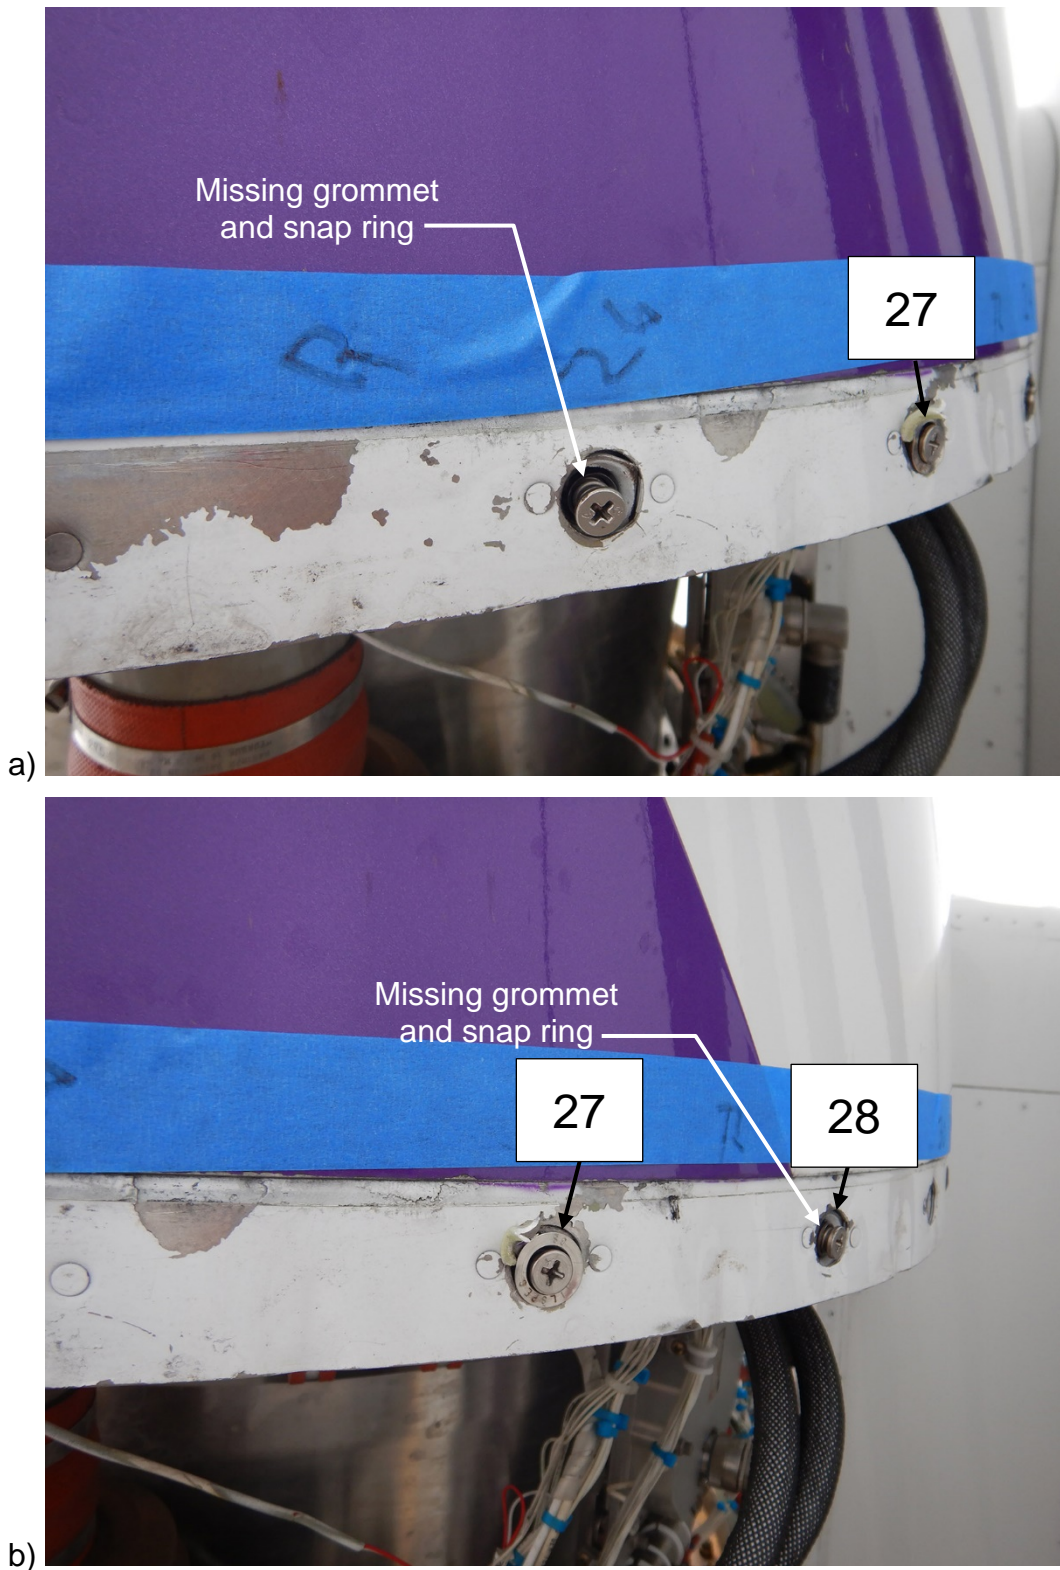
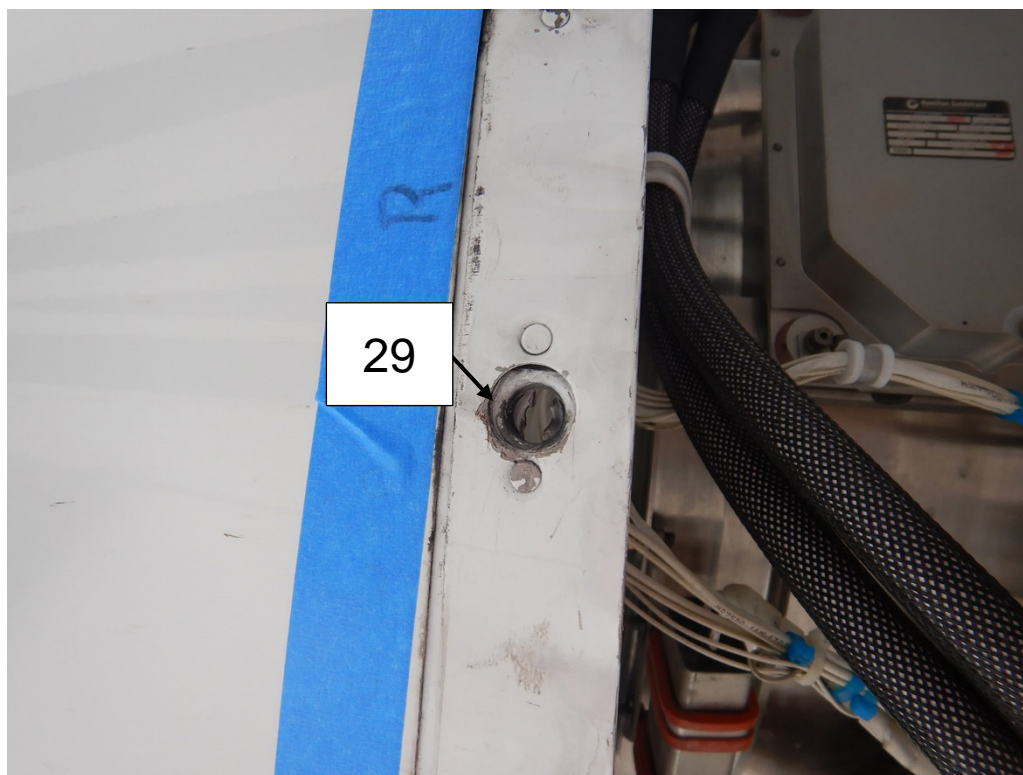
Figure 3: On-site images of the right-engine forward attachment flange showing the location of missing hardware: a) the missing grommet and snap ring at receptacle 26; b) the missing grommet and snap ring at receptacle 28;

Figure 3 (cont.): and c) the missing stud, grommet, and snap ring at receptacle 29.

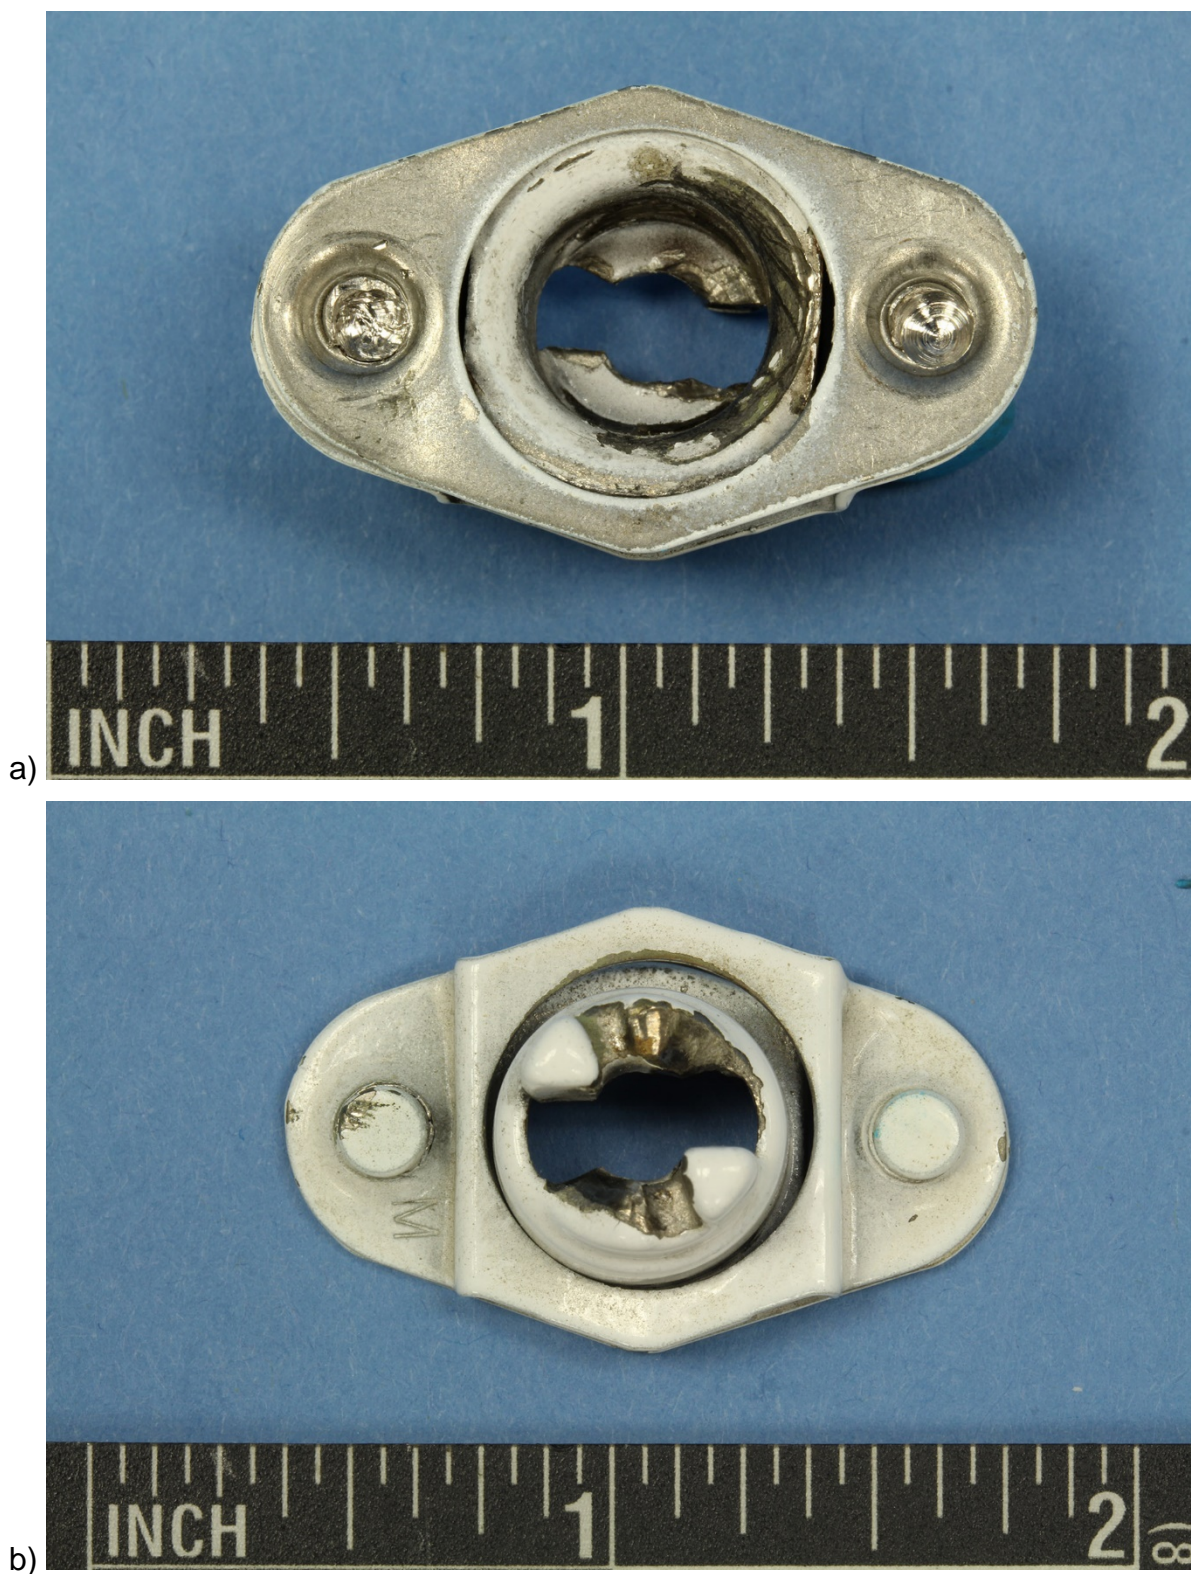
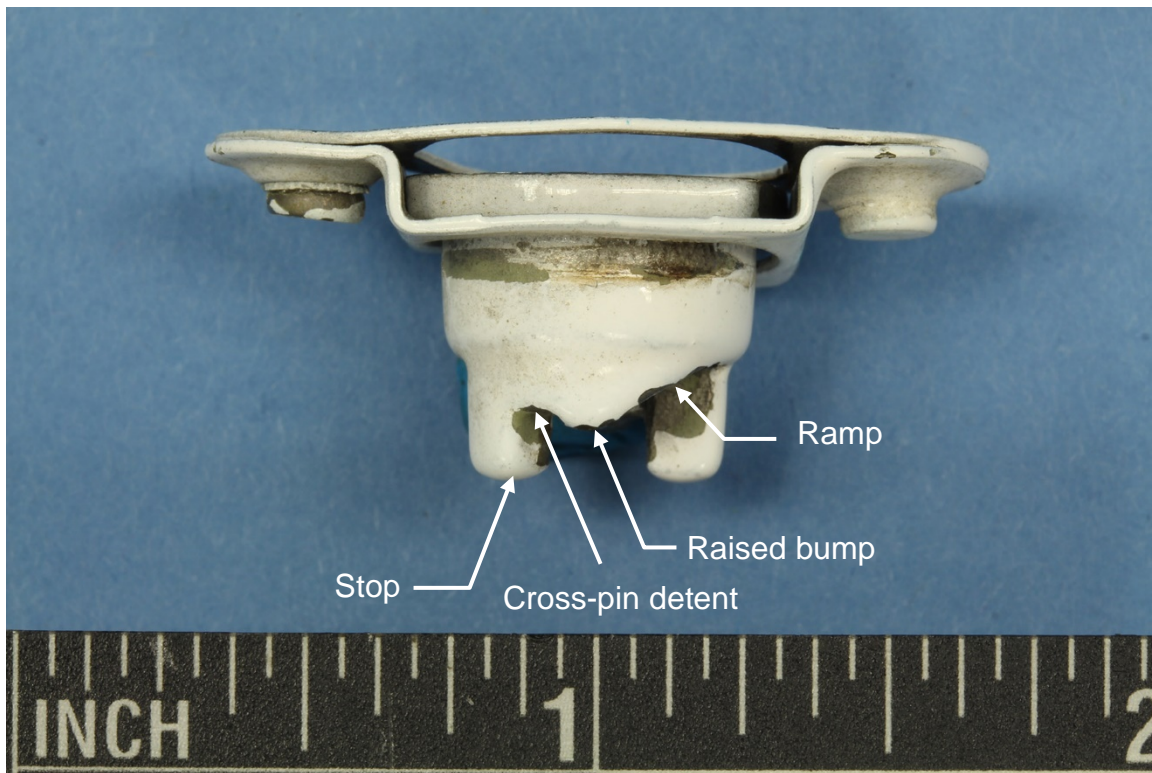
The number 29 receptacle was examined for any notable features, but none were found. Top-down, underside, and sideview images of the receptacle are shown in figures 4a – c, respectively. The interior of the number 29 receptacle cup is shown in figure 5a and closer view of the cup backside is shown in figure 5b. Deformation and wear of material was observed at the edge of the slot where the cross-pin passed through the

Figure 4: Images of receptacle 29: a) top down image; b) backside image;

Figure 4 (cont.): and c) side view image with annotations of the cross-pin locking features.

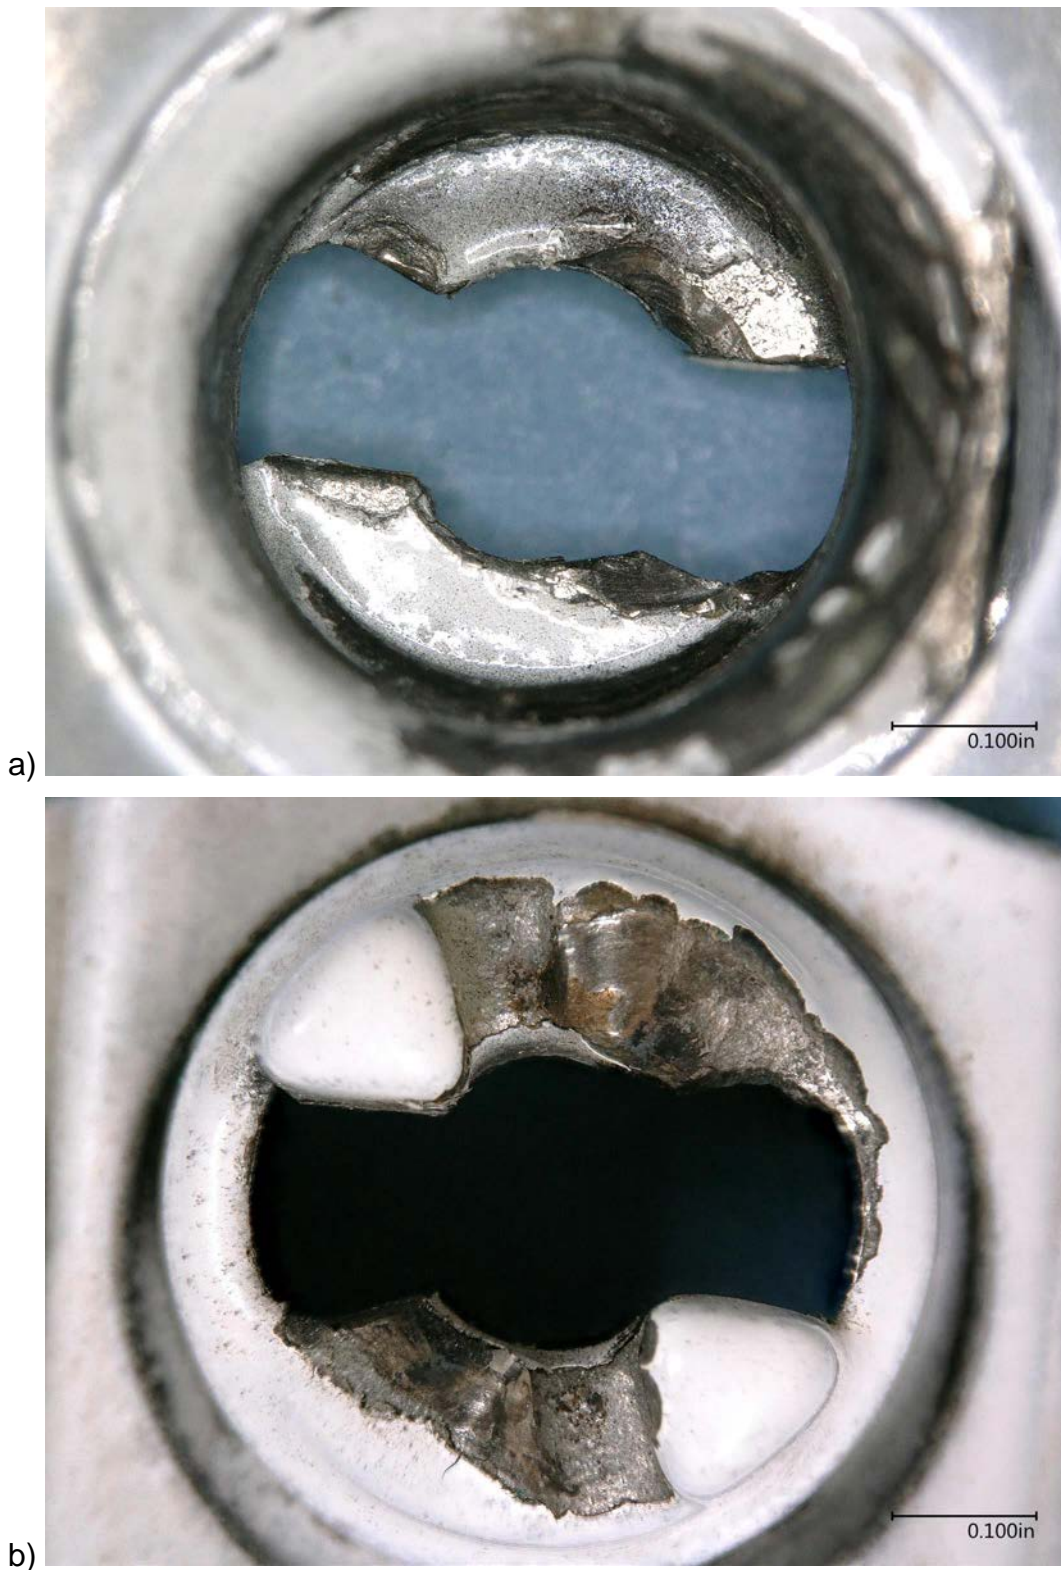
base of the cup. The ramps and detents on the backside of the cup exhibited a rubbed appearance consistent with sliding contact.

Figure 5: Higher magnification views of the receptacle cup for receptacle 29: a) cup side into which the stud and spring cup are inserted and b) backside with the ramp, raised bump, and detent that engage the cross-pin on the stud.

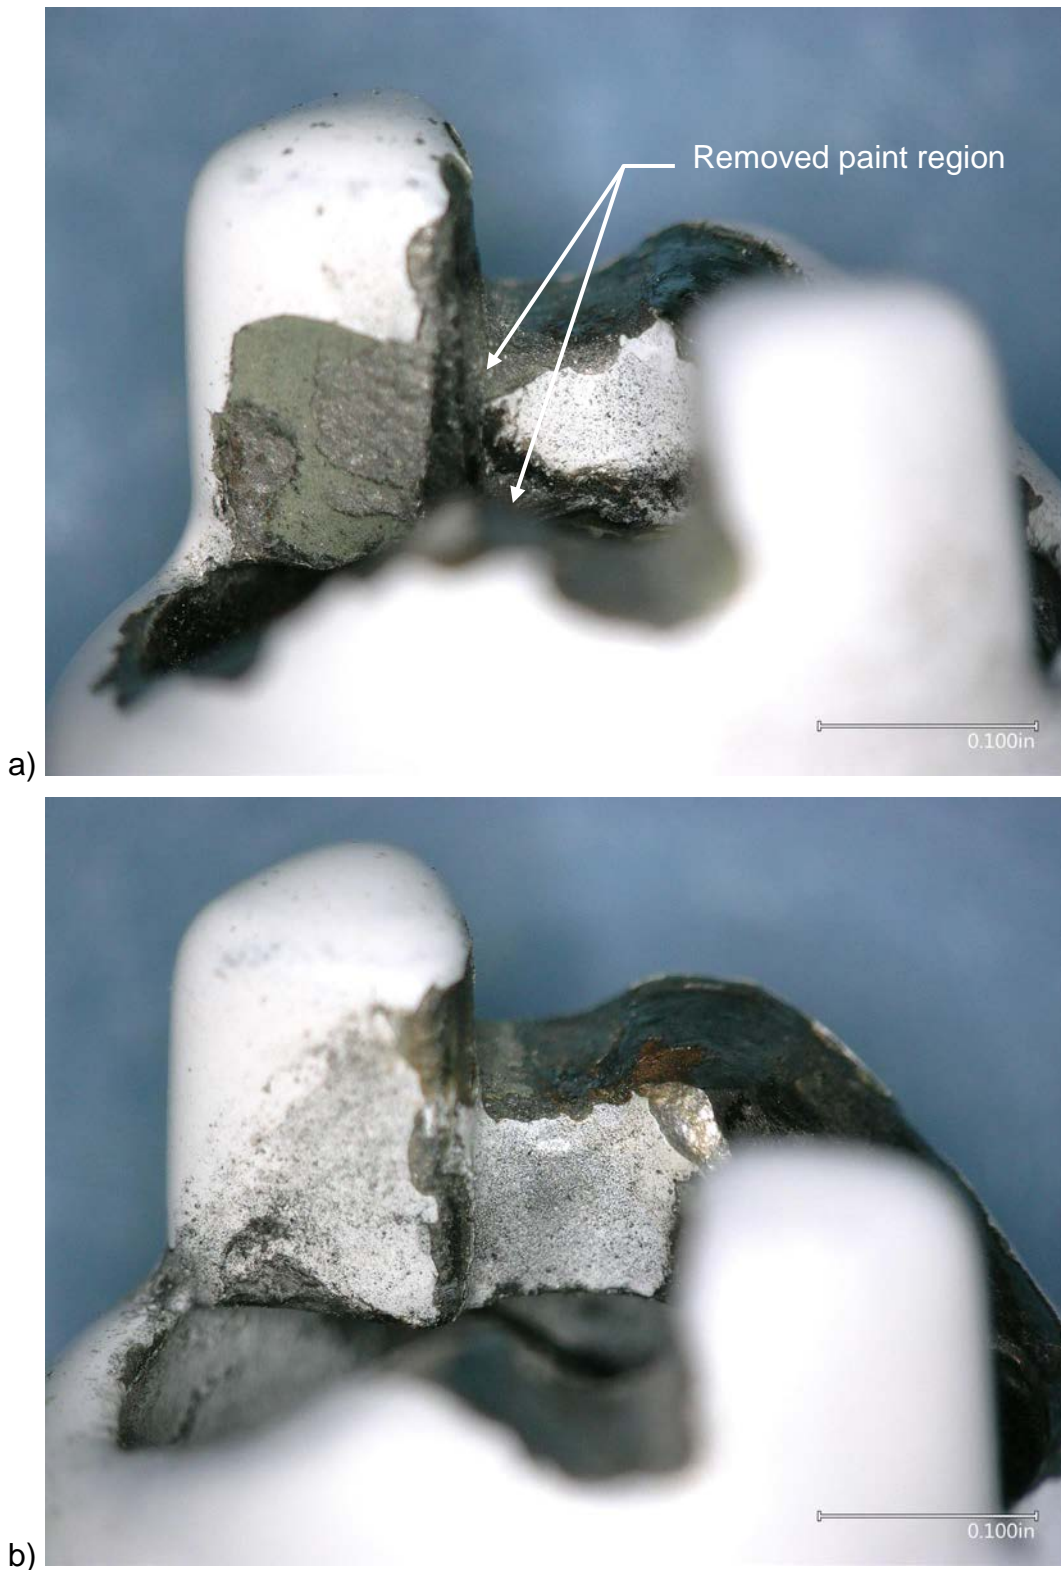
The vertical walls of the slotted hole adjacent to the detent were examined for any deformation or contact damage as shown in figures 6a and 6b. The majority of the two vertical wall regions was still coated with white paint. On the side shown in figure 6a, the

paint had chipped adjacent to the detent as indicated, but the metal surface exhibited a matte as-manufactured appearance. Another area, adjacent to the cup interior, exhibited removed paint and a rubbed appearance as indicated in the figure.

Figure 6: Images of the slotted hole on receptacle 29 showing paint still present on the vertical wall below the detent: a) one detent region with paint chipped adjacent to the detent and removed from a spot adjacent to the cup and b) the second detent region with no paint removed.

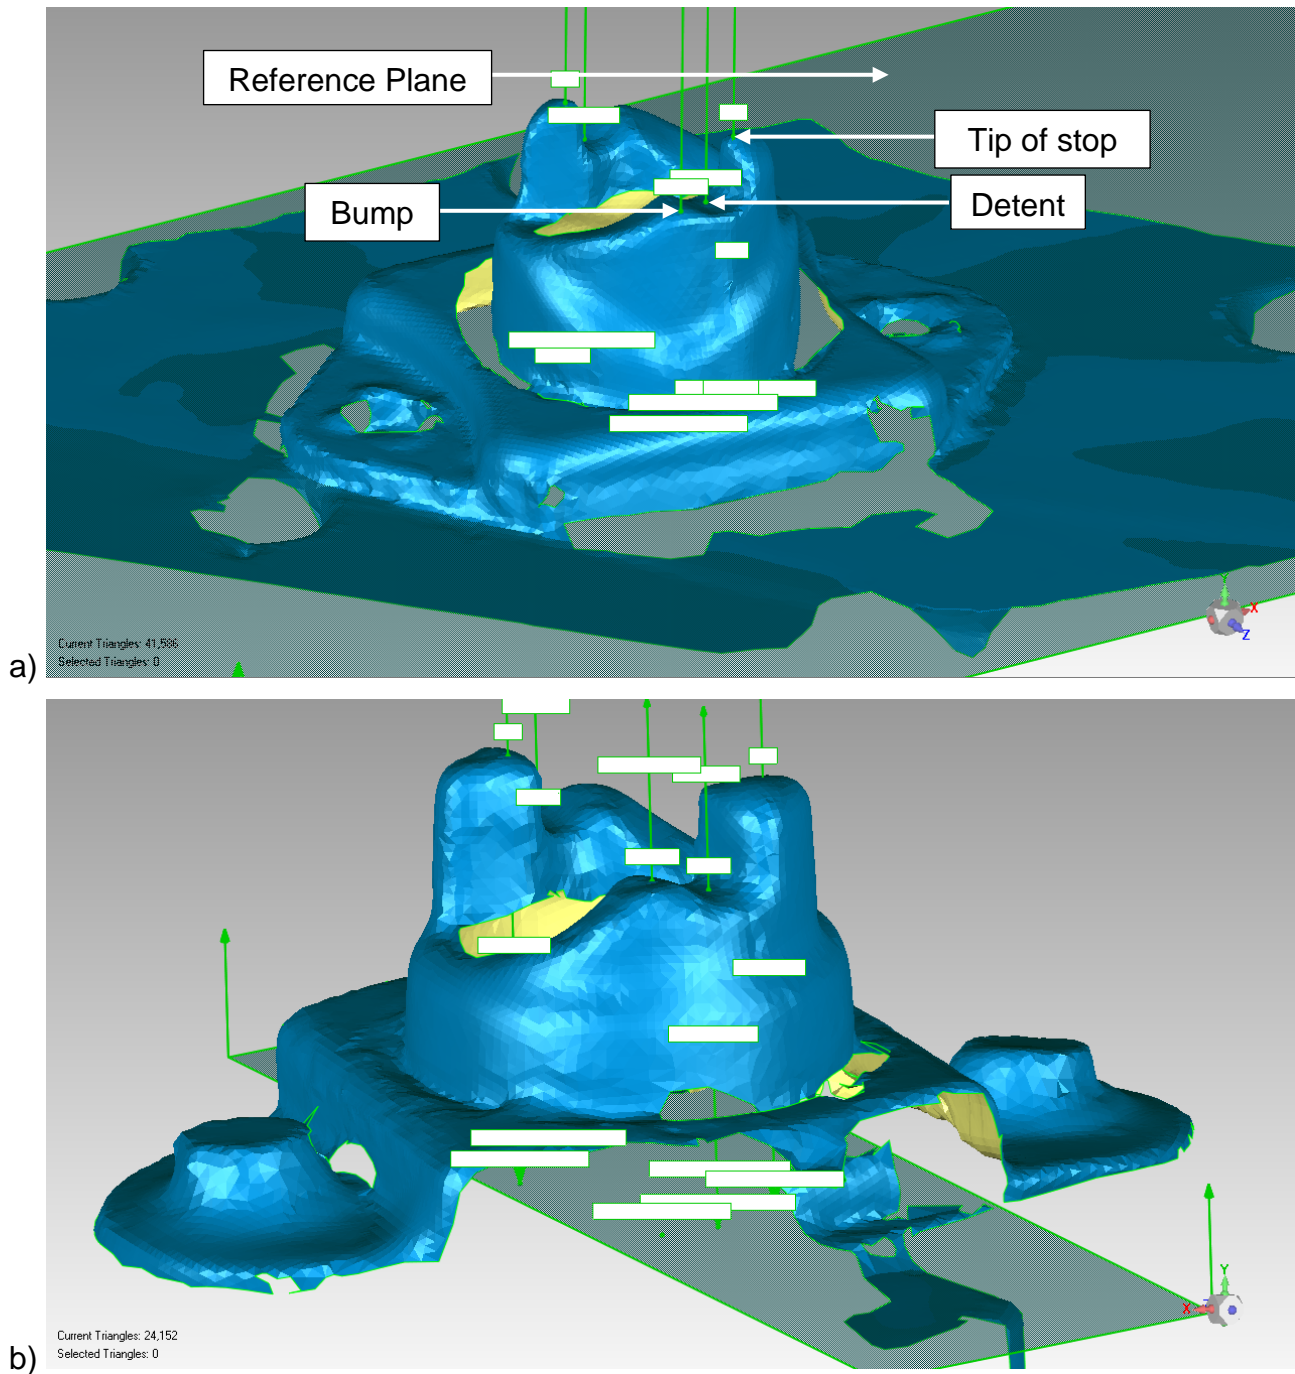
The receptacle 29 cup backside was measured for indications of wear of either the detent or raised bump using a laser scanner. Receptacle 29 and an exemplar receptacle were scanned with a tabletop coordinate measurement machine (CMM) with a laser scanner attachment and single point precision of 0.001 inch. The receptacles were scanned in two steps and the two scans were later merged. For the first scan, each receptacle was placed bottom-side up and clamped against a flat plate which served as a reference plane. For the second scan, the clamps were removed and the areas obscured by the clamps were scanned. The two scans were then aligned, merged, and converted into a mesh, the results of which are shown in figures 7a and 7b for the exemplar and receptacle 29, respectively. The scans were then used to measure the vertical distance from the reference plane to the tip of each stop, detent, and raised bump, as indicated in figure 7a. The tip/detent and bump/detent vertical distances were then calculated. The results are shown in table 3 below and are for information purposes only. The two sides of each receptacle were arbitrarily labelled 1 and 2.

The maximum and minimum distances from the tip of the stop to base of the detent were 0.112 inch and 0.111 inch, respectively; a difference of 0.001 inch. The vertical distances from the tip of the raised bump to the base of the detent measured 0.025 inch and 0.027 inch for the exemplar receptacle and 0.022 inch and 0.028 inch for receptacle 29.

Figure 7: 3D laser scan surface meshes used to measure the vertical distance from the flat face of the receptacle (coincident with the reference plane) to the tip end of the stop, the detent, and the tip of the raised bump: a) scan of an exemplar receptacle and b) scan of receptacle 29.

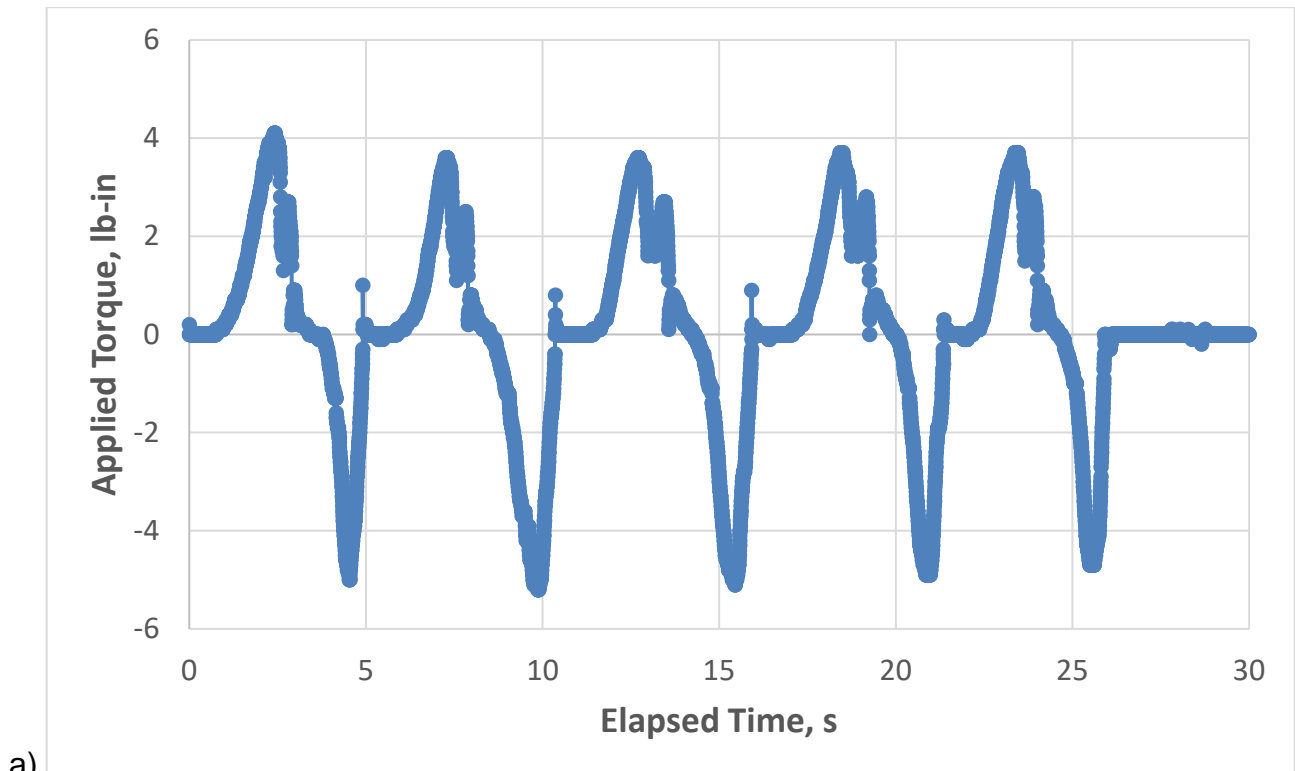
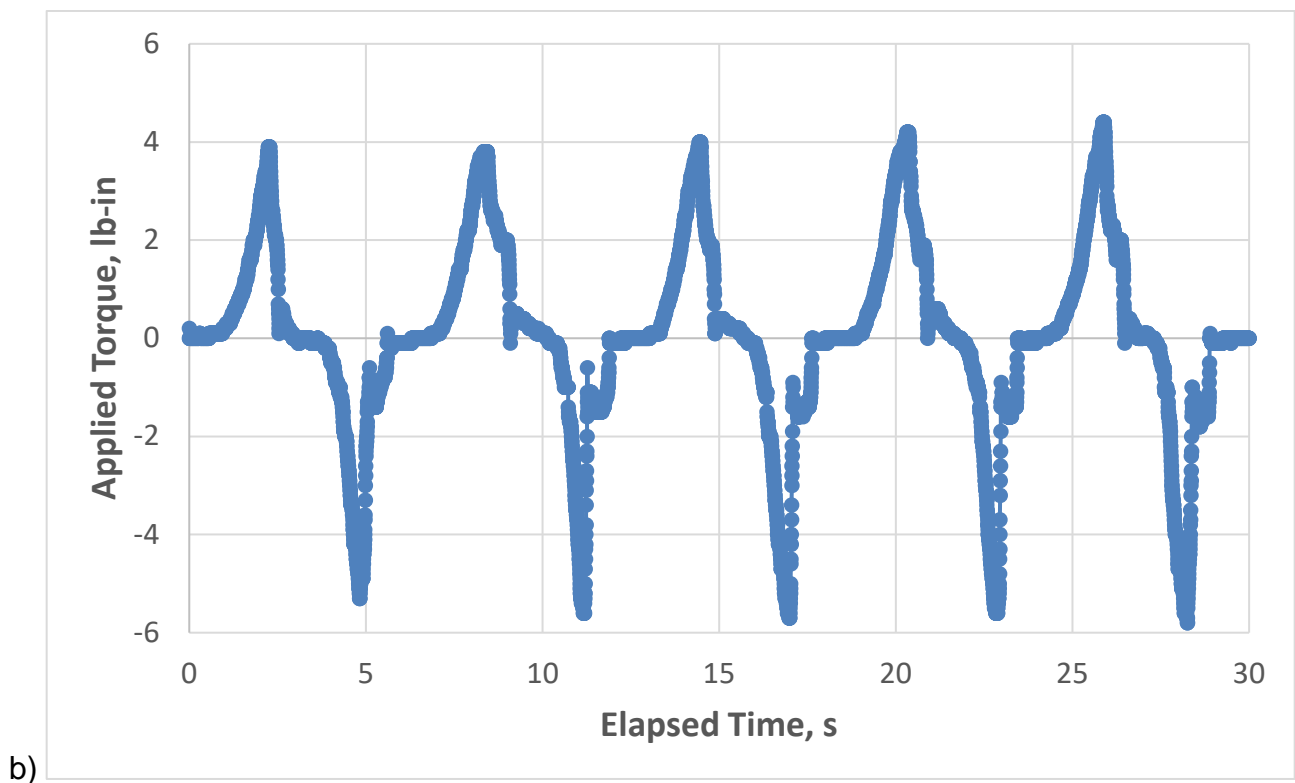
The results for the 0.085-inch thick plate are presented first followed by the results for the 0.130-inch thick plate. Figure 8a shows the locking and unlocking torque data for an exemplar S3412-103 stud, exemplar S2319-63 grommet and 0.085-inch thick plate. Over five cycles, the applied torque increased from 0 lb-in to a peak that ranged between 3.5 lb-in – 4.1 lb-in at which point the cross-pin crossed over the bumps into the detents and the applied torque was removed. During the unlocking phase, counterclockwise torque was applied and the torque decreased to a minimum that ranged between -4.7 lb-in to -5.2 lb-in, at which point the cross-pins popped out of the detents and the applied torque was removed. Figure 8b shows data from a similar test but with a “-3” stud from receptacle 5 on the accident aircraft right engine. Over the course of the test, the peak locking torques ranged from 3.8 lb-in to 4.4 lb-in and the peak unlocking torques ranged from -5.3 lb-in to -5.8 lb-in.

Figure 8: Locking and unlocking torque curves using an exemplar receptacle mounted to a plate with an effective thickness of 0.085 inch, an exemplar grommet, and different studs as follows: a) an exemplar “-3” stud (0.72 inch in length) and b) a “-3” stud from receptacle 5 from the accident aircraft.

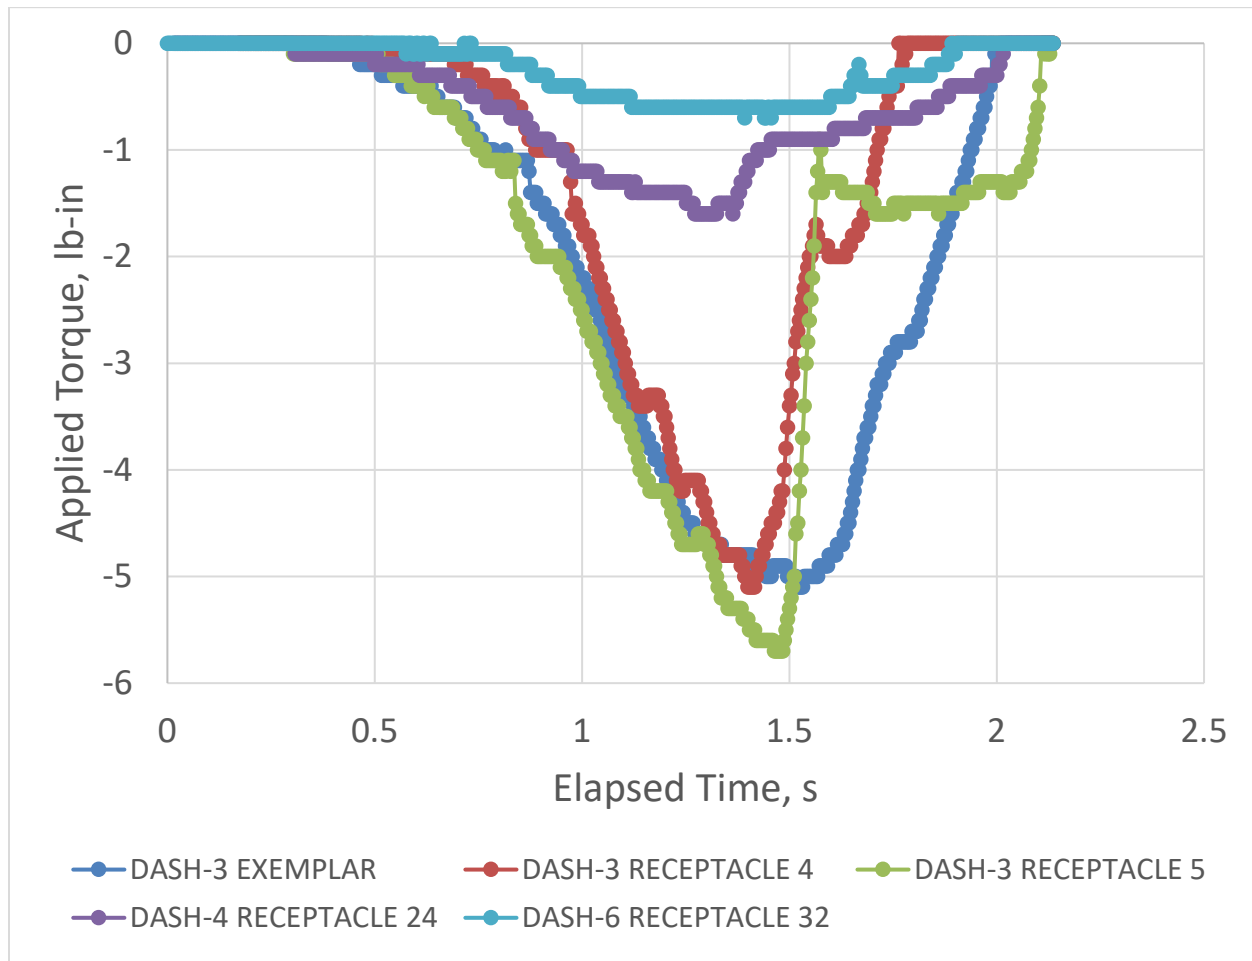
In addition to the exemplar stud and the stud at receptacle 5, locking and unlocking torque measurements were taken for a “-3” stud from receptacle 4, a “-4” stud from receptacle 24, and the “-6” stud at receptacle 32. For comparison, the data from one unlocking sequence from each measurement set have been extracted and time-aligned, as shown in figure 9. Over five cycles, the peak unlocking torques for the stud from receptacle 4 ranged from -4.9 lb-in to -5.7 lb-in. The peak unlocking torques for the “-4” stud from receptacle 24 ranged from -1.5 lb-in -1.6 lb-in and peak unlocking torques for the “-6” stud from receptacle 32 ranged from -0.6 lb-in to -0.7 lb-in.

Figure 9: Time-aligned single unlocking curves extracted from the locking/unlocking data on the 0.085-inch thick plate. The data are from a “-3” exemplar stud, “-3” studs from receptacles 4 and 5, a “-4” stud from receptacle 24, and a “-6” stud from receptacle 32.

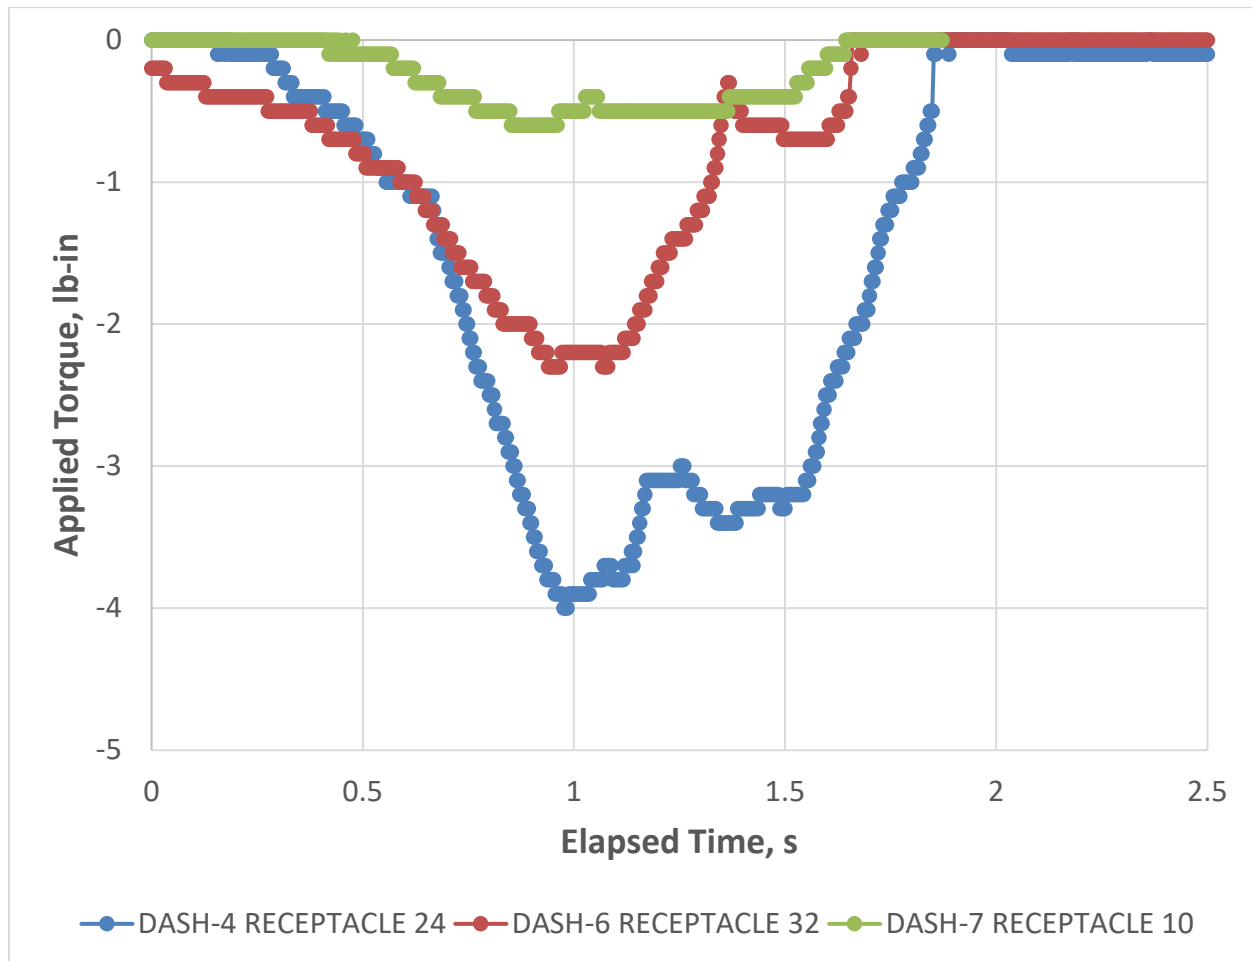
The 0.130-inch plate thickness was greater than the maximum total material thickness for a “-3” stud so neither the exemplar nor any “-3” stud from the accident aircraft was tested at this plate thickness. Instead, locking and unlocking torque measurements were taken for the “-4” stud from receptacle 24, the “-6” stud from receptacle 32, and a “-7” stud from receptacle 10. For comparison, the data from one unlocking sequence from each measurement set have been extracted and time-aligned, as shown in figure 10. Over five cycles, the peak unlocking torques for the “-4” stud from receptacle 24 ranged from -3.9 lb-in to -4.1 lb-in. The peak unlocking torques for the “-6” stud from receptacle

32 ranged from -2.2 lb-in -2.3 lb-in and the peak unlocking torques for the “-7” stud from receptacle 10 ranged from -0.6 lb-in to -0.7 lb-in. In the locked position, the “-6” and “-7” stud heads stood proud of the grommet as shown in figures 11a and b, respectively.

Figure 10: Time-aligned single unlocking curves extracted from the locking/unlocking data on the 0.130-inch thick plate. The data are from a “-4” stud from receptacle 24, a “-6” stud from receptacle 32, and a “-7” stud from receptacle 10.

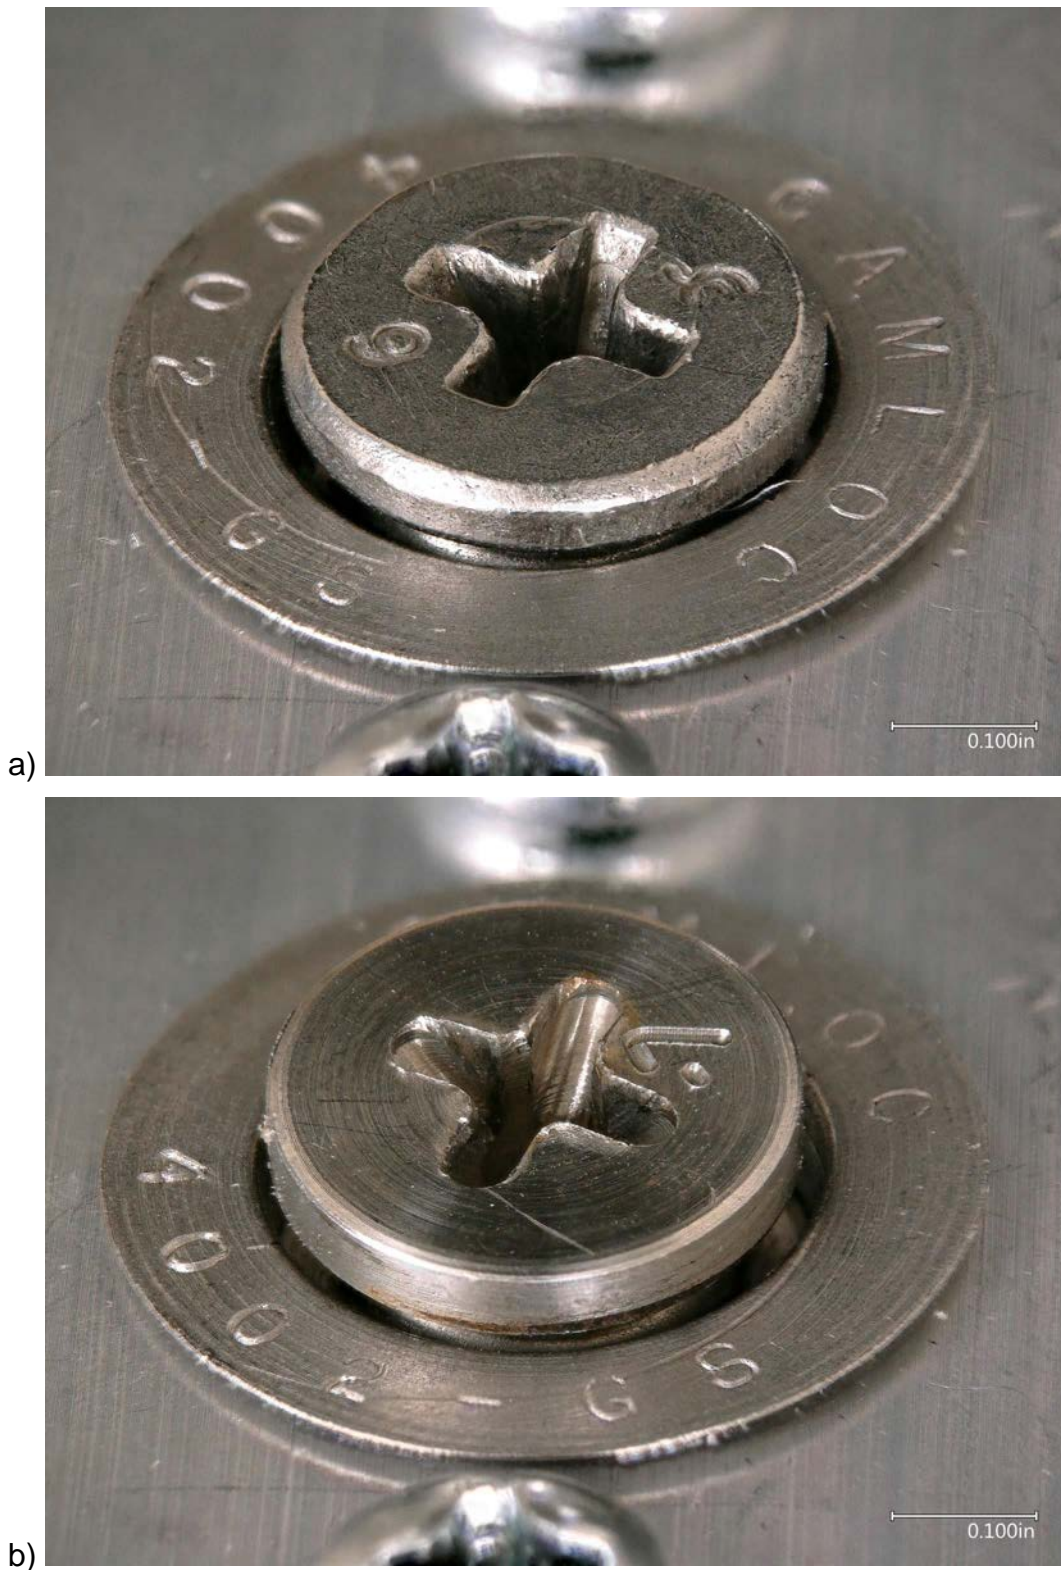
Figure 11: Images of studs in the locked position on the 0.130-inch thick test plate. The stud heads protrude above the top of the grommet: a) “-6” stud from receptacle 32 and b) “-7” stud from receptacle 10.
