SUBJ: ENGINE COWLING SYSTEM,
Quarter-Turn Fastener Maintenance Information

SAIB: AIR-22-10
Date: April 29, 2022

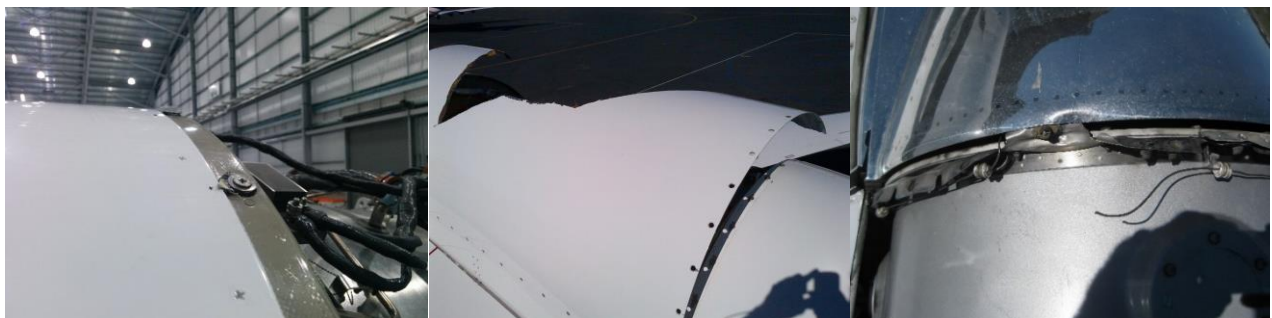
Several incidents of engine cowl damage and resulting separations have occurred across the Textron turbofan-powered airplane product line. The separation incidents resulted in damage to the airplanes, and some incidents have marginally affected airplane handling capabilities. The FAA has not yet determined the root cause of these events but considers maintenance error to be the primary contributing factor.

The Textron turbofan-powered fleet uses quarter-turn fasteners to assemble the engine cowl system. The extent of the use of these fasteners varies depending on the airplane model. Failure to verify engagement of all quarter-turn fasteners can lead to cowl door damage and/or separation due to the aerodynamic loads. Cowl doors that separate from the airplane may strike empennage components, causing structural damage and potential loss of airplane control.

Figure 1: Examples of damage attributed to quarter-turn fastener problems

The FAA recommends thorough pre-flight by all pilots, and repetitive inspections of the quarter-turn fasteners on engine cowl components. All airplane owners and operators should acquaint themselves with the configuration of the airplane, including the components that use quarter-turn fasteners. Knowledge of the location and correct installation configuration of quarter-turn fasteners will assist in any pre-flight or repetitive inspection to identify fasteners that are not normal or that may have changed since the last inspection.

In addition, engine maintenance activities require frequent cowl removals. Our investigation indicates that a single inspection may not always reveal an incorrect cowl re-installation. The FAA recommends a second visual inspection of the complete engine cowl installation immediately after a cowl has been removed and prior to returning the airplane to service to ensure that all quarter turn fasteners have been secured properly. Simple tools such as a ladder, flashlight, or mirror may assist in the inspection process. A complete inspection should consist of checking that all quarter-turn fasteners are correctly seated and latched.

Textron recommends replacing any cowling system component that fails maintenance manual inspection procedures or that is found defective (Ref. 14 CFR part 43 Appendix D, (d) (11)). The FAA recommends verifying that each quarter-turn fastener has been correctly repaired and replacing

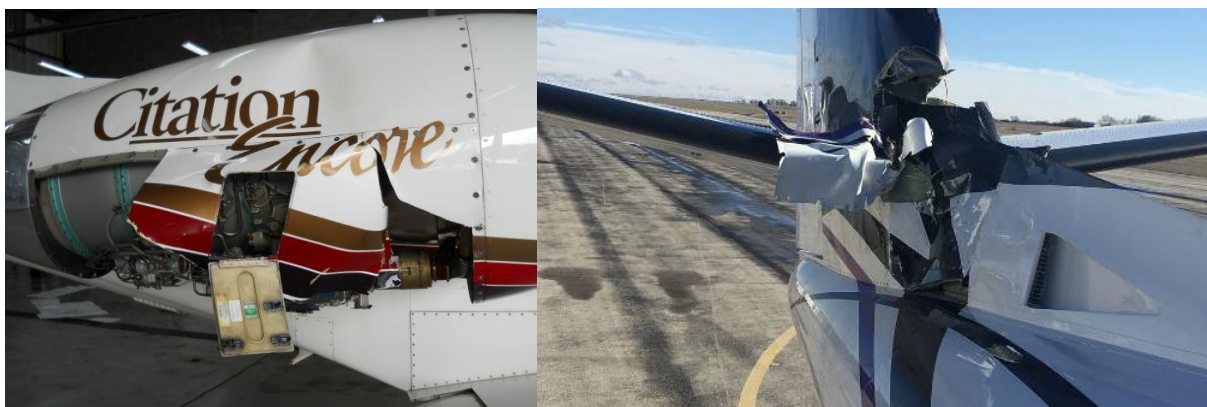
Figure 2: Additional examples of damage attributed to quarter-turn fastener problems

Investigation by the National Transportation Safety Board, Textron, and the FAA determined that these quarter-turn fasteners are frequently repaired or replaced during the service life of the airplane. The investigation also found that replacement quarter-turn fasteners often do not conform to type design or an approved repair. These nonconformities commonly include substitution of alternate parts or combinations of different manufacture types, installation of quarter-turn studs of inappropriate grip-length, and stud replacement without commensurate receptacle replacement. It is also common for cowl doors to have cracks that extend to or from a quarter-turn fastener location.

The FAA strongly encourages consulting with a part 145 repair station that has experience and expertise in cowl door inspection and repair, prior to attempting the repair of any nacelle or cowl system component.
