Aviation Investigation Final Report

Location:	Lawrenceville, Illinois	Accident Number:	CEN20LA367
Date & Time:	August 29, 2020, 01:23 Local	Registration:	N607SR
Aircraft:	Cirrus SR22	Aircraft Damage:	Destroyed
Defining Event:	Controlled flight into terr/obj (CFIT)	Injuries:	1 Fatal
Flight Conducted Under:	Part 91: General aviation - Personal

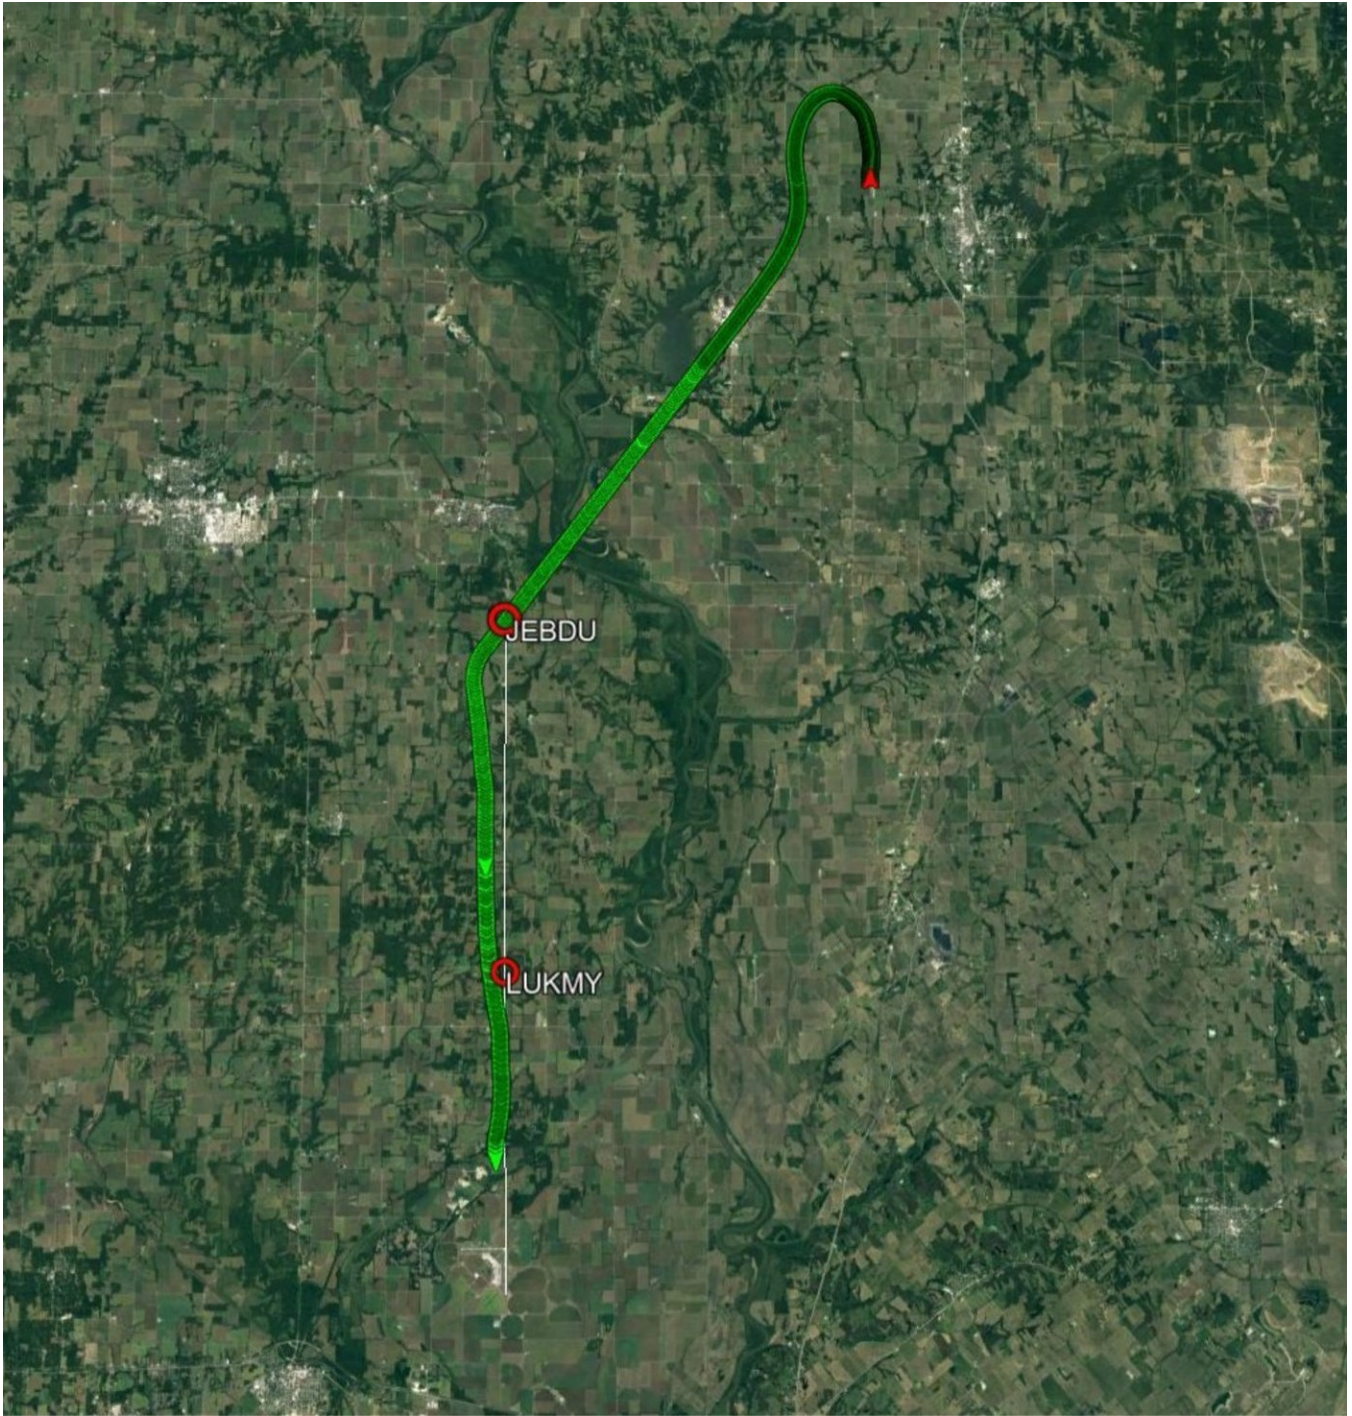
From 0118 to 0121, the airplane descended and reduced airspeed as it continued toward LWV and west of the final approach course. About 0121, at LUKMY, the final approach fix, the airplane was at 2,200 ft and west of the LUKMY. For the next 2 minutes, the airplane descended from 2,200 ft to 600 ft at an average rate of 800 ft per minute and an average ground speed of 116 knots. The airplane's final recorded altitude was 600 ft (See figures 1 and 2).

Figure 1. Airplane flight track (Google Earth image)

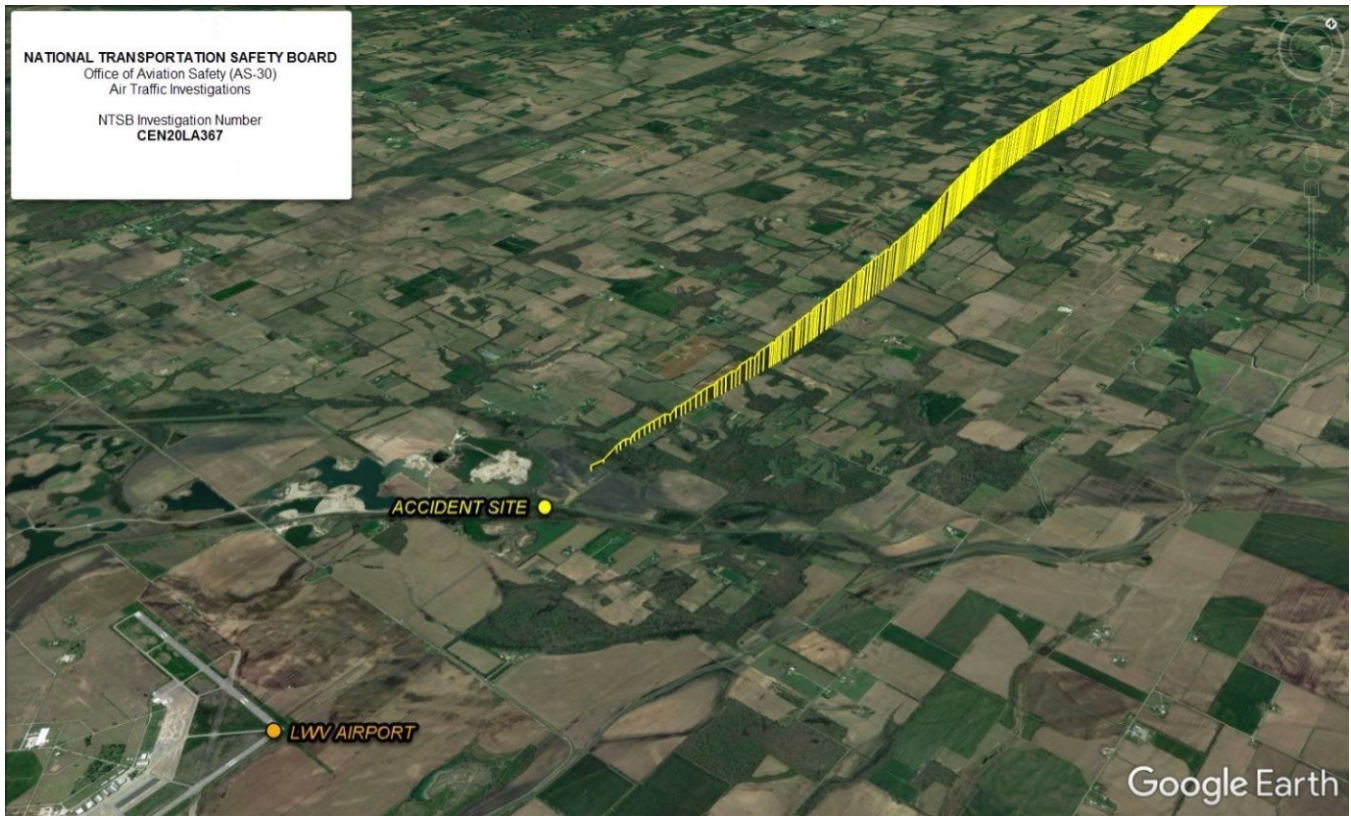
Figure 2. Accident flight track (Google Earth image)
