Aviation Investigation Final Report

Location:	Katy, Texas	Accident Number:	CEN19FA078
Date & Time:	January 31, 2019, 16:10 Local	Registration:	N56359
Aircraft:	Mooney M20K	Aircraft Damage:	Destroyed
Defining Event:	VFR encounter with IMC	Injuries:	1 Fatal
Flight Conducted Under:	Part 91: General aviation - Personal

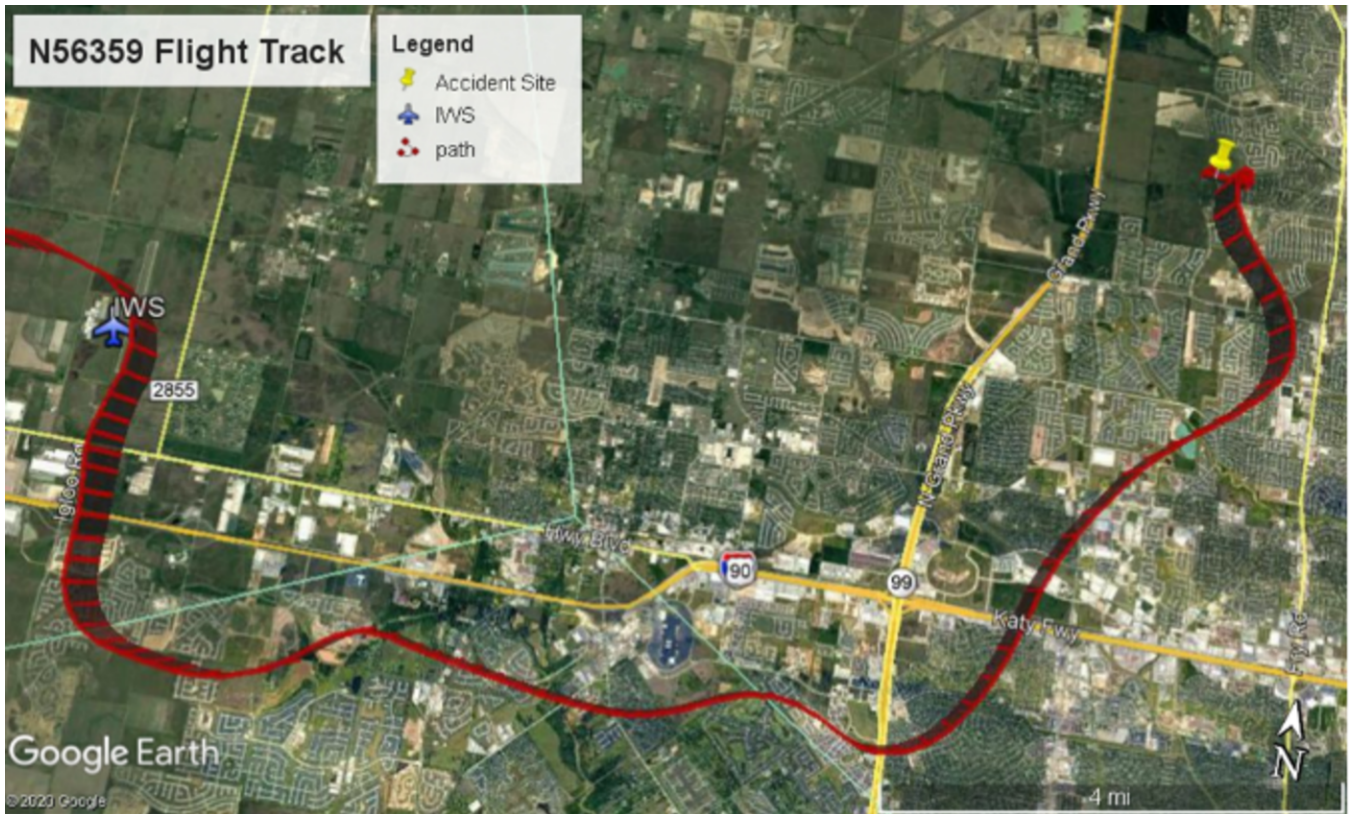
Figure 1: End Portion of Flight Track and Location of Main Wreckage

The pilot filed a VFR flight plan and took off from ELP about 1250. The flight track showed the pilot proceeded east toward IWS at a cruise altitude between 9,600 to 9,800 ft. As the flight approached IWS, the pilot descended and overflew the airport at midfield at 2,775ft. The pilot then turned southbound; paralleling the east side of the runway and climbed to 3,300ft. The pilot made descending a left turn and continued east bound, at an altitude between 2,800ft to 2,525ft. The flight track turns north with a gradual decrease in altitude before the pilot makes a descending right-hand turn into terrain (see Figure 1).

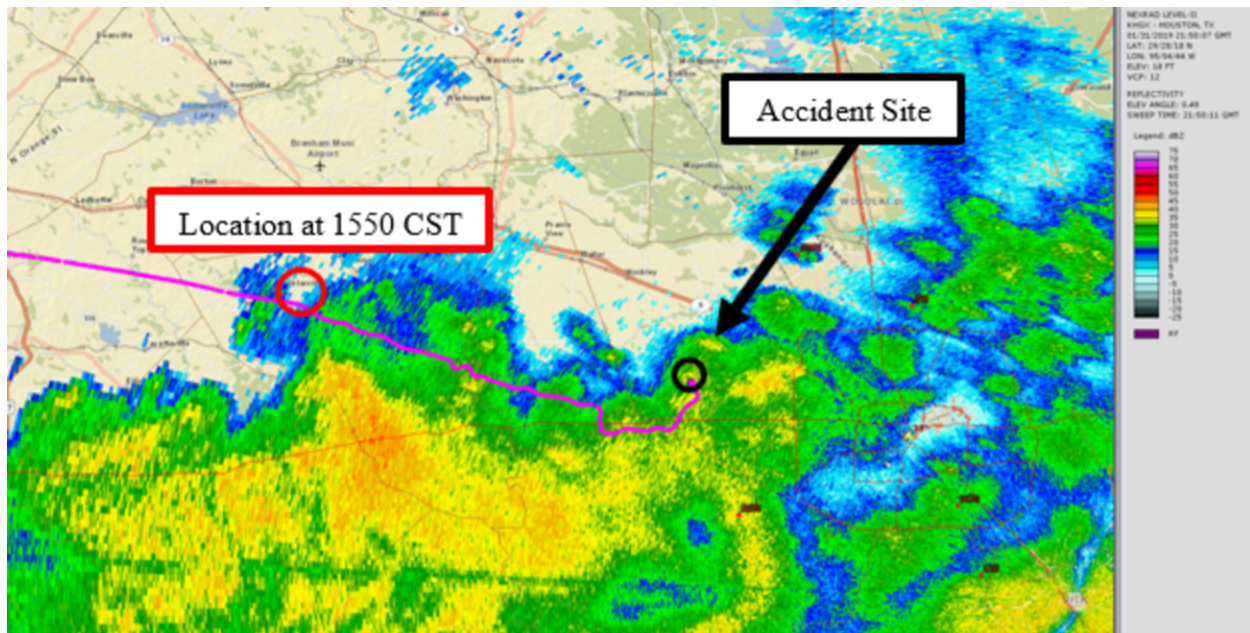
Figure 2: Reflectivity scan initiated at 1550:10 CST with the accident site marked with black circle, and the accident flight track in pink

As the airplane approached the Houston area, it first encountered precipitation around 1550. The reflectivity bands shown in Figure 2 were moving from west to east.

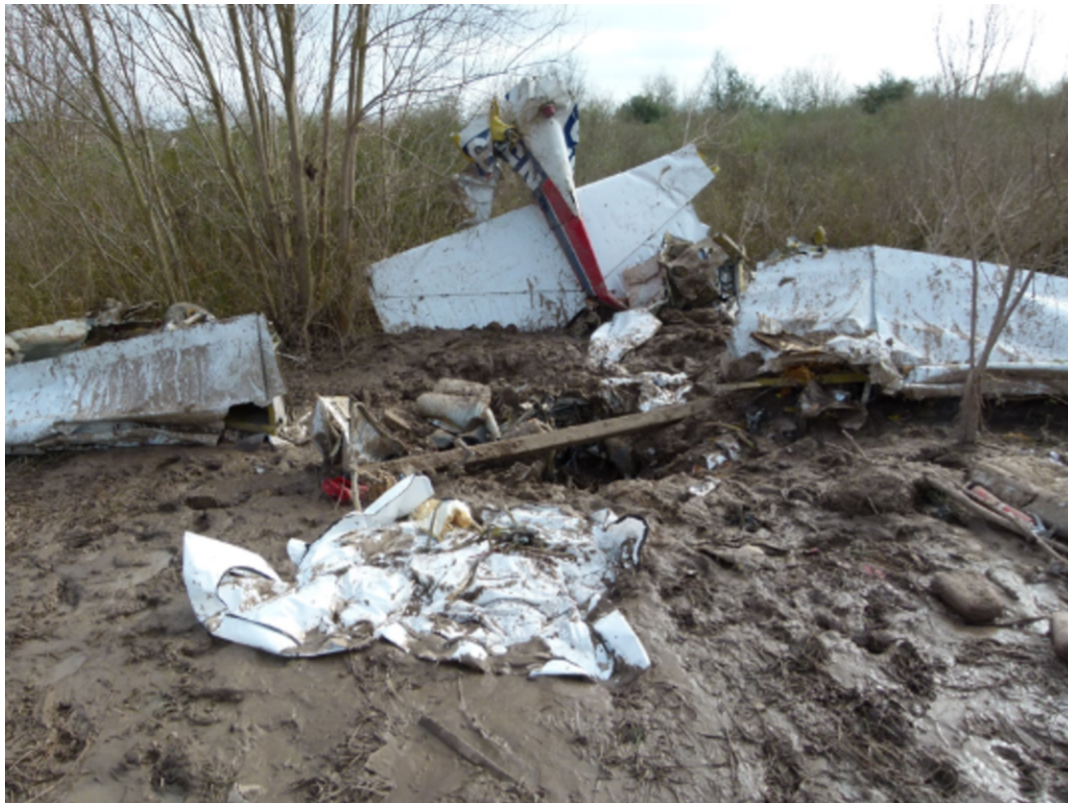
Figure 3: Airplane Main Wreckage

The main wreckage came to rest in a muddy field on the west side of a residential development. The airplane impacted the ground in a near-vertical attitude. The propeller and engine were embedded about 6 ft into the ground. The airplane's wings and empennage were separated and the forward fuselage, cockpit and baggage area were highly fragmented. See Figure 3.
