# Aviation Investigation Final Report

| <b>Location:</b> | San Diego, California | <b>Accident Number:</b> | WPR15MA243 |
| <b>Aircraft:</b> | Cessna 172M | <b>Aircraft Damage:</b> | Destroyed |
| <b>Defining Event:</b> | Midair collision | <b>Injuries:</b> | 1 Fatal |

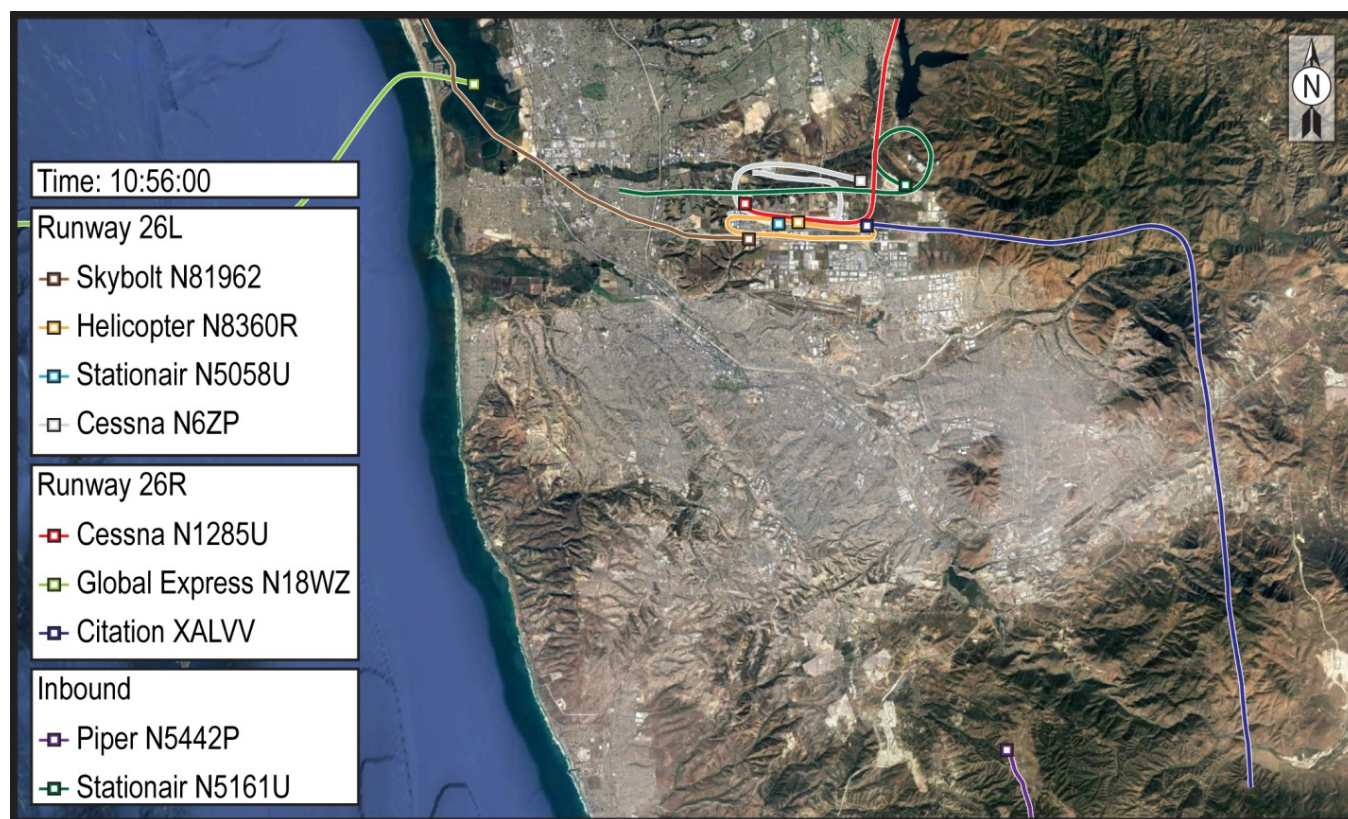
**Figure 1.** Aircraft in the SDM traffic pattern about 8 minutes before the accident.

At 1056:31, the LC trainee advised the pilot of N1285U to expect runway 26L on the next approach, which the pilot acknowledged. At that time, three aircraft were using runway 26R (Global Express [N18WZ] was inbound for landing, N6ZP was on a right base for a touch-and-go, and XALVV was on short final) and three aircraft were using runway 26L (N1285U was turning right downwind for the touch-and-go, N81962 was on a left downwind for landing, and N8360R was conducting a touch-and-go operation). Figure 1 shows the aircraft in the SDM traffic pattern about 8 minutes before the accident.

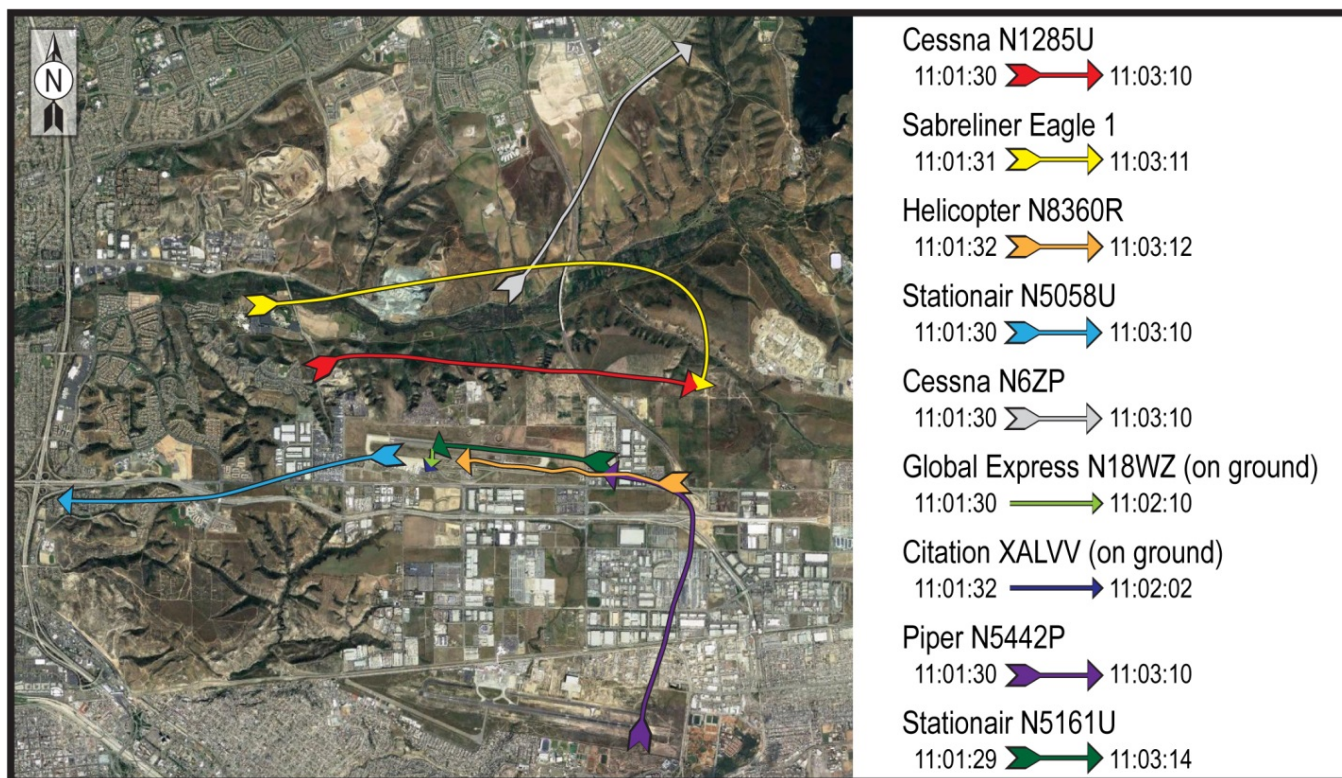
**Figure 2.** Aircraft in the SDM traffic pattern from about 1101 until the time of the accident.

During the next 2 minutes, the LC made several errors that were either corrected by him or by the pilots under his control. At 1059:44, after the pilot of N6ZP completed a touch-and-go on runway 26R, he requested a right downwind departure from the area. The LC did not respond. At 1100:23, the LC instructed, "stationair five eight uniform two six right cleared for I'm sorry two six left cleared for takeoff." At 1100:29, the pilot of N5058U stated, "uh I'm sorry was that for five eight uniform?" The LC then cleared the pilot of N5058U for takeoff from runway 26L. At 1100:36, the LC transmitted, "helicopter six zero romeo there is a ces ah cen ah correction stationair just ahead they are going to the right runway base leg for two six left." At 1100:46, the pilot of N6ZP repeated his request for departure; the LC then approved N6ZP's departure request, and N6ZP departed the traffic pattern in a northeasterly direction. At 1100:53, the LC instructed the helicopter pilot, "helicopter six zero romeo listen up turn crosswind" before correcting the instruction 4 seconds later to "turn base." At 1101:15, the Eagle1 CVR recorded the copilot state, "got one on the runway," and at 1101:19, the Eagle1 CVR recorded the pilot comment, "wowwww. he's like panicking" (with an emphasis on panicking). Figure 2 shows the aircraft in the SDM traffic pattern from about 1101 until the time of the accident.

At 1101:49, the Eagle1 CVR recorded one of the mission specialists seated outside the cockpit ask "see him right there?" At 1102:14, while on the right downwind leg (and, according to radar data, while overtaking N1285U from behind and to the left) and abeam the tower, the Eagle1 flight crew reported to the ATCT that they had traffic in sight to the left and the right of their position. Radar data indicated that N6ZP was to the left of Eagle1 and heading to the northeast, and N1285U was between Eagle1 and SDM, on a closer-in right downwind leg.

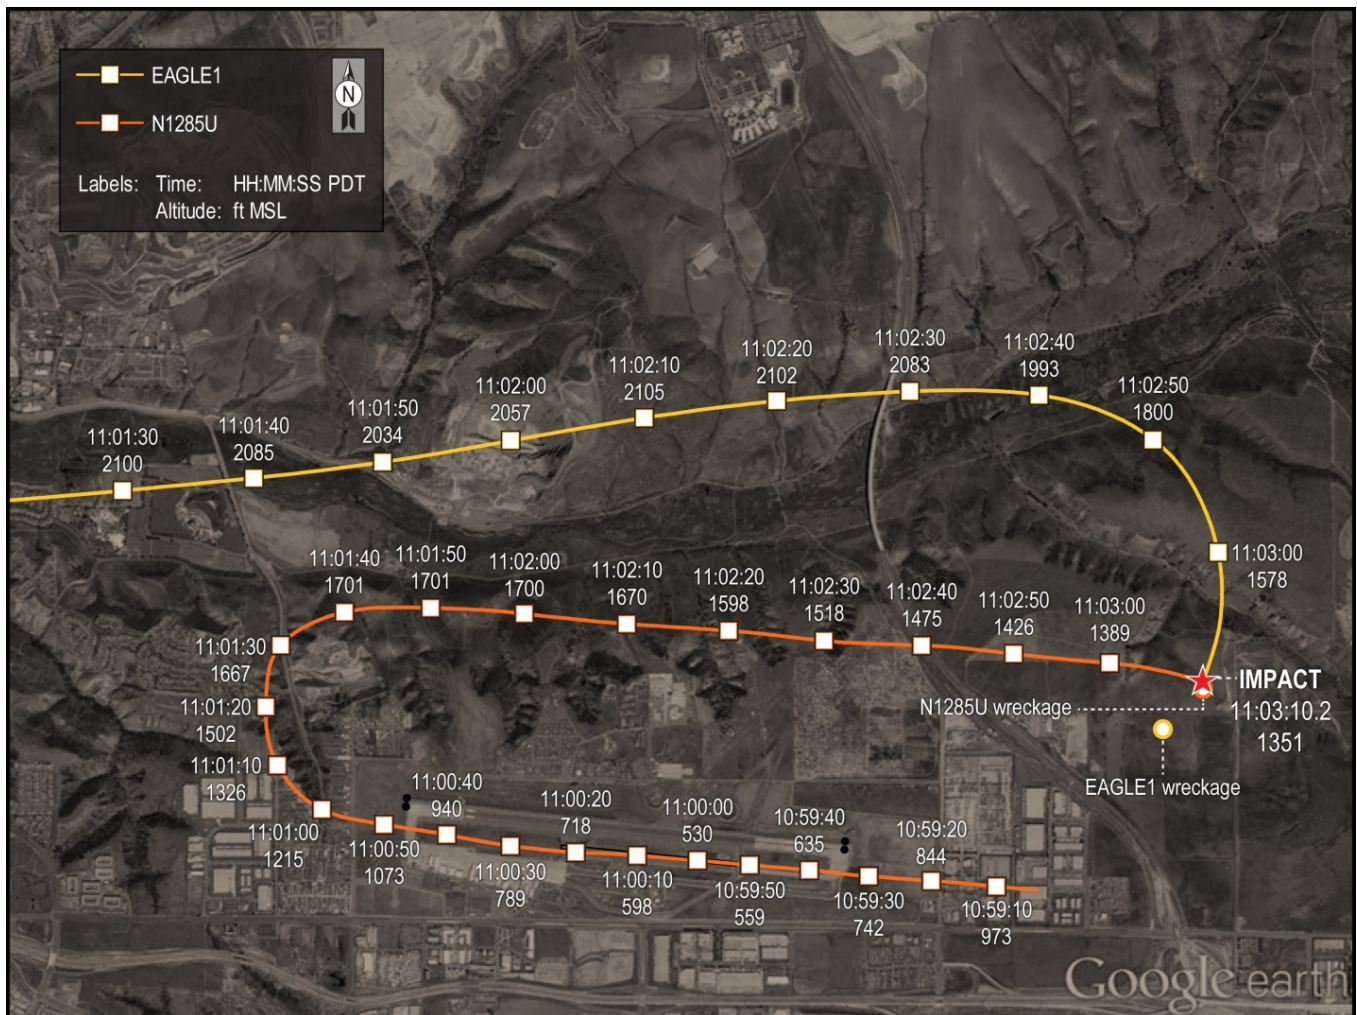
**Figure 3.** Calculated flight tracks of Eagle1 and N1285U.

traffic alert; however, the moment he realized that Eagle1 was turning into N1285U, it was too late to help. Figure 3 shows the calculated flight tracks of Eagle1 and N1285U. Figure 4 shows the aircraft under SDM ATCT control from 1049 until the time of the collision.

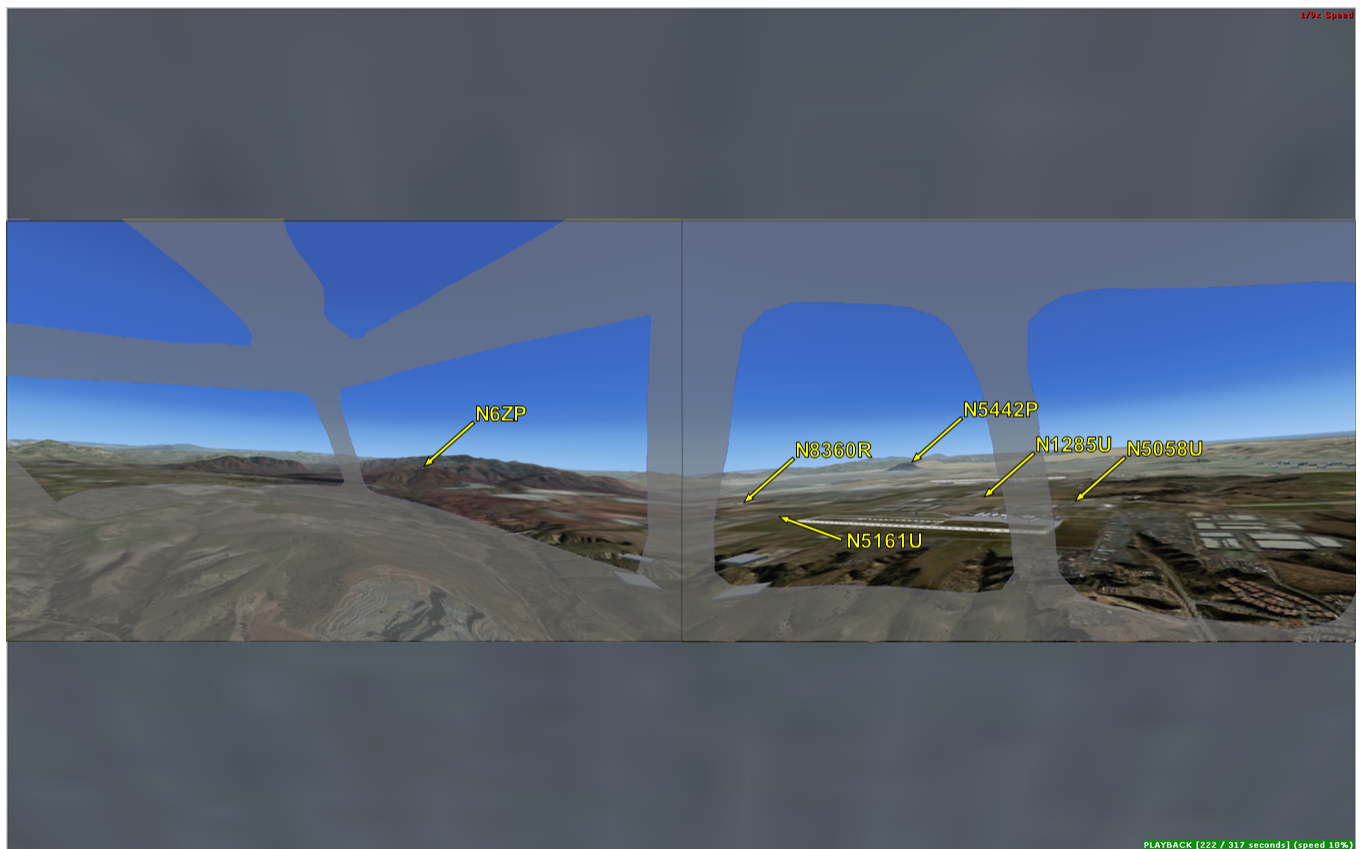
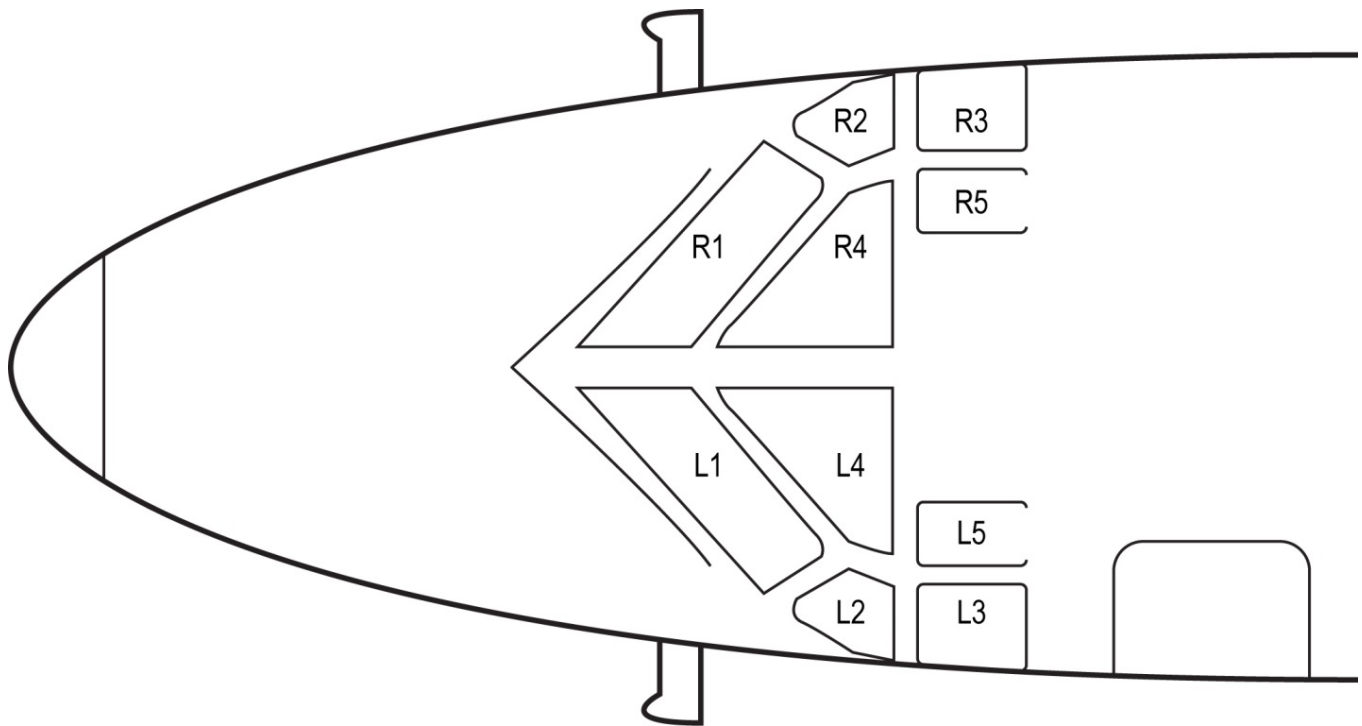
At 1101:43.1, N1285U would have been located just to the left of the window post separating Eagle1's R2 and R3 windows, and N5058U would have been just to the right of this post (see figure 7a). Eagle1 would have appeared in the left window of N1285U, just below the wingtip (see figure 7b). Eagle1 and N1285U were both on the right downwind leg for runway 26R, with Eagle1 about 0.4 nm north of N1285U.

**Figure 7a.** View from the copilot seat of Eagle1 at 1101:43.1, when the airplanes were 0.5 nm apart.

**Figure 7b.** View from the pilot seat of N1285U at 1101:43.1, when the airplanes were 0.5 nm apart.

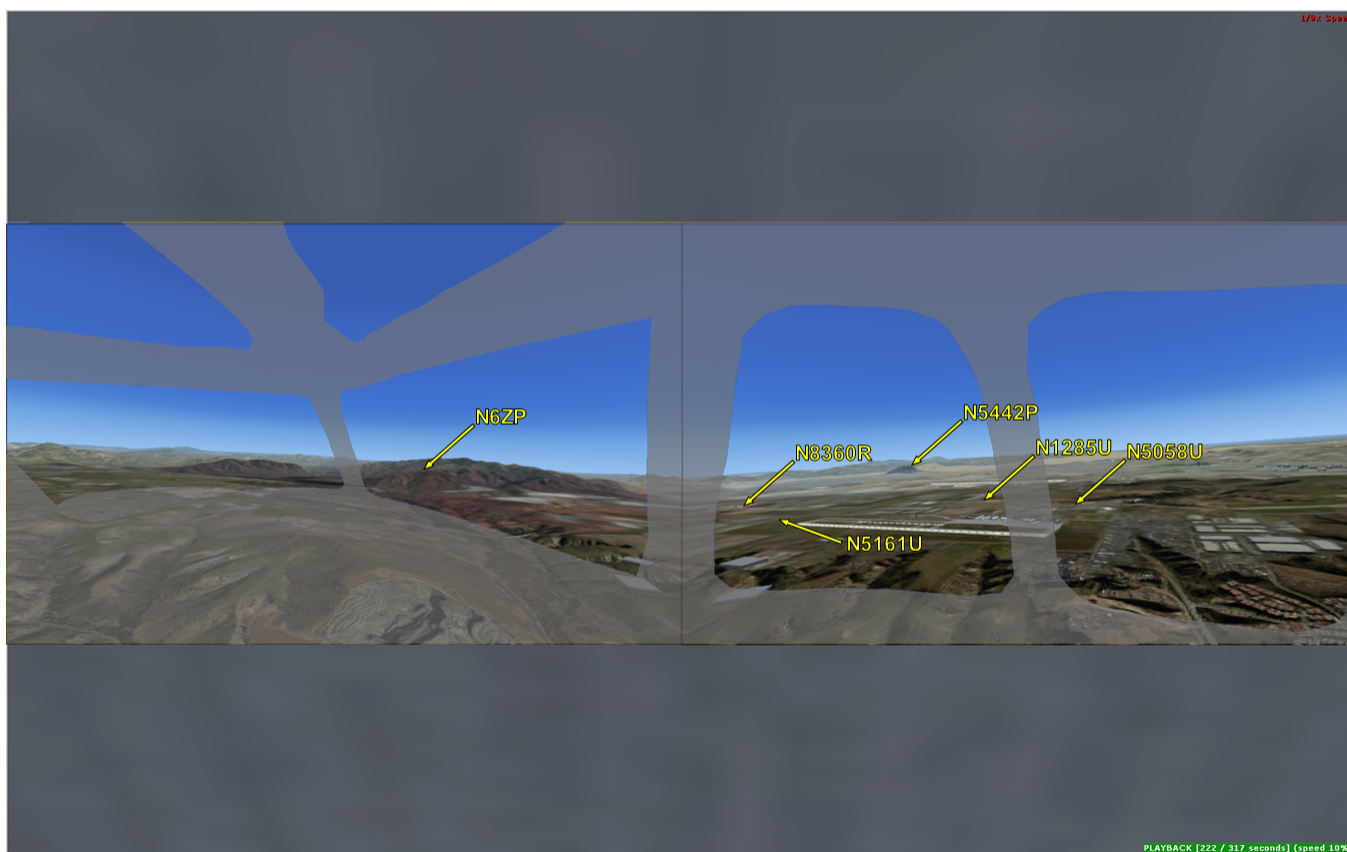
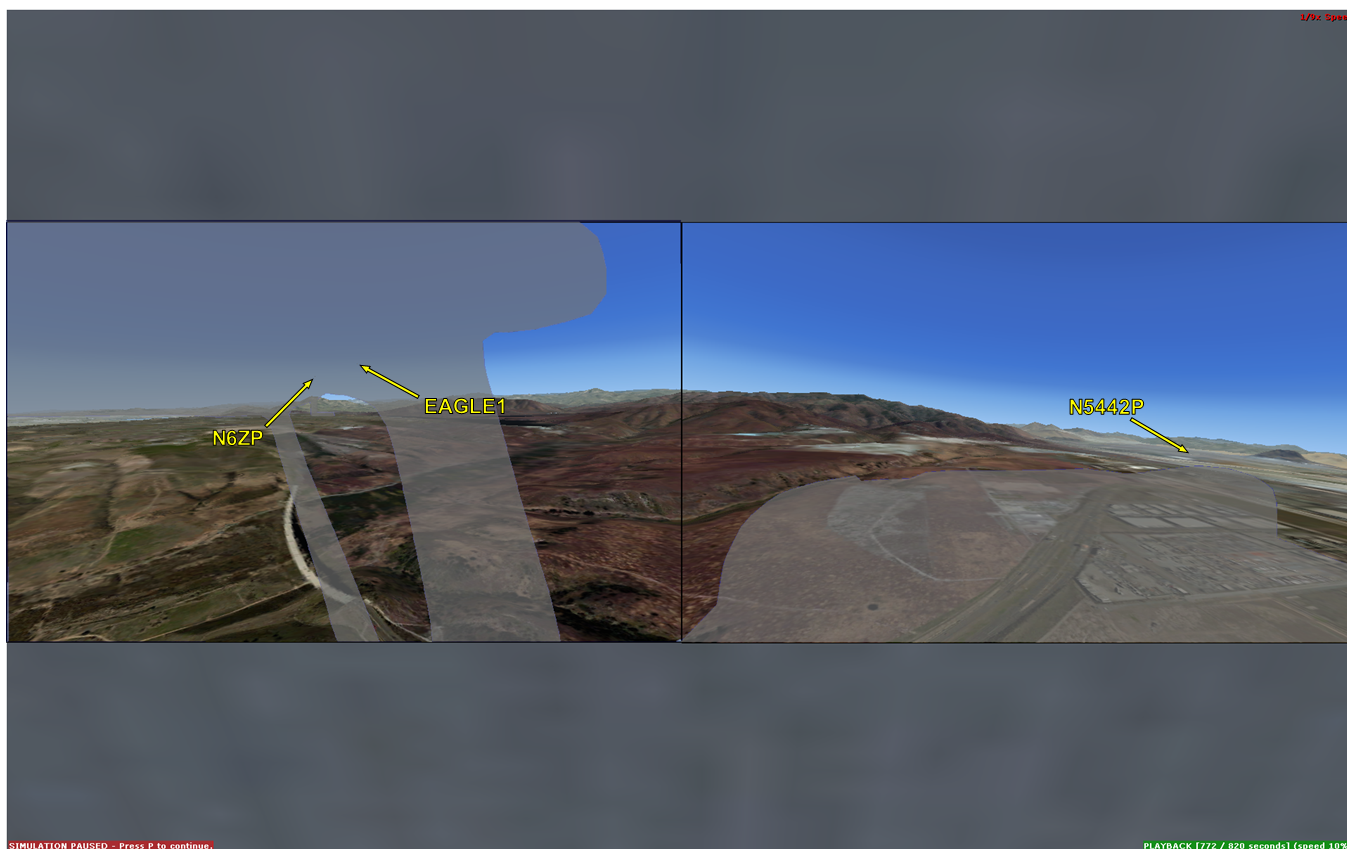
At 1102:32.0, when the LC mistakenly instructed N6ZP to make a right 360° turn, intending the instruction for N1285U, Eagle1's CVR recorded the pilot ask "you still got the guy on the right side?" N1285U was 0.8 nm away and would have appeared in Eagle1's R3 window (see figure 8a). Also to Eagle1's right were N8360R (on short final approach for runway 26L), N5442P (on a left base leg for runway 26L), and N5058U (which was climbing through 1,500 ft about 2.6 nm to the west of the runway 26R threshold). Eagle1 would have been obscured from the N1285U pilot's field of view by the left wing and strut (see figure 8b). Eagle1 started banking to the right, turning toward right base, shortly after this time.

**Figure 8a.** View from the copilot seat of Eagle1 at 1102:32.4, when the airplanes were 0.8 nm apart.

**Figure 8b.** View from the pilot seat of N1285U at 1102:32.4, when the airplanes were 0.8 nm apart.

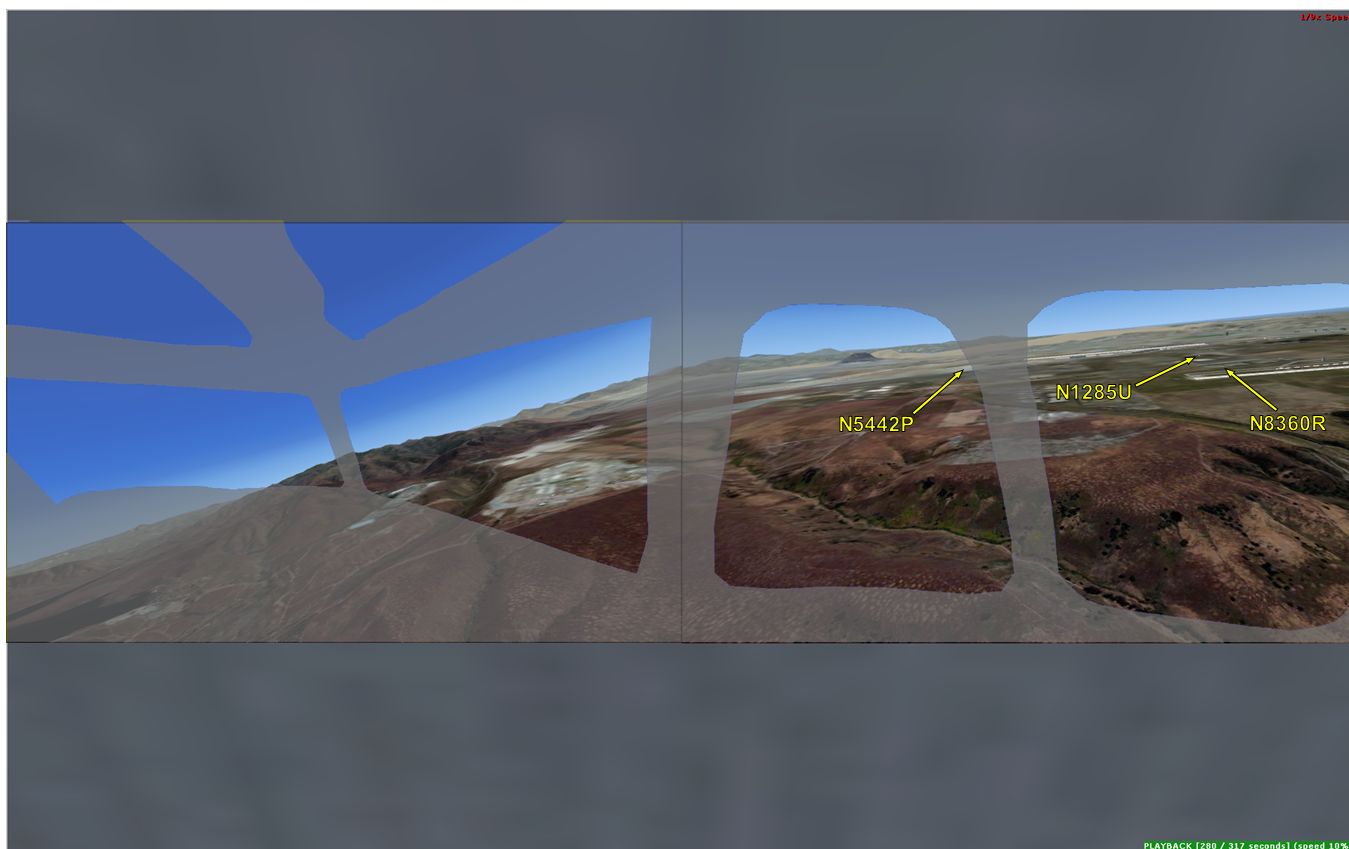
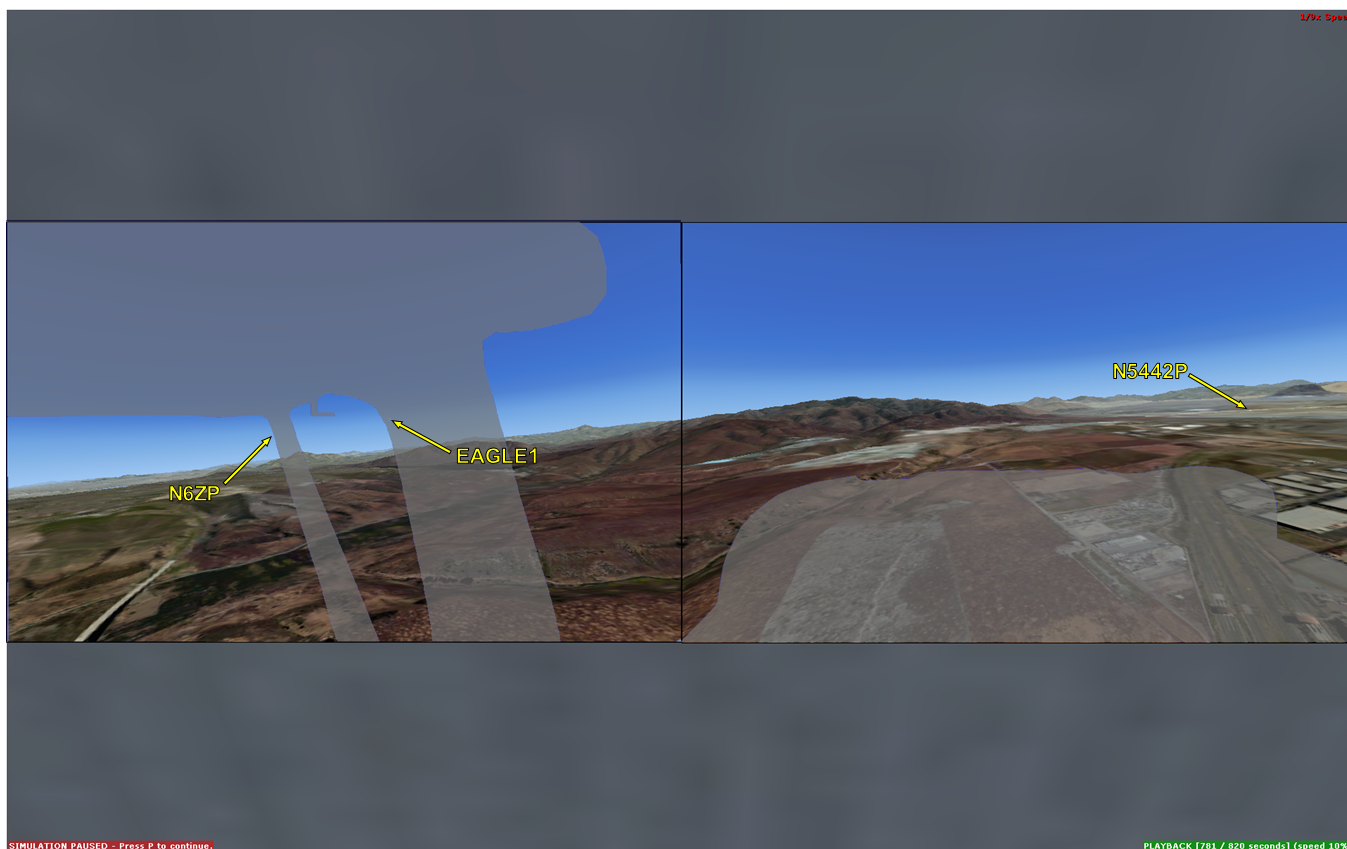
At 1102:42.0, when the LC instructed the pilot of Eagle1 to "turn base two six right cleared to land," Eagle1 was descending through 1,960 ft in a right bank, about 1.3 nm north and 0.7 nm east of the runway 26R threshold. N1285U was descending through 1,460 ft, about 0.6 nm north and 0.3 nm east of the threshold, and would have appeared in Eagle1's R3 window (see figure 9a). Eagle1 would have appeared in the N1285U pilot's field of view near the edge or slightly behind the window post separating the left window from the windshield (see figure 9b). The airplanes were still about 0.8 nm away from each other.

**Figure 9a.** View from the copilot seat of Eagle1 at 1102:42.0, when the airplanes were 0.8 nm apart.

**Figure 9b.** View from the pilot seat of N1285U at 1102:42.0, when the airplanes were 0.8 nm apart.

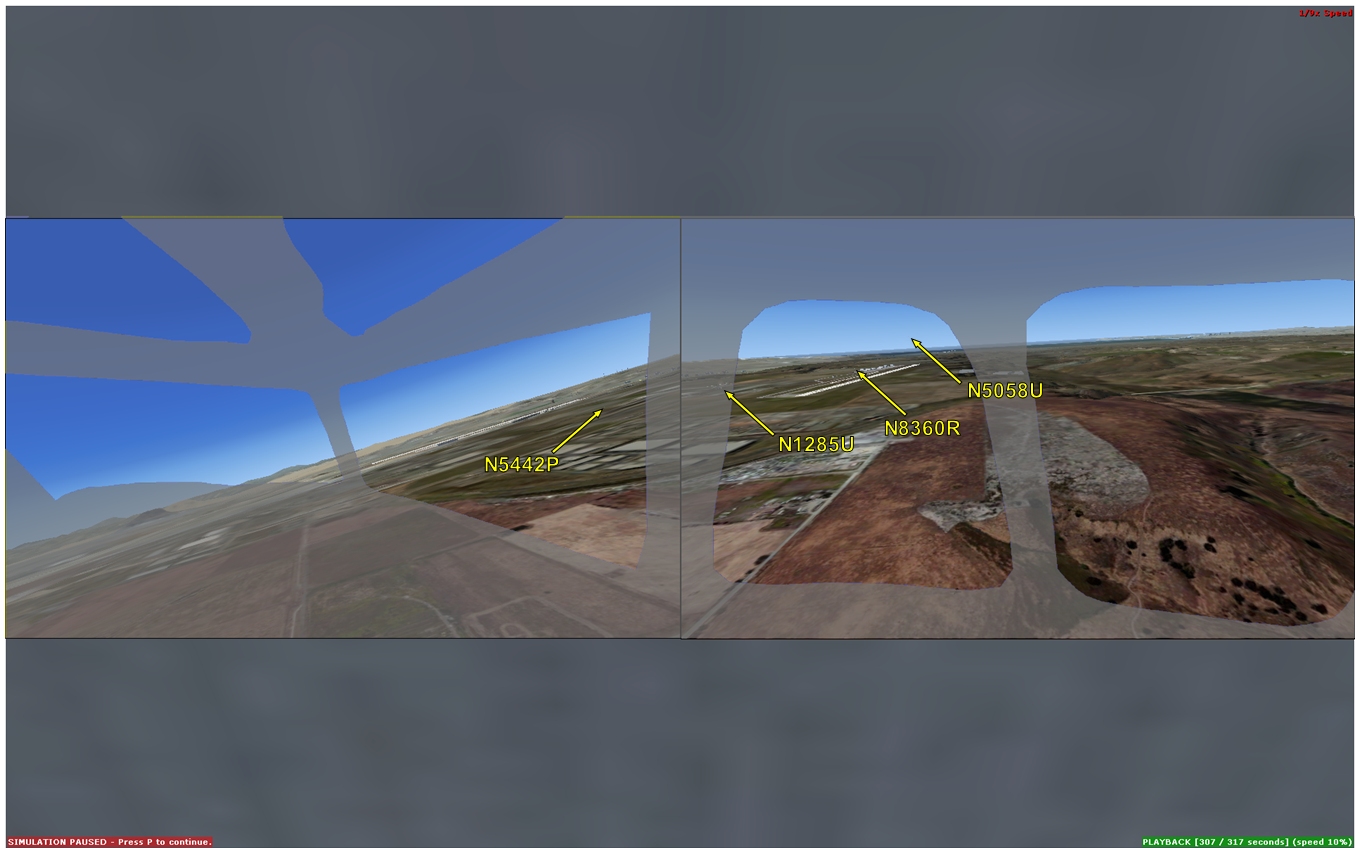
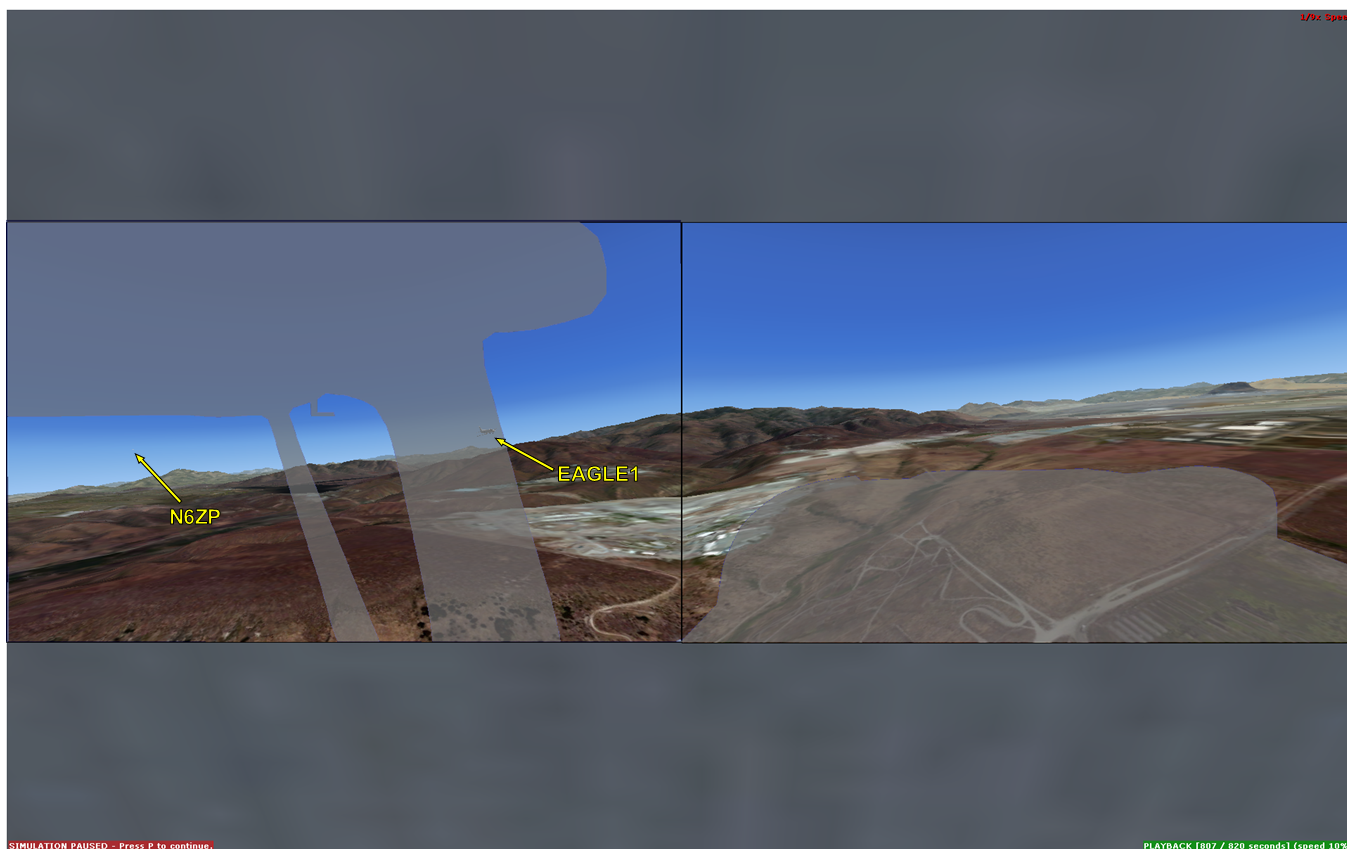
At 1103:08.0, when the controller asked the N1285U pilot if he was still on downwind, Eagle1 and N1285U were about 0.1 nm apart. N1285U may have been obscured by the post between Eagle1's R1 and R2 windows, and Eagle1 may have been obscured by N1285U's window post (see figures 10a and 10b).

**Figure 10a.** View from the copilot seat of Eagle1 at 1103:08.0, when the airplanes were 0.1 nm apart.

**Figure 10b.** View from the pilot seat of N1285U at 1103:08.0, when the airplanes were 0.1 nm apart.
