Aviation Investigation Final Report

Location:	Woodland, Washington	Accident Number:	WPR16FA095
Date & Time:	April 21, 2016, 14:45 Local	Registration:	N97119
Aircraft:	MOONEY AIRCRAFT CORP. M20K	Aircraft Damage:	Substantial
Defining Event:	Miscellaneous/other	Injuries:	1 Fatal, 2 Serious
Flight Conducted Under:	Part 91: General aviation - Personal

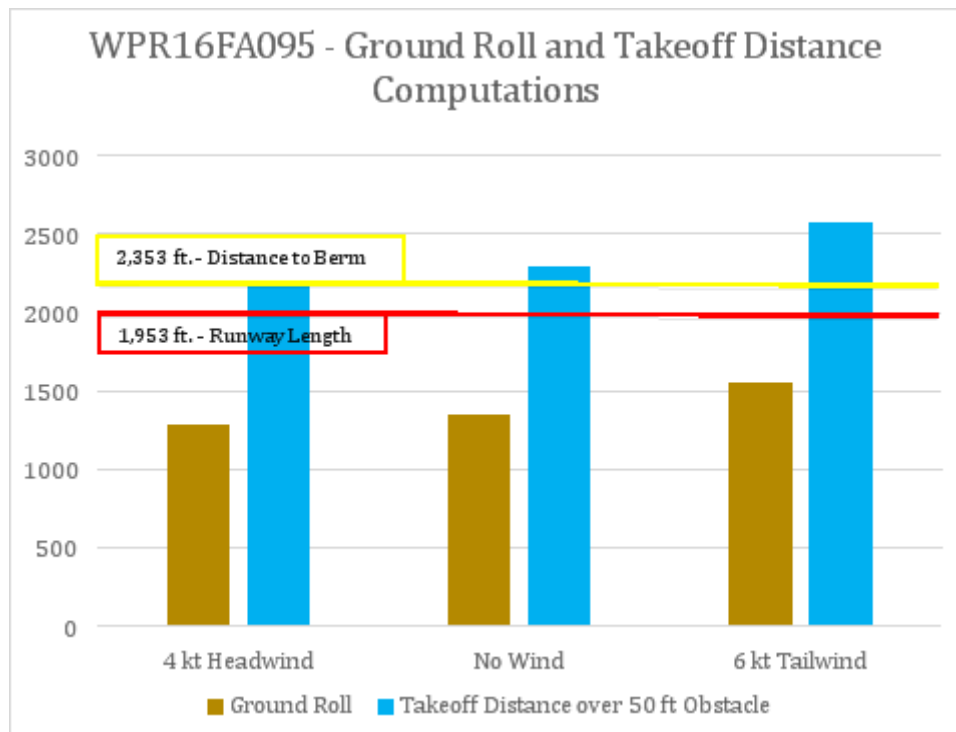
Table 1: Ground Roll and Takeoff Distance Chart

The AFM takeoff performance section includes charts for both ground roll and takeoff distance over a 50-ft obstacle. Both charts assume conditions that include 10° flaps, 40 inches manifold pressure, mixture full rich, and a paved level runway surface. These performance charts do not account for weights above the airplane's maximum gross weight of 2,900 pounds (lbs). Using the charts, the airplane's ground roll and takeoff distance over a 50-ft obstacle were calculated assuming an outside air temperature of 23°C and a gross weight of 2,900 lbs. As shown in Table 1, the airplane's zero-wind ground roll and takeoff distance over a 50-ft obstacle were about 1,350 ft and 2,300 ft, respectively. With a 4-knot headwind, the airplane's ground roll and takeoff distance over a 50-ft obstacle were about 1,200 ft and 2,200 ft, respectively. With a 6-knot tailwind, the airplane's ground roll and takeoff distance over a 50-ft obstacle were about 1,550 ft and 2,600 ft, respectively.
