(The following report is provided by Aerospace Engineer Jeff Janusz from the Wichita Aircraft Certification Office. Affected Cessna models are the 310, 320, 321, 335, 340, 401, 402, 404, 411, 414, and 421 Series aircraft. This counsel is published as received, along with contact information at the article's end.)

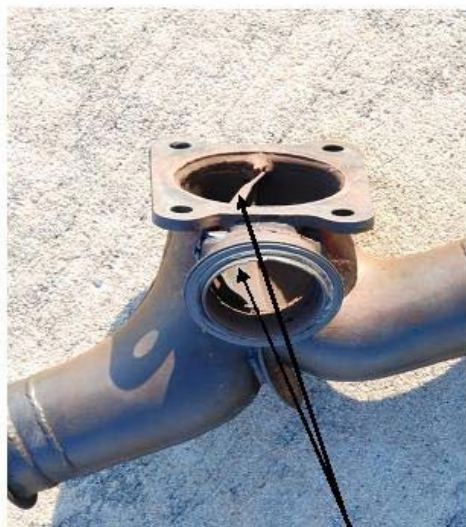
Photo 1: Wye, with failed internal baffle.

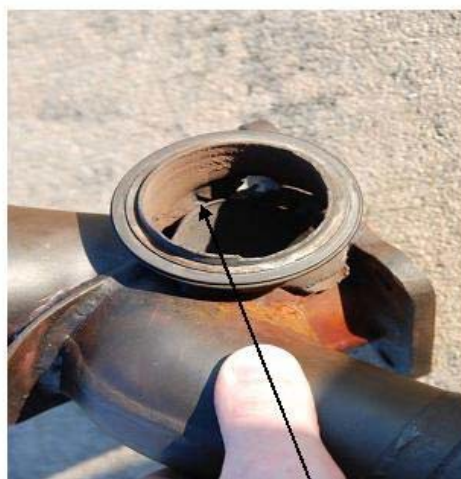
Photo 2: Wye waste-gate elbow attach flange fatigue failure.

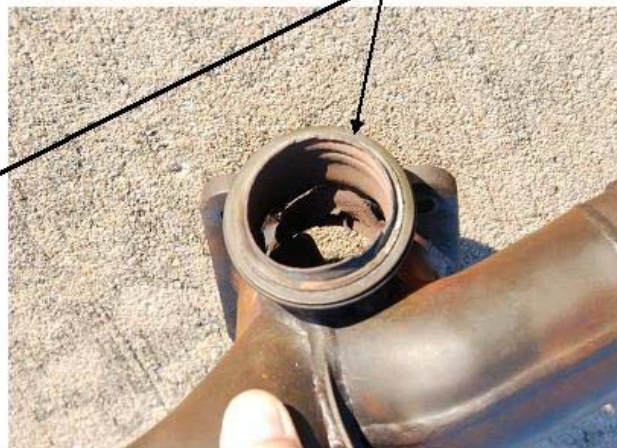
Photo 4:

**Failed wye to waste-gate attach flange.**

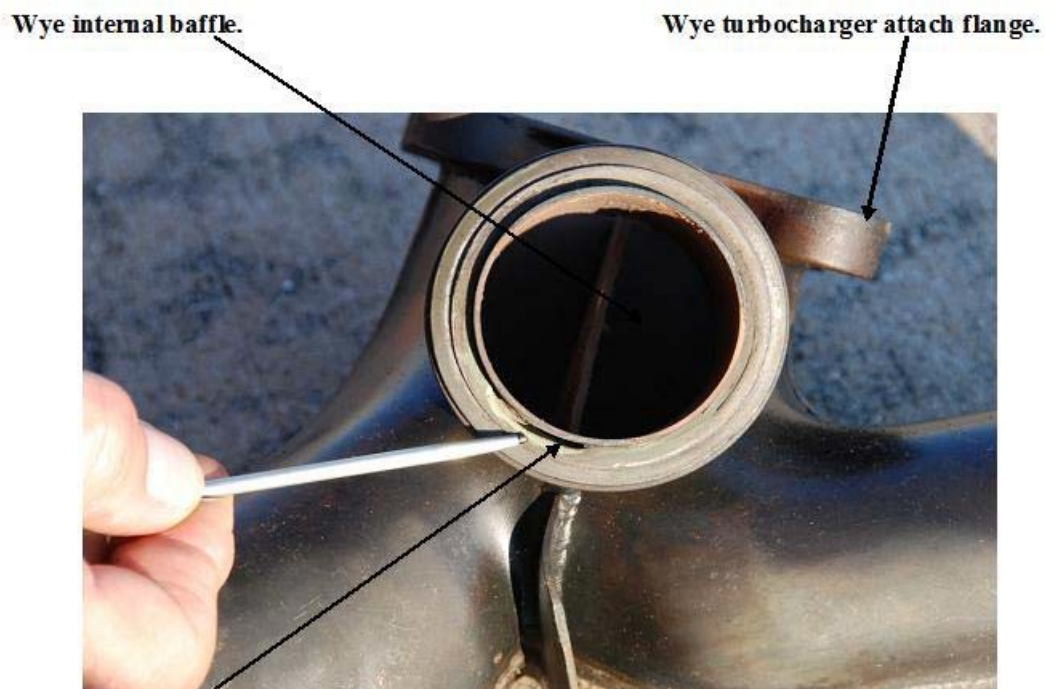
New evidence indicates exhaust system parts have failed after satisfactorily passing numerous inspections and being *signed off* with no discrepancies noted. The failures appear to be due to improper assembly of the exhaust system after engine or exhaust system inspection, repairs or overhaul. The improper installation resulted in the parts being preloaded (pre-stressed), eventually leading to fatigue failure. These failures had also gone undetected through multiple inspection cycles.

**Photo 5: 3° deflection of the wye waste-gate attach flange due to preloaded installation and subsequent fatigue failure.**

It is extremely important all exhaust system components removed or replaced for any reason be installed carefully and without preload, using approved, accepted methods and techniques. Cessna has available service manual information and numerous service publications which address exhaust systems. These exhaust systems have a very good safety record if regularly and properly inspected, but the importance of these inspections to safety-of-flight cannot be overstated.

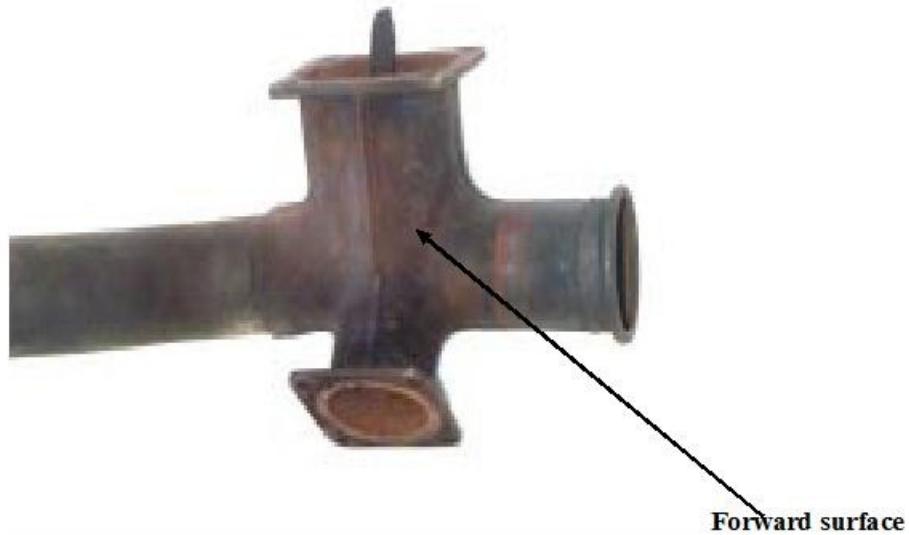
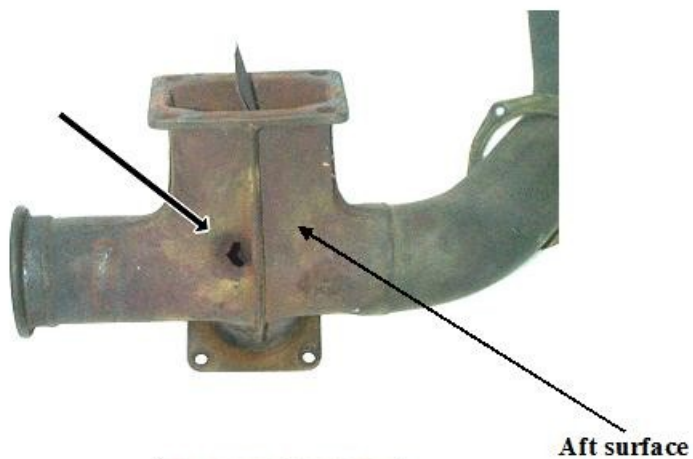
**Another example of wye forward surface with pin holes through (left arrow) and staining (right arrow).**

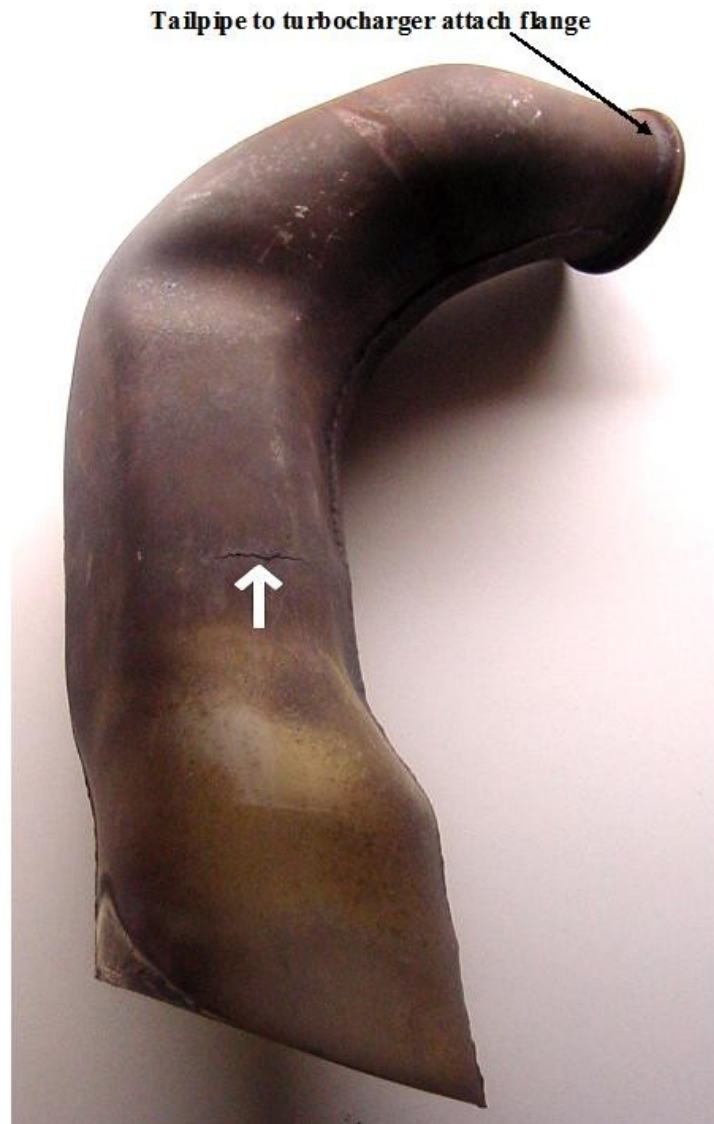
**A tailpipe; with arrow pointing to crack through forward surface.**

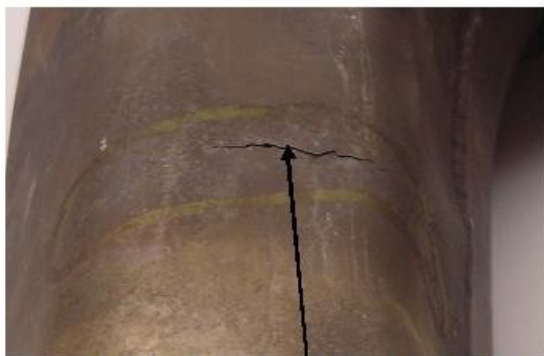
**Crack through forward side of tailpipe.**

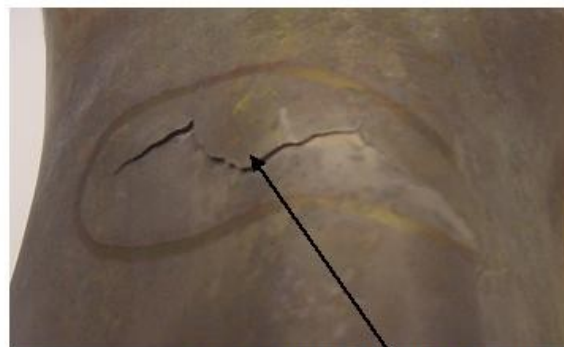
**Crack through aft side of tailpipe**
