## Aviation Maintenance Alert - Cirrus SR20 and SR22 Aircraft.

This Alert results from an accident that occurred on May 27, 2018 in Houston, Texas where a SR-20 airplane crashed shortly after takeoff.

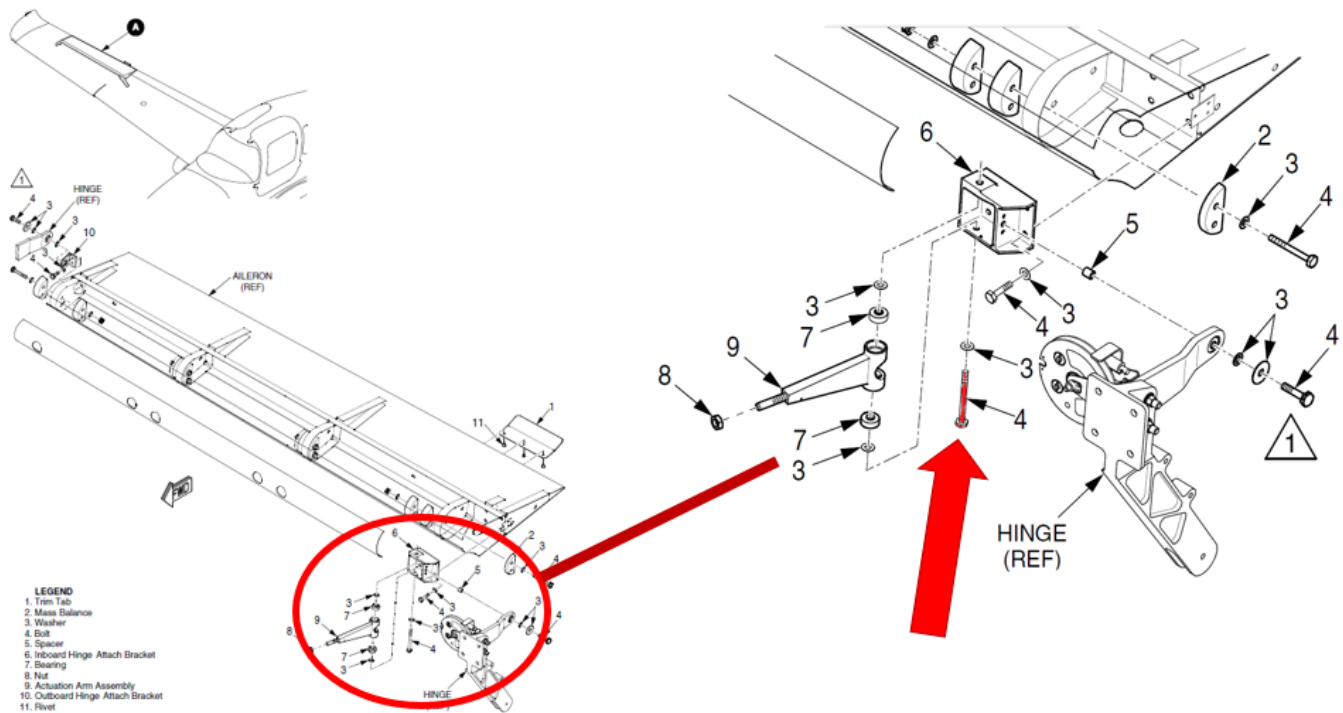
The pilot report that he could not maintain roll control of the airplane immediately after takeoff. The airplane began to roll to the left. The pilot was able to counteract with right aileron input initially, but the airplane continued to roll to the left. The pilot continued to use right aileron and trim, lowered the nose, and executed a straight-in forced landing just beyond the departure end of the runway. Examination of the airplane after the accident revealed that the left aileron actuation arm and attach bolt were missing with no associated impact damage.

Further investigation indicated that the safety wire was missing from the actuation bolt, indicated by the red arrow below.

As the bolt is readily visible during a walk around inspection, we recommend that all owners and operators visually verify the presence of the required safety wire before further flight. (See the illustration photo) If safety wire is not present, have a qualified maintenance provider correct the situation before further flight.
