Tucson International Airport (TUS) Hot Spot Information  
Western-Pacific Region  
Runway Safety Operations Field Group

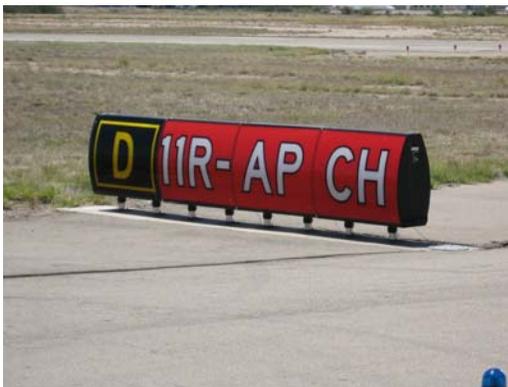
**Hot<sup>2</sup>** - Taxiway Delta and aligned taxiways for Runways 11L and 11R – These areas are where a large number of pilot deviations have occurred, involving pilots taxiing along Taxiway D and entering the area to be protected for Runway 11L and/or 11R. (See the hot spot chart below.) There are elevated mandatory holding position signs protecting the approach areas along with runway holding position markings. Pilots are crossing the holding position markings on Taxiway Delta without a clearance.

One contributing factor appears to be that the signs only depict Runways 11L and 11R and not 29L or 29R. Air traffic controllers will only use the runway designator of the active runway. It is becoming apparent that pilots are not associating 11L or 11R with 29R or 29L when instructed to hold short of Runway 29R or 29L on Taxiway Delta.

Pilots are strongly encouraged to include airport movement along with their flight planning. Study the airport diagram and trace the expected taxi route from parking, to run-up, to the expected departure runway. Identify complex intersections and prepare to successfully navigate those intersections. Always keep your head up when taxiing and remember, if in doubt, ASK!

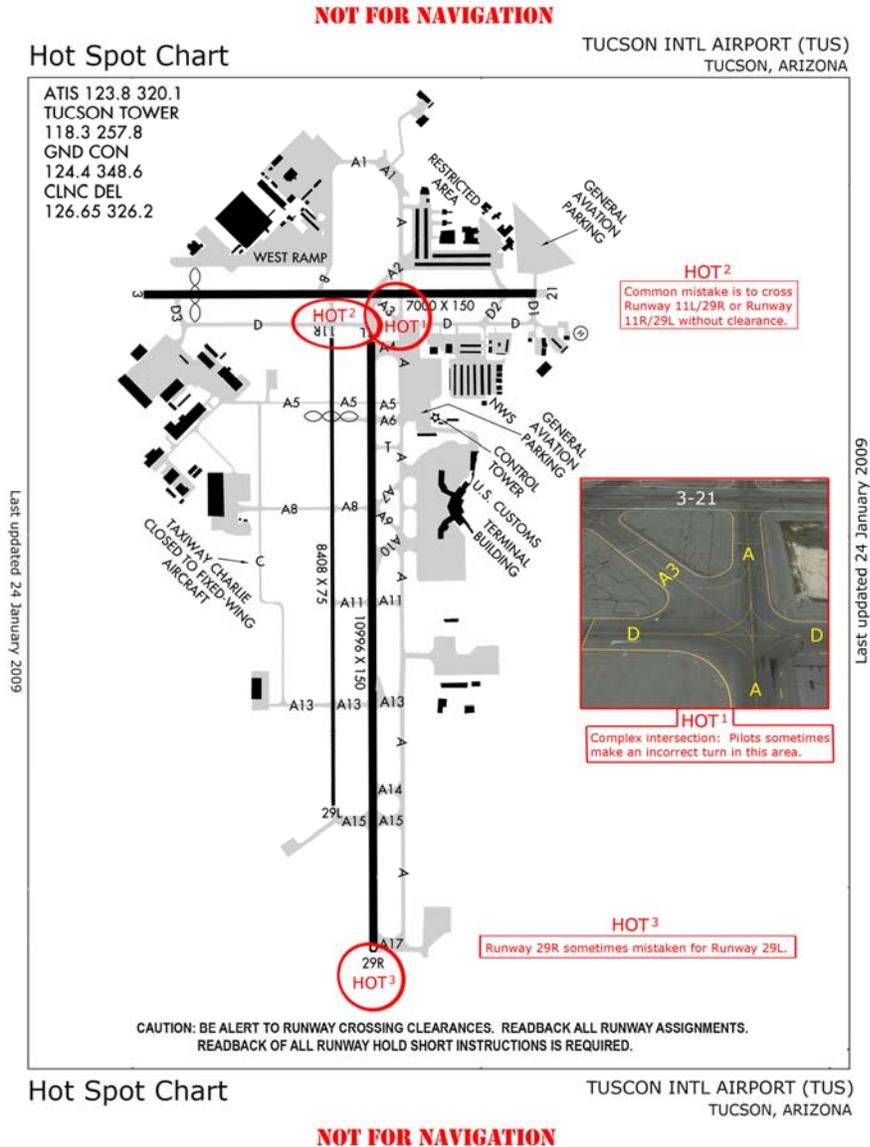
**Hot<sup>1</sup>** - Intersection of Taxiways Alpha, Alpha 3, and Delta – This is a complex intersection that presents an even higher level of navigating difficulty because the pavement beyond the taxiway edge lines is the same color and has a tendency to blend with the taxiway. Pilots approaching from the south along Taxiway A or approaching from the east along Taxiway D may become confused with the wide expanse of pavement. The FAA and airport are working on solutions to improve this area.

**Hot<sup>3</sup>** – Runway 29R approach end - Pilots are having difficulty in landing on the correct runway. Tucson has a set of parallel runways where the south thresholds do NOT align. Runway 29R threshold is located approximately 2600 feet southeast of the threshold for Runway 29L, and there have been occurrences where pilots have incorrectly landed on Runway 29L.
